**COASTAL EROSION PROBLEMS IN THE
GILBERT ISLANDS GROUP REPUBLIC
OF KIRIBATI**

Richard D. Gillie

SOPAC Secretariat

SOPAC Technical Report 167

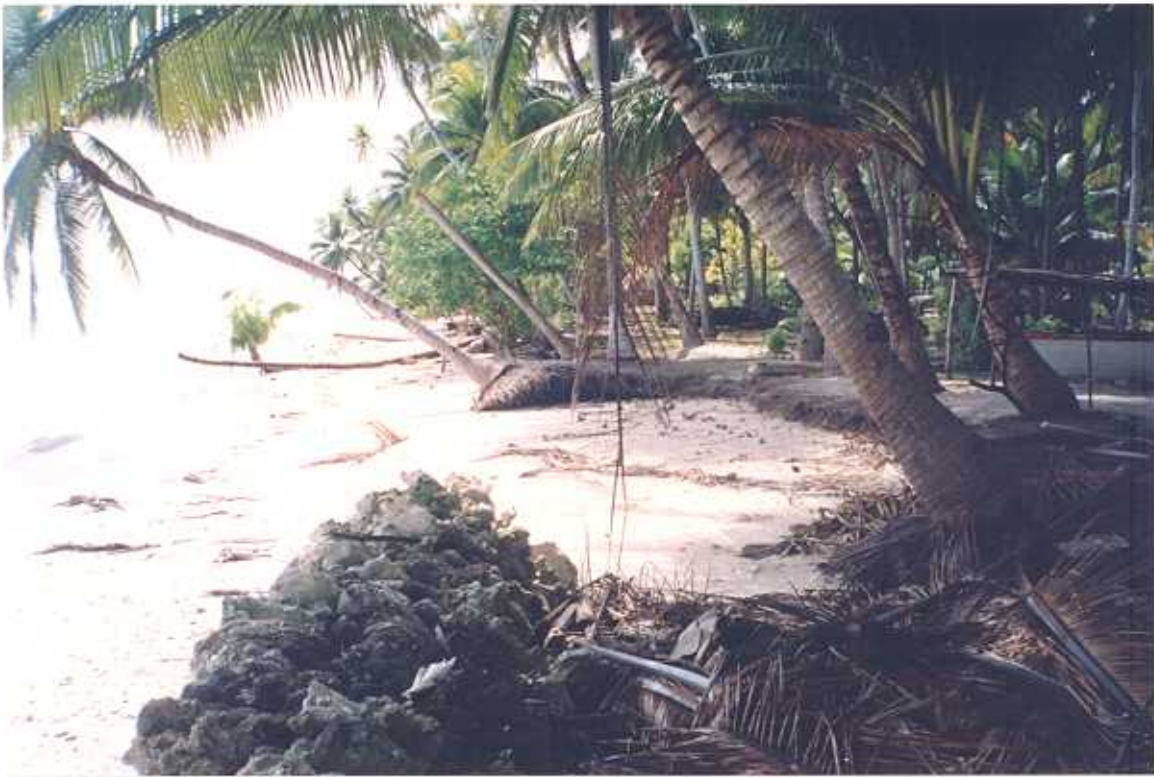
Figure 3. Eita District, Tabiteuea North. View north of beach profile location Eita-1. Note coastal erosion as indicated by beach scarp, fallen coconut trees and remains of coral boulder seawall in the foreground. Seawall foreshore protection makes up less than 5 % of the shoreline in this area.

from the eroding shoreline. Although it was not possible to obtain an exact measurement of the amount of erosion that has occurred, local sources estimated it at about 10 metres. Local attempts at foreshore protection have been made in the form of loose coral boulder seawalls (Figure 3) and 10 fences which amounts to about five percent of the shoreline length.

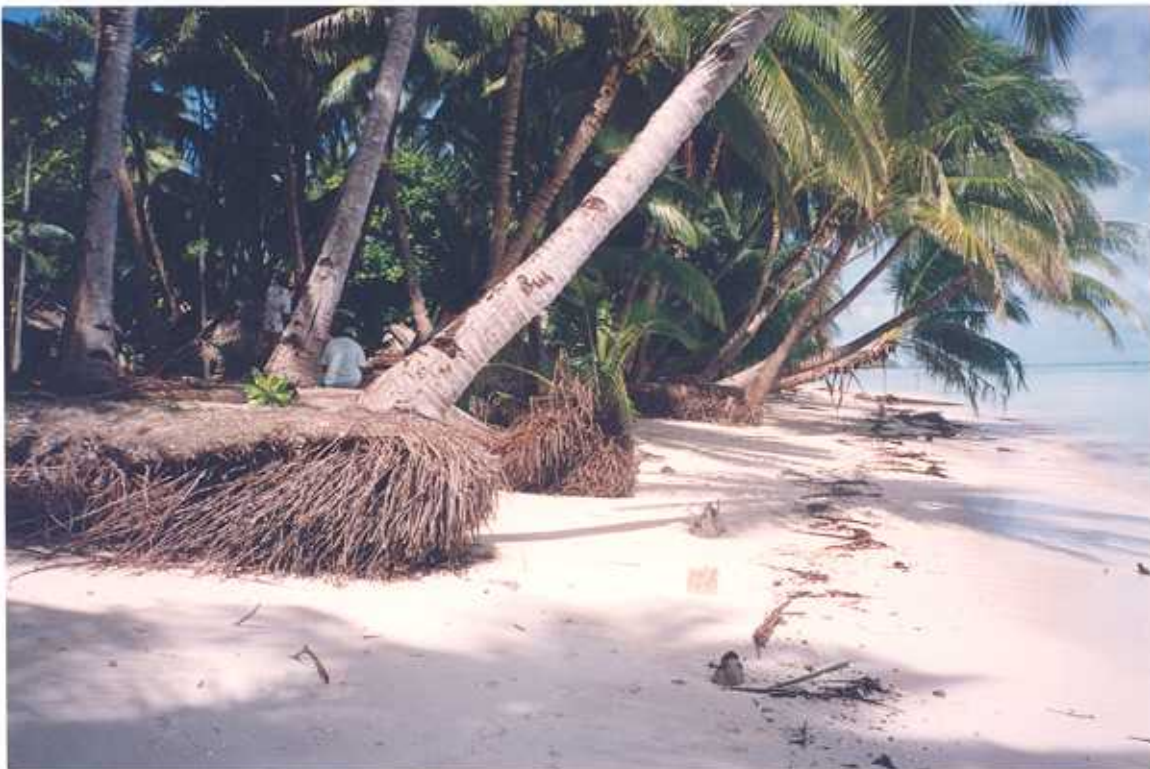
Figure 4. Eita District, Tabiteuea North. View south past location of beach profile Eita-1. Coastal erosion extends north from this point along the lagoon shoreline for approximately 1.5 km.

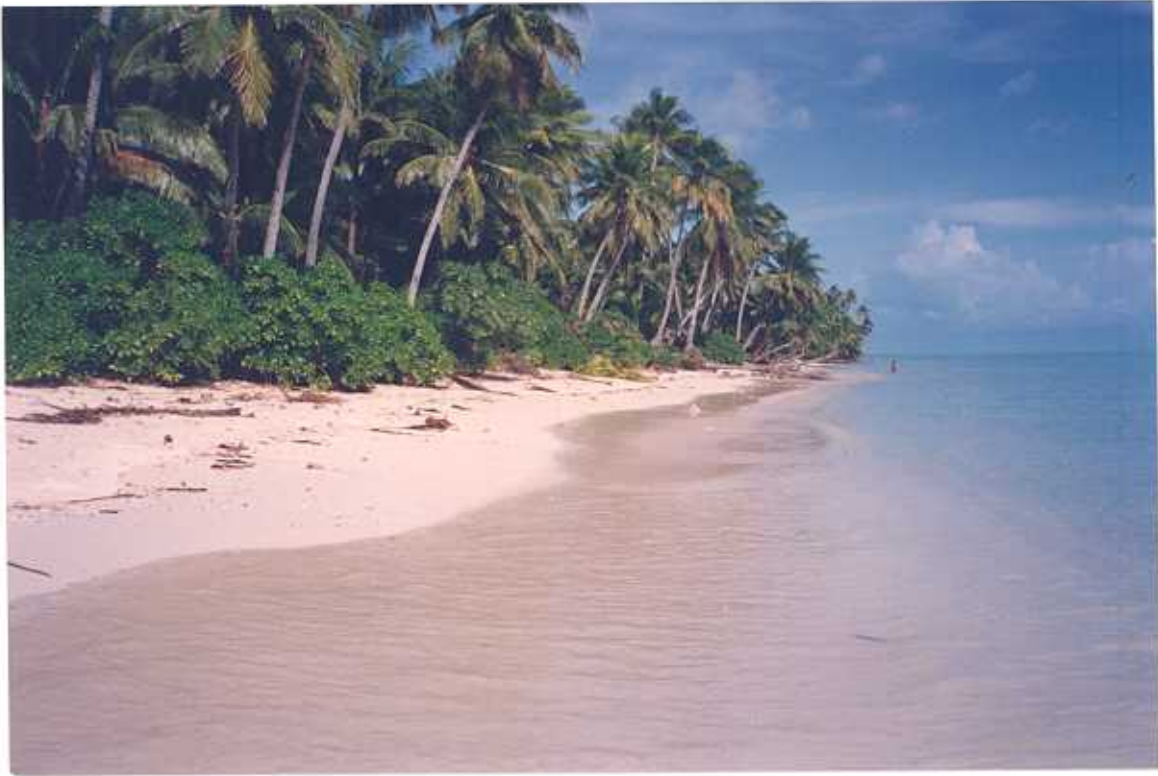
Figure 5. Eita District, Tabiteuea North. View south in front of beach profile Eita-2. This point marks the end of approximately 1.5 km of active erosion along the lagoon shoreline.

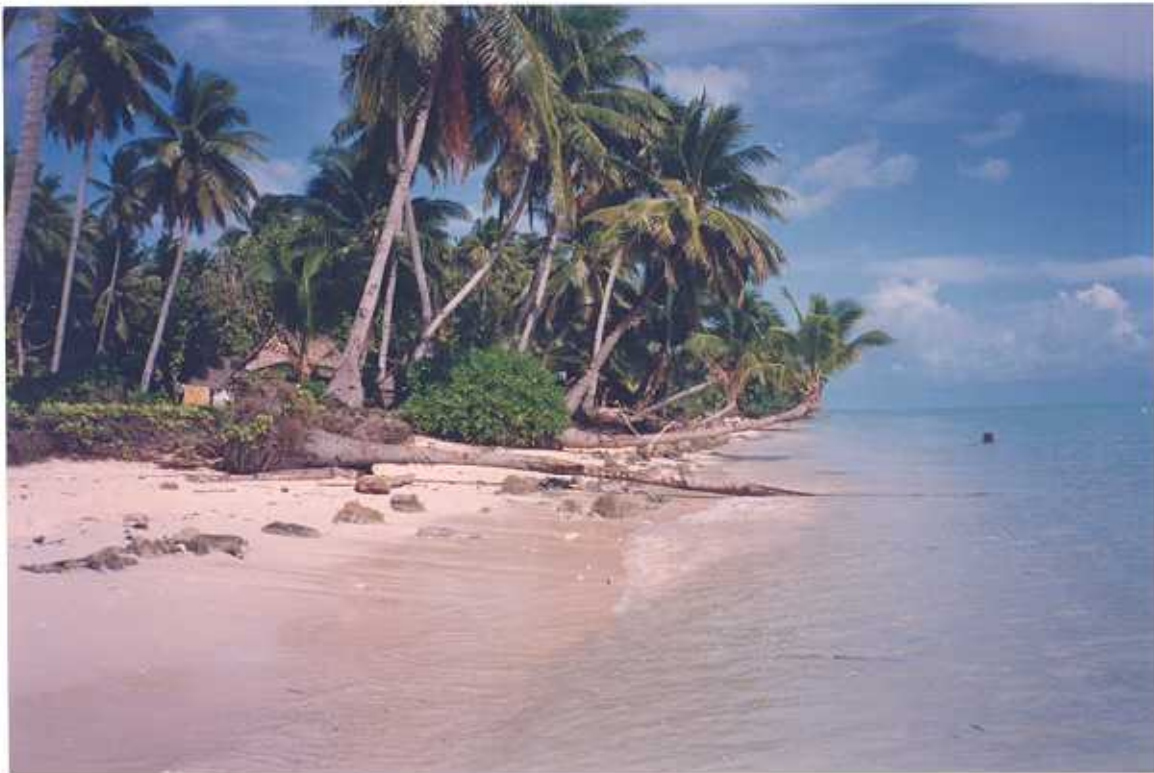
Figure 6. Eita District, Tabiteuea North. View south approximately 30 m south of Figure 5. Note evidence of erosion as indicated by beach erosion scarp, fallen coconut trees and remains of seawall on beach.

Any effort given to the construction of foreshore protection along a 1.5 km length of shoreline would be extremely costly. Previous attempts at low cost foreshore protection, as shown in Figure 6, have only provided a temporary solution. If the nature of the erosion is long term, then any effort given to low cost (less than \$ 200/m) foreshore protection would be ill advised since any scheme would be doomed to failure. If the nature of the erosion is short term and/or cyclical, then the erosion problem will diminish or stabilize in the future. It is therefore recommended that re-location of existing buildings be continued as an appropriate response to the erosion problem. It is also recommended that the possibility of further coastal erosion be taken into consideration in the planning process for siting any permanent buildings in this area.

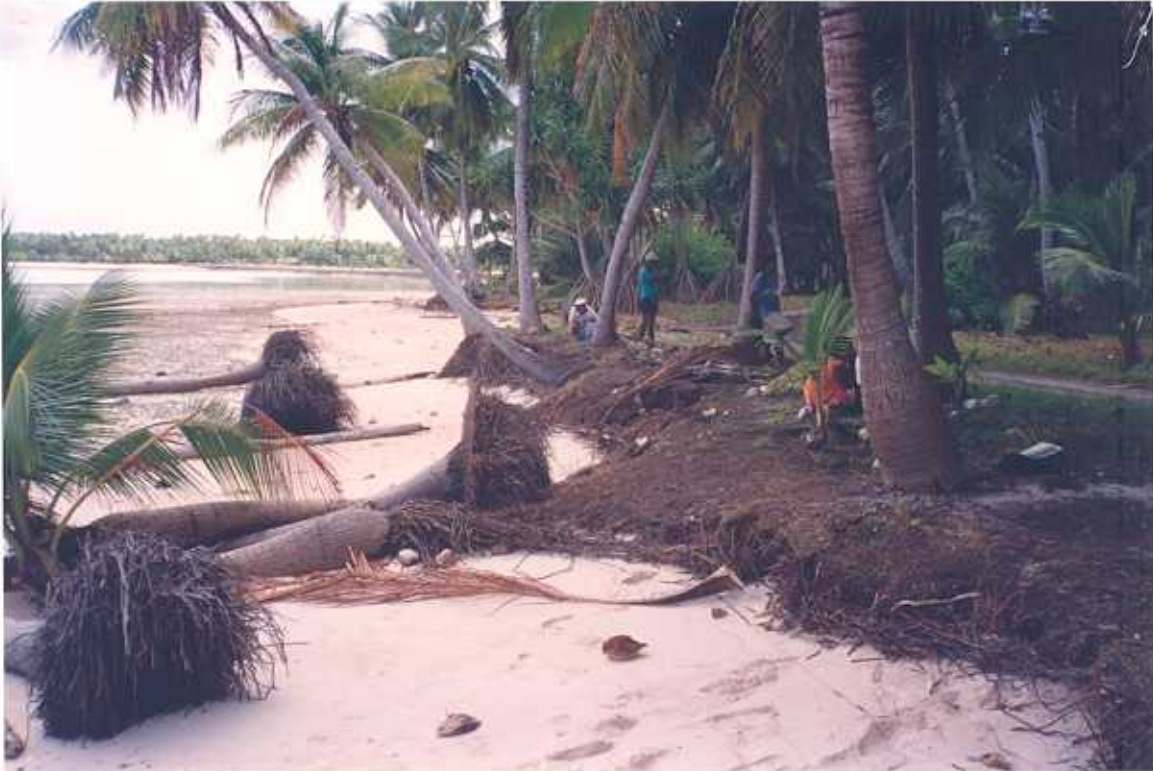
Figure 8. Nikutiri Island, Tabiteuea South. View north along lagoon shoreline at beach profile site showing erosion as indicated by beach scarp and fallen coconut trees. Erosion is also undermining the road. Causeway shown in Figure 9 is visible in the distance.

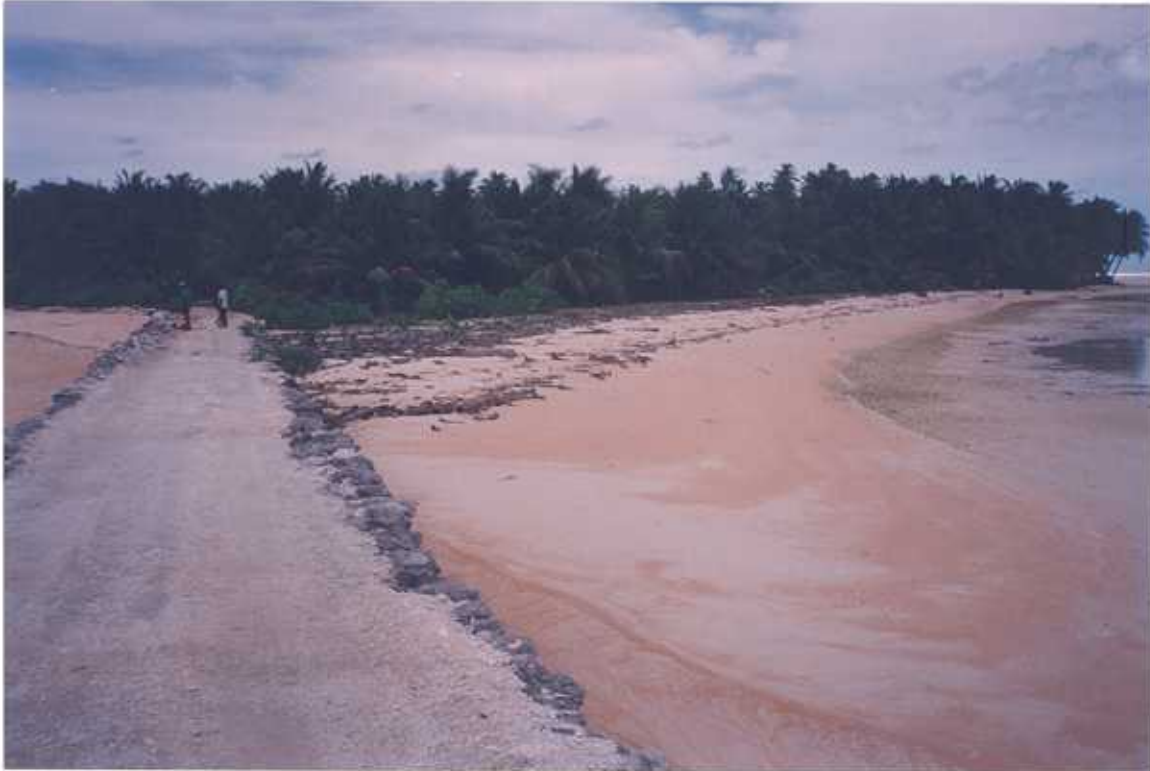
The cause of the coastal erosion appear to be man-made and is related to the construction of the causeway to the north of Nikutiri Island (Figure 9). The causeway was originally constructed in the late 1950 s using manual labour to move and place coral boulder material from the ocean reef forming a solid structure. The causeway was upgraded in the 1980's with additional boulders and concrete. As a result, the causeway reduced water flow in the inter-islet channel, intercepting the sediment transport pathway from the ocean to the lagoon. Shoreline sediment has also been redistributed from the lagoon beaches to beside the causeway. As a result, accretion has occurred adjacent to the causeway on both the ocean to the lagoon sides. In particular, the accretion on the lagoon side has amounted to about 100 m beside the causeway and island shoreline. The wedge- shaped area of accretion is vegetated with coconut trees which become progressively shorter, and the therefore younger, towards the present shoreline (Figure 9).

Figure 9. Nikutiri Island, Tabiteuea South. View south to Nikutiri Island from causeway. Accretion has occurred adjacent to the causeway on both the ocean (left) and lagoon (right) sides of the shoreline. Erosion site is located 200 m southwest of photo.

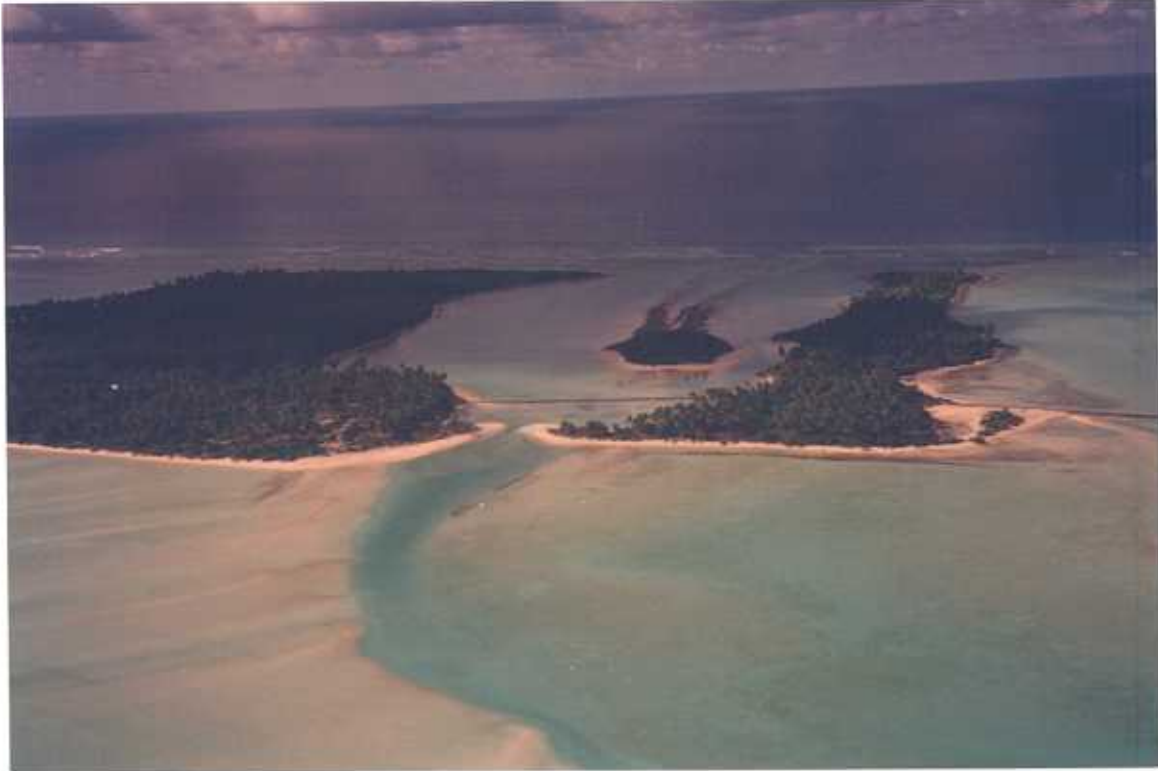
Figure 10. Aranuka Island, Tabiteuea South. View northeast to lagoon shoreline on Nikutiri Island (left) and Aranuka Island (right). Causeways joining islands have caused redistribution of lagoon shoreline sediments, specifically as erosion of island lagoon beaches and formation of lagoon spits across inter-islet channels. Note that the channel between Aranuka and Nikutiri is almost closed by spit growth.

The causeways were built in the early 1960s using manual labour and local materials. Erosion of the lagoon beach on Aranuka was noticed shortly after. In addition to the lagoon beach erosion, spits have formed at both the north and south ends of the island in response to inter-islet channel closure by causeway construction. On the north end, spit growth has almost totally closed the inlet opening (Figure 10).

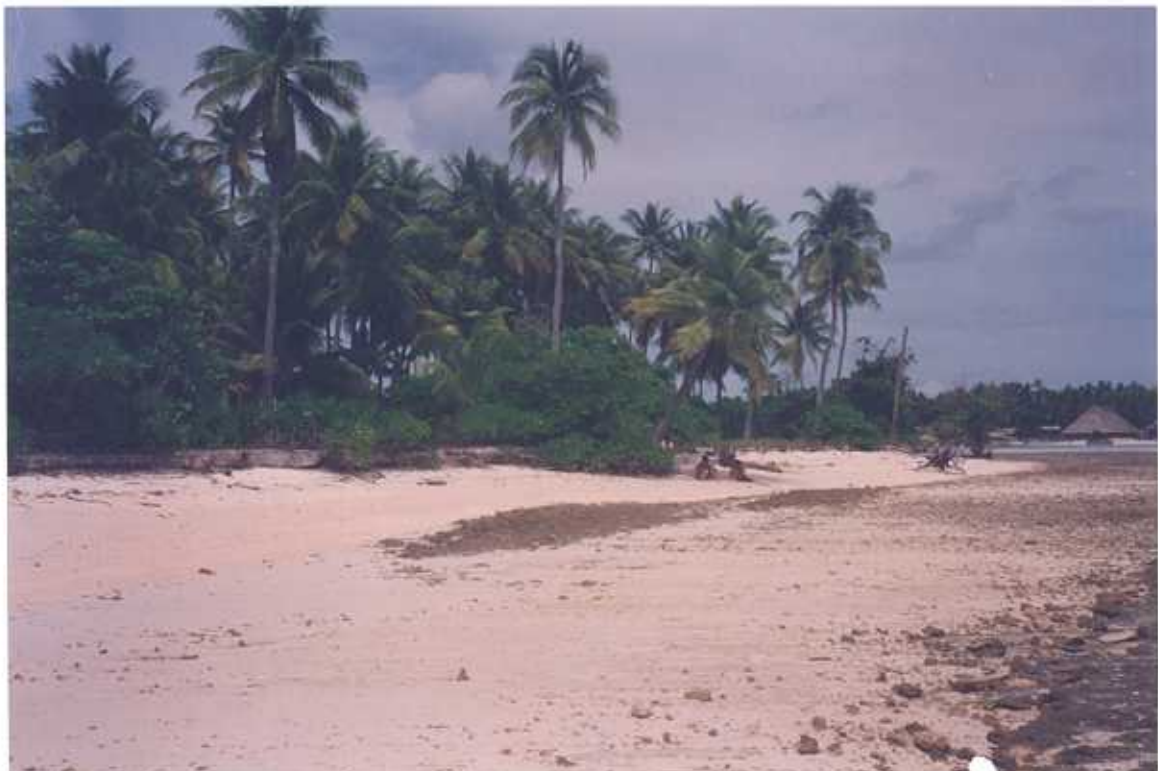
Aranuka Island is located immediately southeast of Nikutiri Island (Figure 7 and 10). Aranuka Island is joined by causeways to the islands to the north and south. The site of erosion extends along the entire length of the lagoon shoreline for a distance of about 200 m (Figure 11).

Figure 11. Aranuka Island, Tabiteuea South. View southeast along lagoon shoreline in vicinity of beach profile. Erosion indicated by erosion scarp and exposure of tree roots. In addition, beach rock exposure is visible in lower right corner of photo.

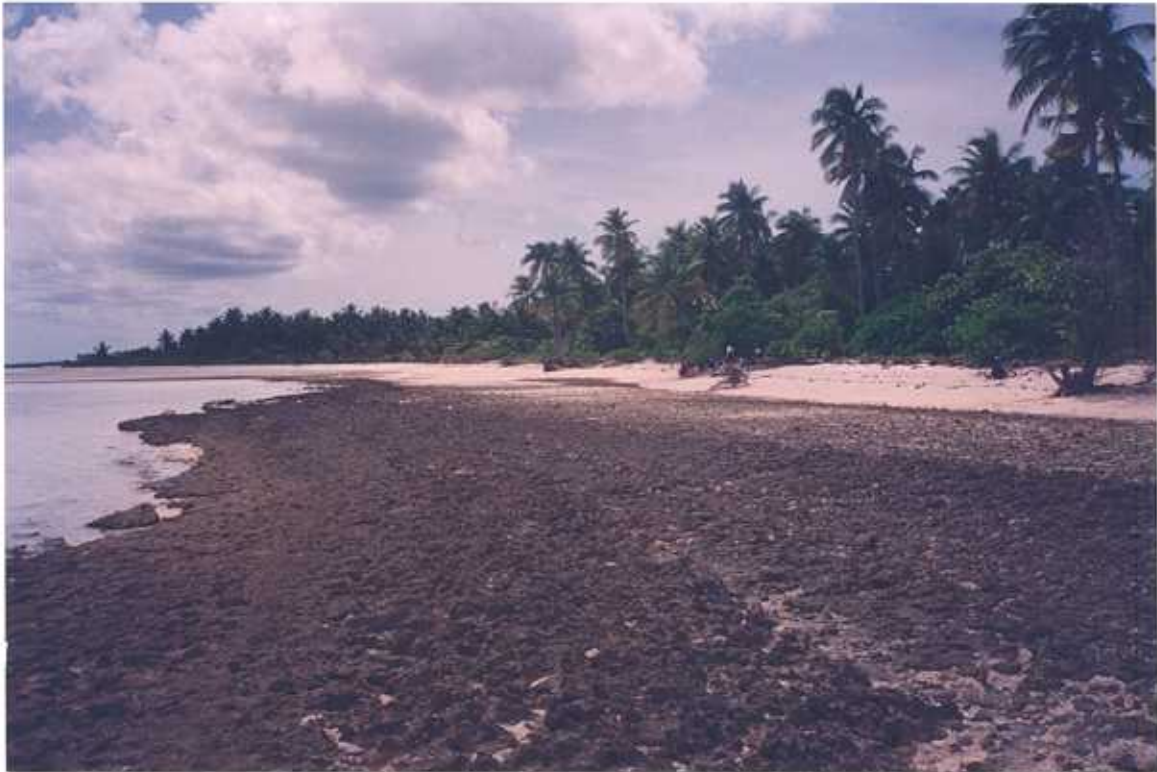
Figure 12. Aranuka Island, Tabiteuea South. View north along beach rock exposed on lagoon shoreline south of beach profile. According to local island sources the beachrock marks the position of the shoreline approximately 20 years ago.

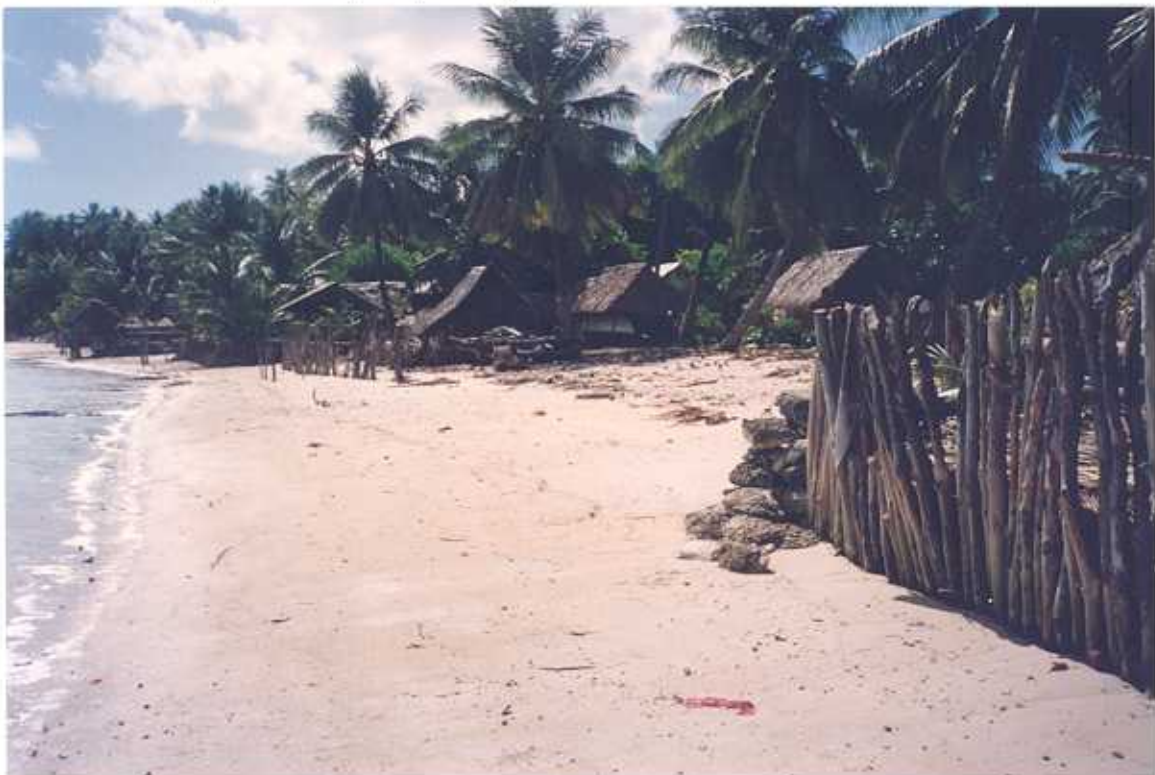
Figure 13. Maneaba at Nikutoru, Tabiteuea South. View northwest along lagoon shoreline beach illustrating local foreshore protection and/or land reclamation methods and the proximity of buildings to the shoreline.

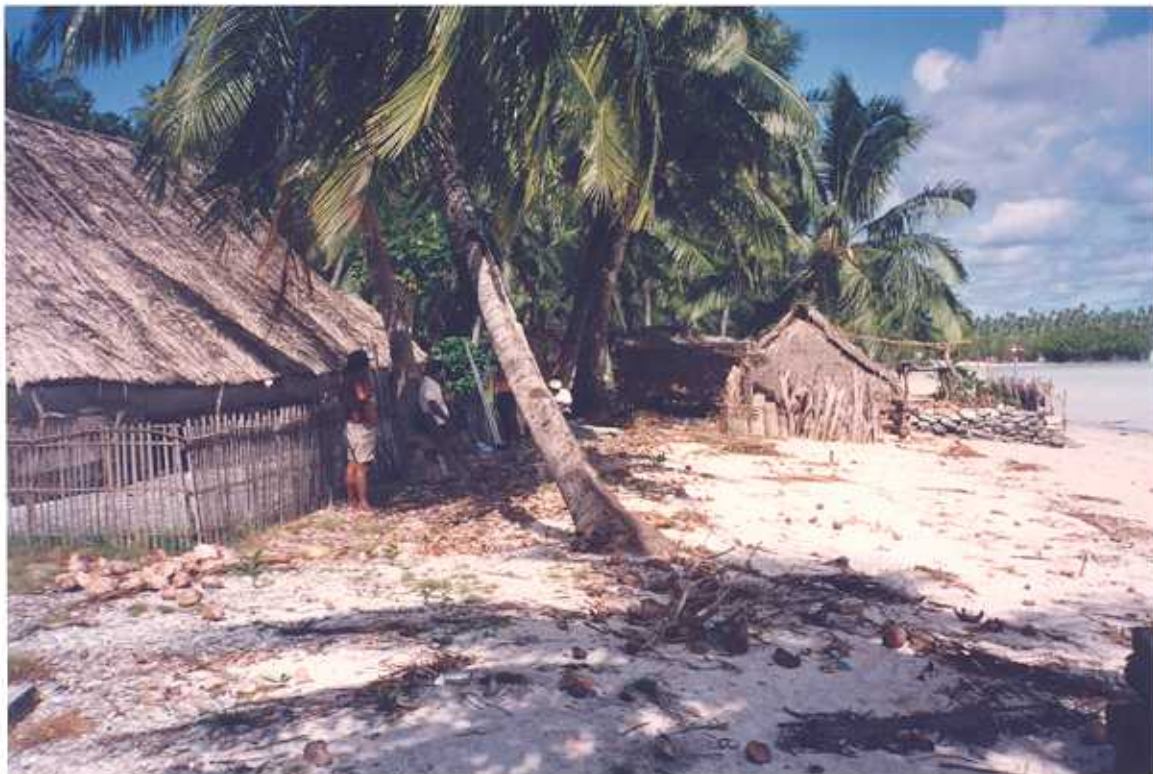
Figure 14. Maneaba at Nikutoru, Tabiteuea South. View southeast along crest of beach (coincides with location of coconut tree). During the combination of strong westerly wind and high tides waves wash up to reach the wall of the maneaba on the left.

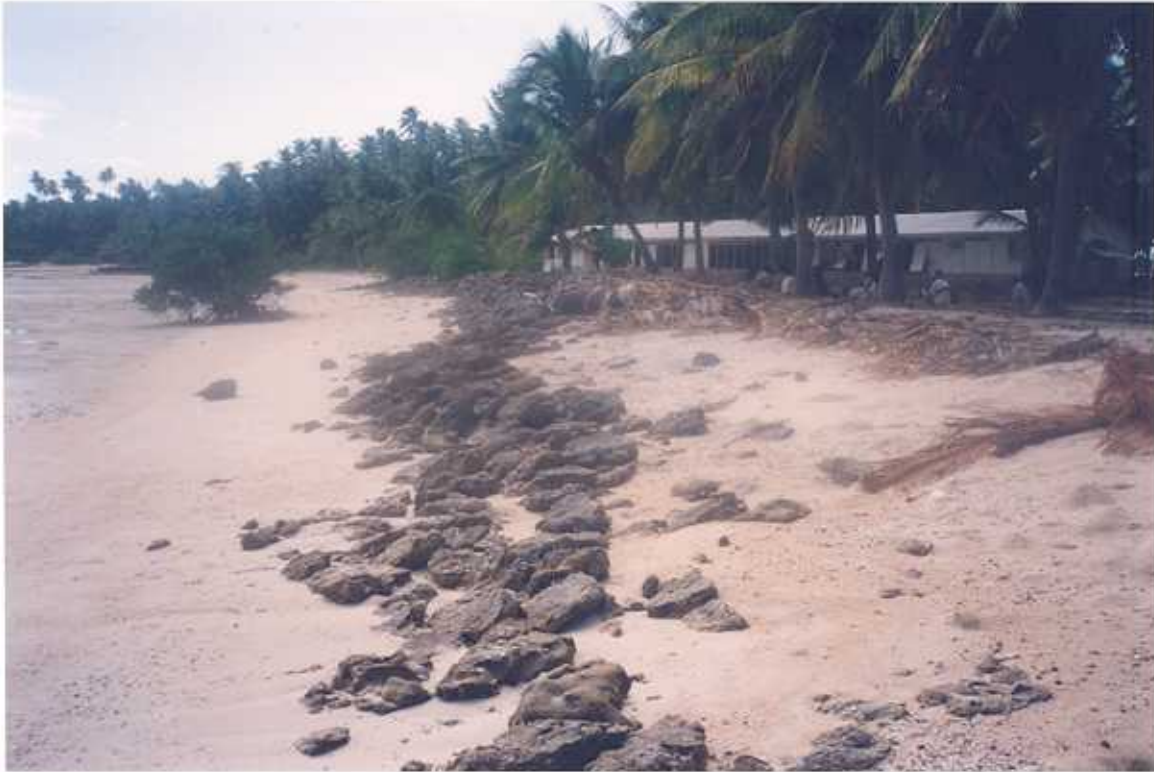
Figure 16. School at Tewai, Tabiteuea South. View northeast along lagoon/channel shoreline showing location of erosion and remains of rubble seawall in front of school. According to local island sources erosion has amounted to about 30 m.

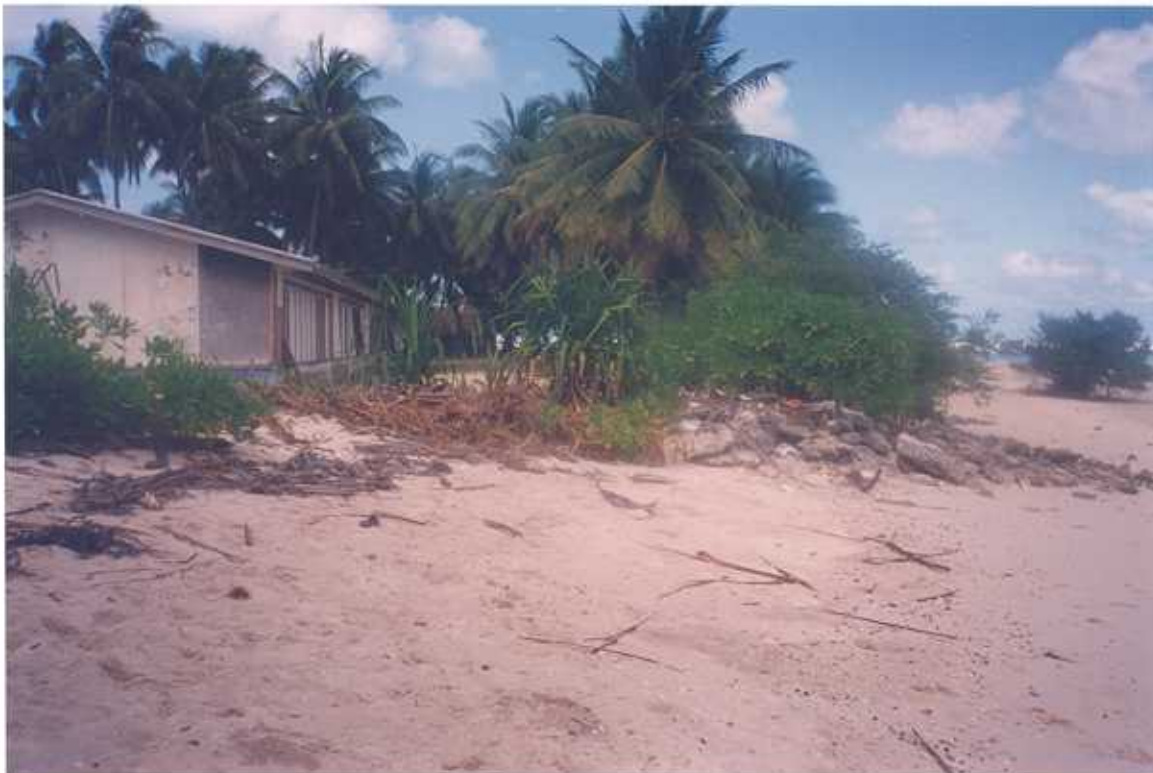
Figure 17. School at Tewai, Tabiteuea South. View southwest along inter-island channel shoreline showing condition of eastern end of seawall and proximity of school building to the shoreline.

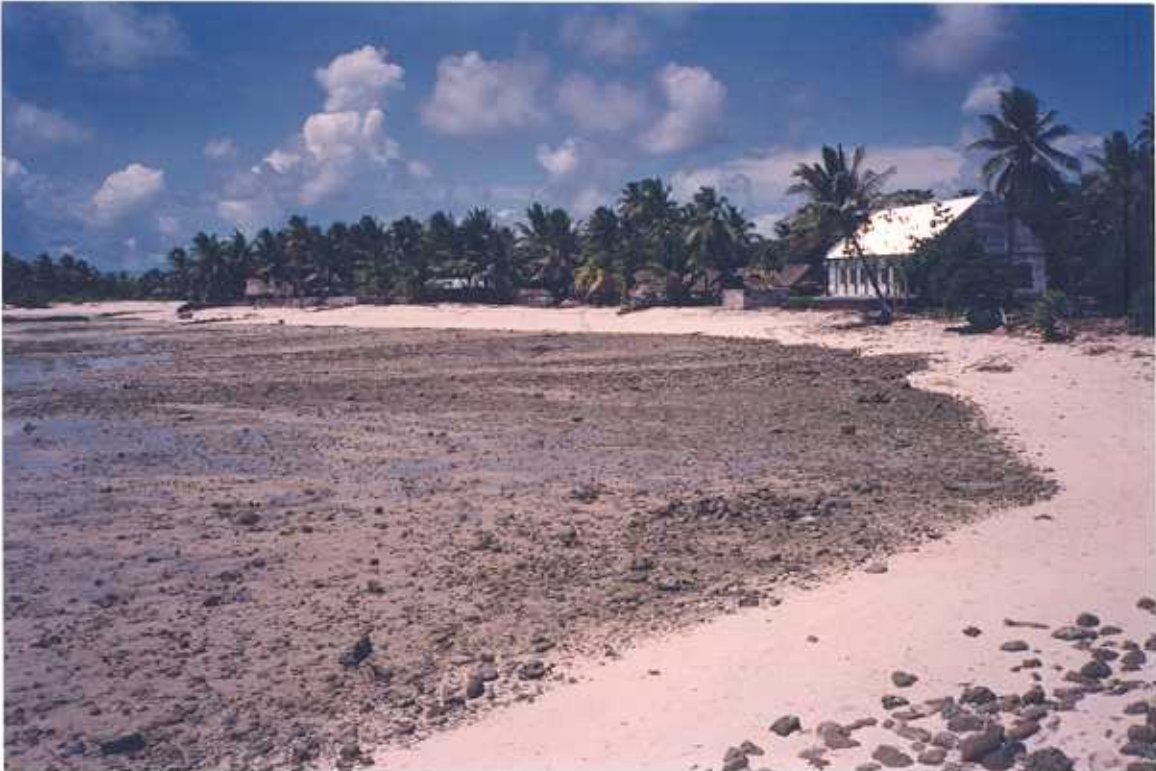
Figure 19. Tabuarorae Village, Onotoa. View east along lagoon shoreline of village showing narrow sandy beach and gravel veneer on reef flat. Most of the shoreline is protected with seawalls. The proximal portion of the rapidly evolving sand spit complex is visible at the extreme left end of the beach.

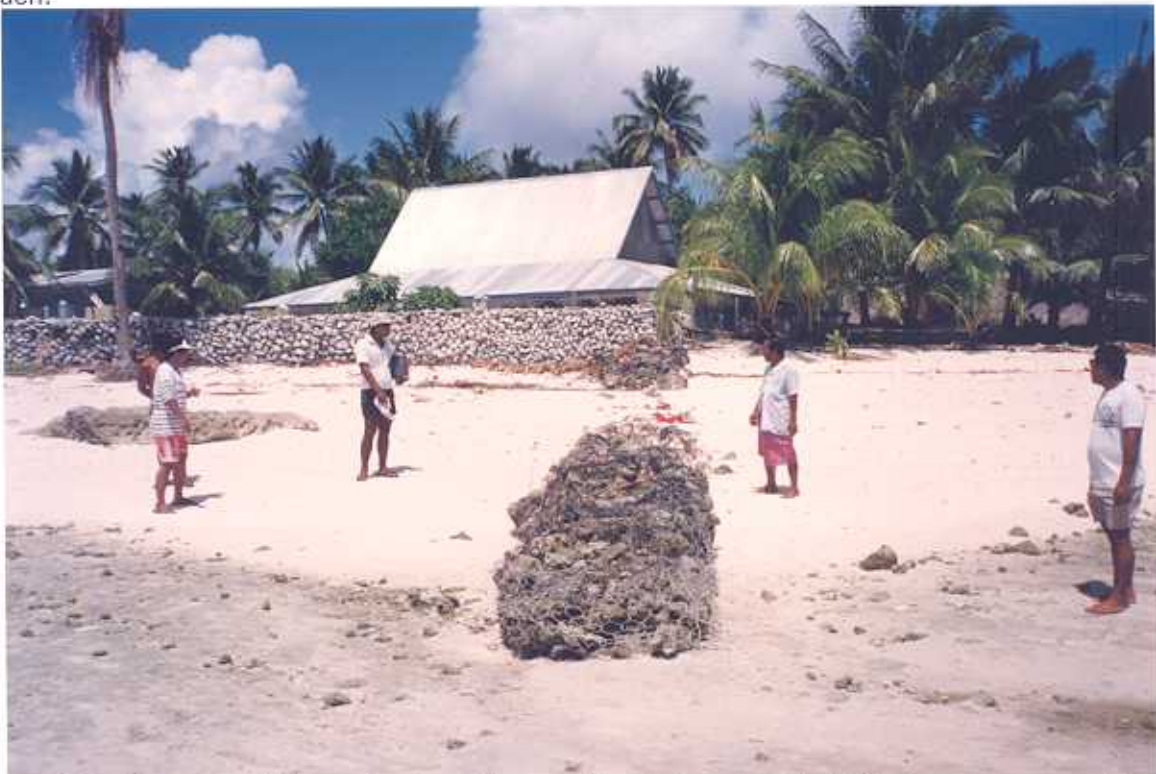
Figure 20. Tabuarorae Village, Onotoa. View southeast from reef flat. Photo shows seawall in front of maneaba and west of two gabion basket groynes. The beach profile runs down the beach to the right of gabion basket.

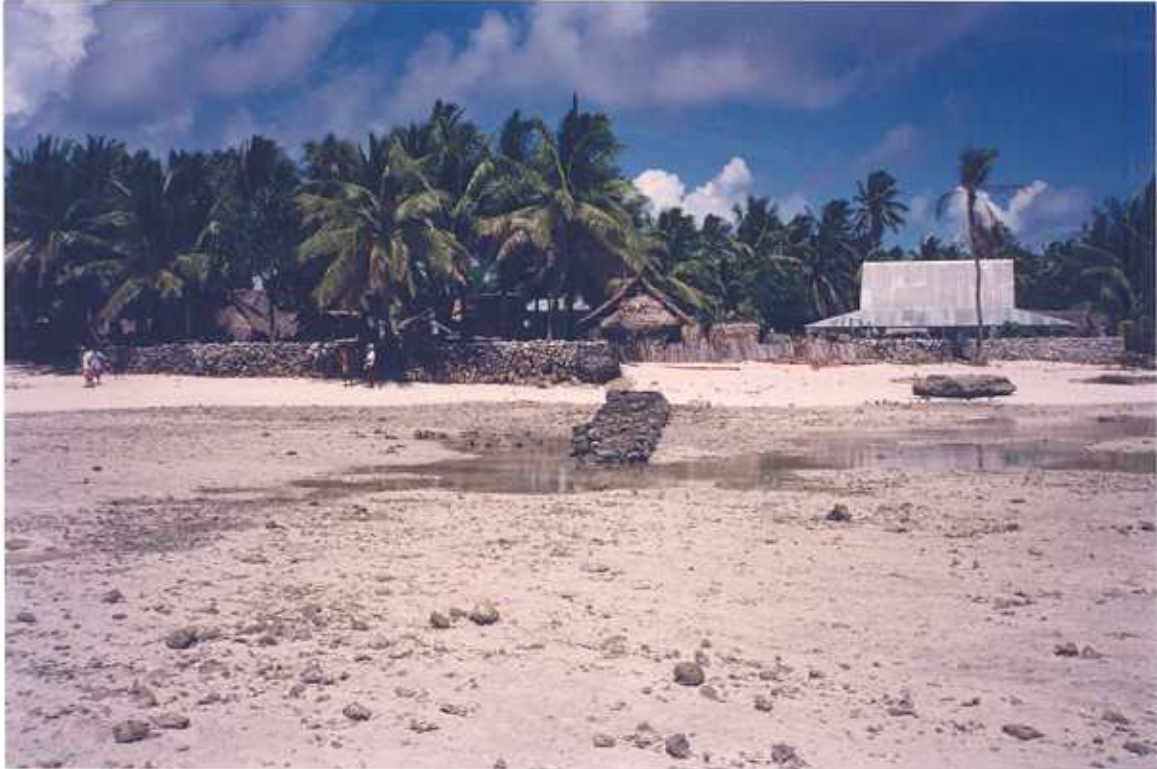
Figure 21. Onotoa, Tabuarorae Village. View southeast from reef flat showing east gabion basket groyne and extensive seawall construction. Photo taken approximately 40 m west of Figure 20.

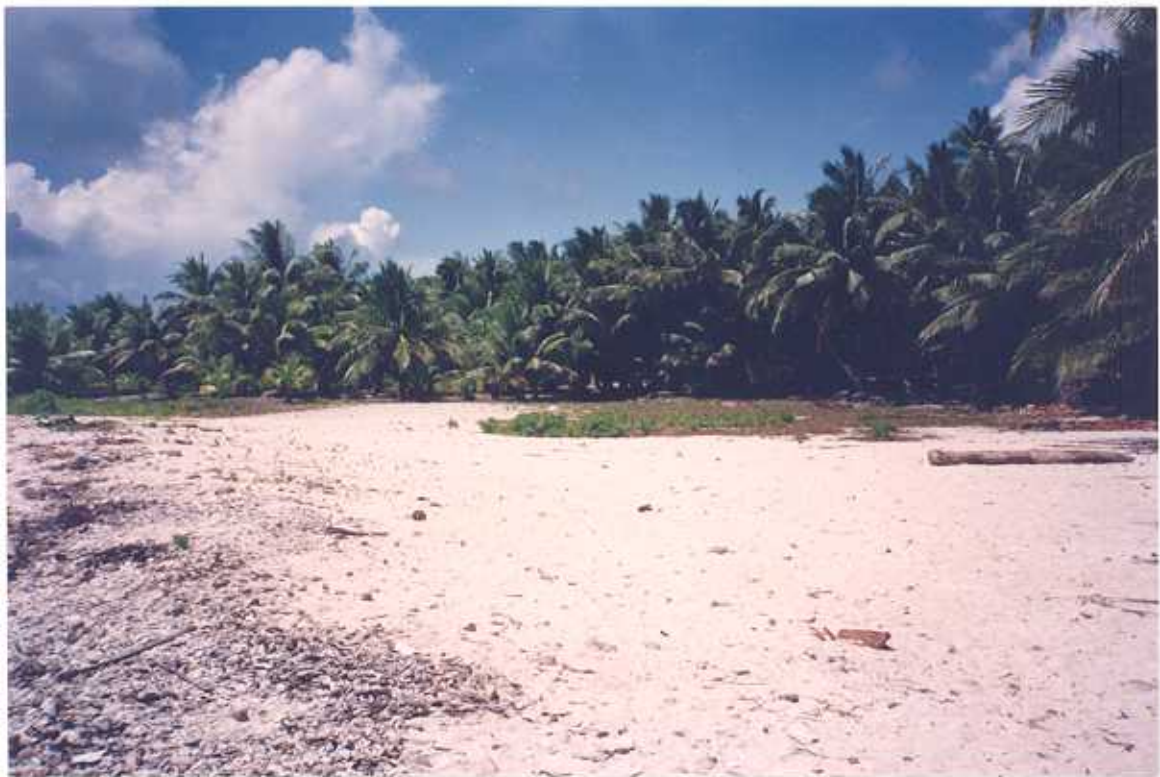
Figure 22. Tabuarorae Village, Onotoa. View east showing large area of accreting shoreline located at end of seawall shown in Figure 21. Area of accretion represents the proximal end of sandy spit complex extending further east.

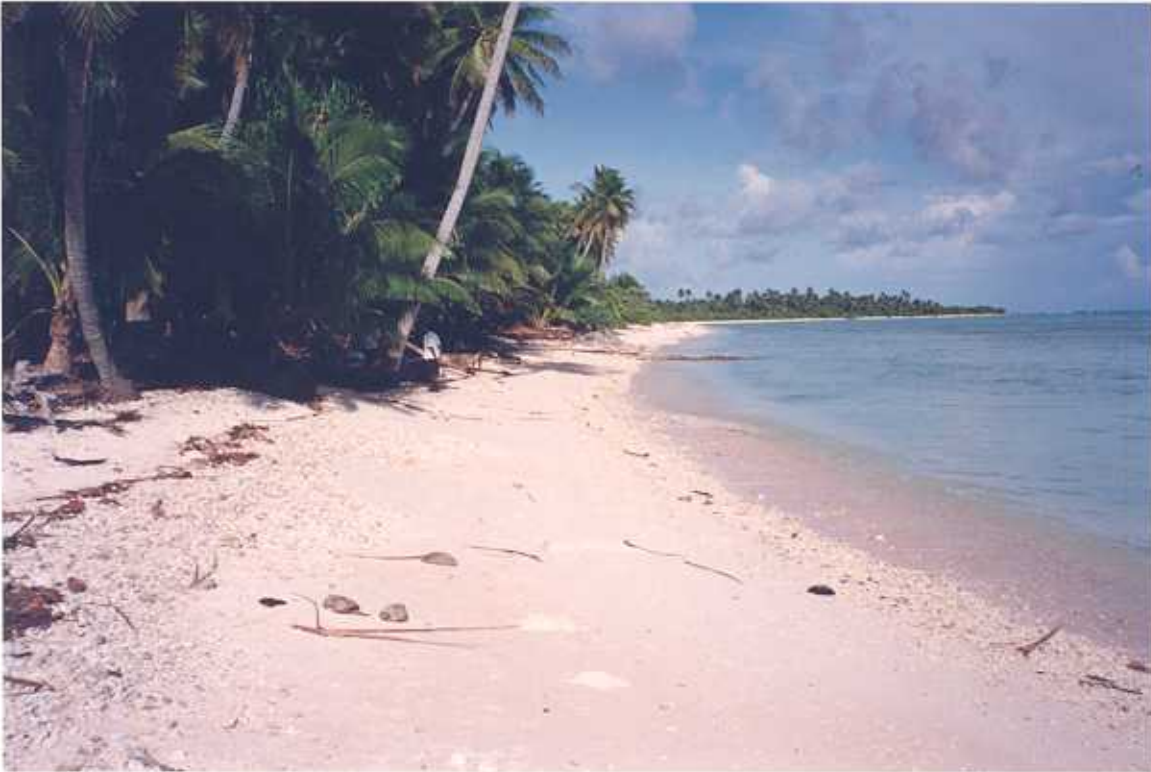
Figure 24. Tebakauto Village (Site 1), Temotu Island, Nonouti. View southeast along ocean reef shoreline. Photo taken from location of raised boulder/gravel platform running perpendicular to shoreline across ocean reef.

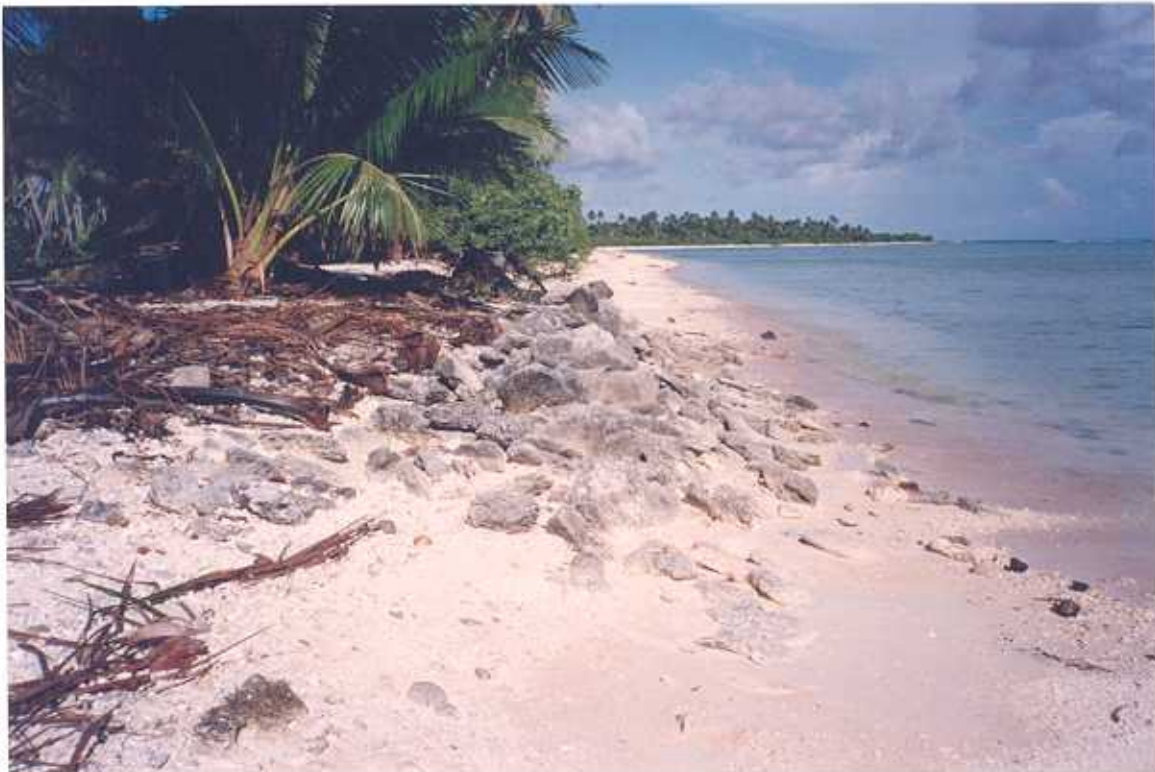
Figure 25. Tebakauto Village (Site 1), Temotu Island, Nonouti. View southeast approximately 50 m east of Figure 24 showing remains of seawall built circa 1983 according to local sources.

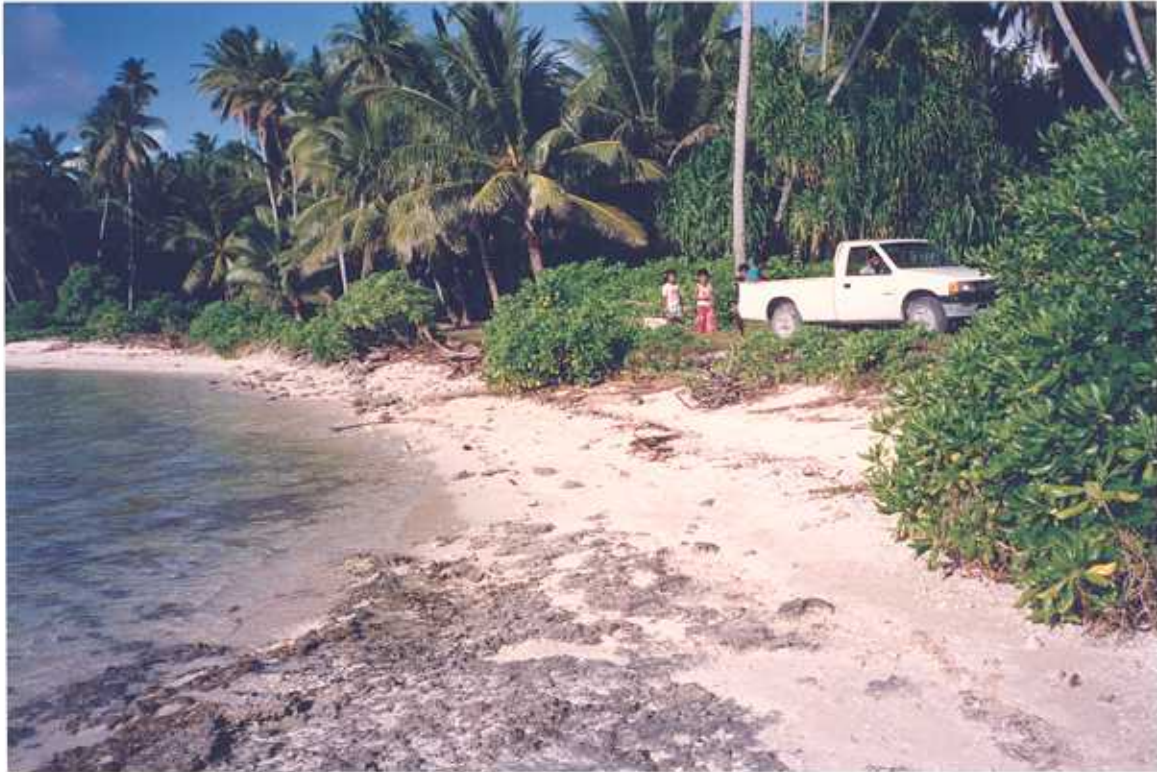
Figure 26. Tetabakea (Site 2), Temotu Island, Nonouti. View northeast along ocean shoreline showing narrow mixed sand and gravel beach and erosion below road.

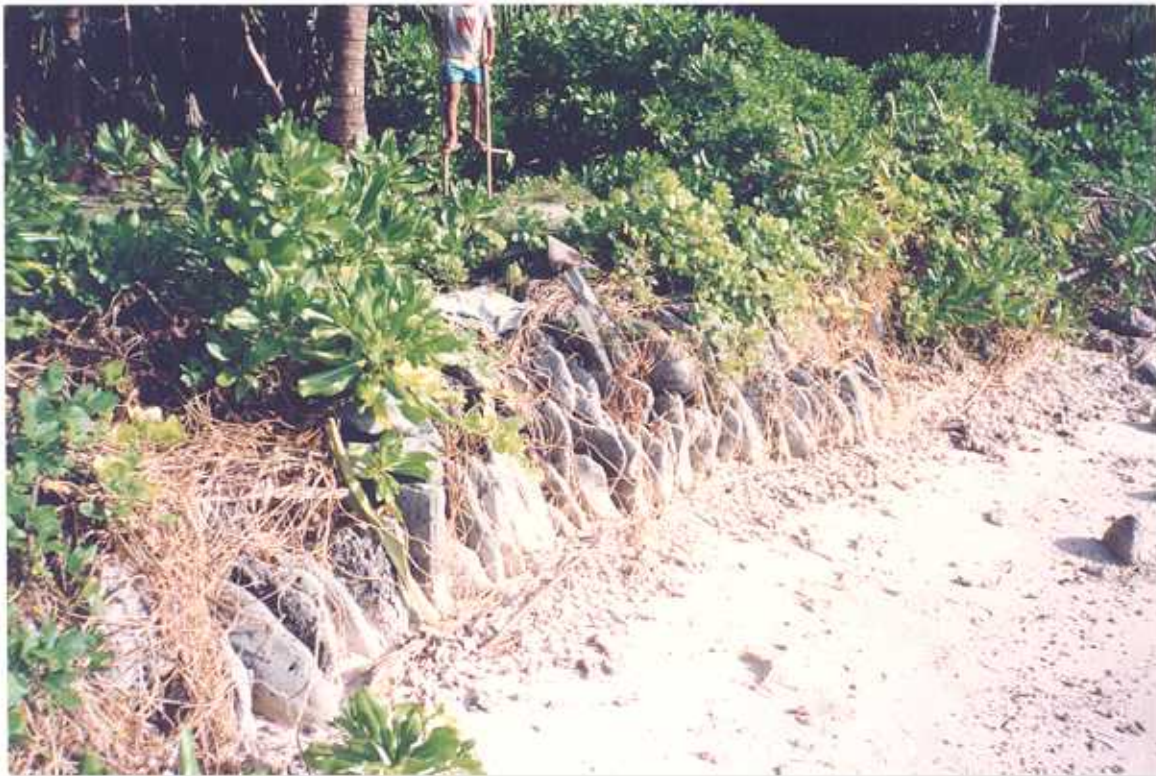
Figure 27. Tetabakea (Site 2), Temotu Island, Nonouti. Beach below road showing traditional seawall constructed of disc-shaped coral boulders. The boulders are stacked vertically. This type of seawall is only suitable for sites of low wave exposure.

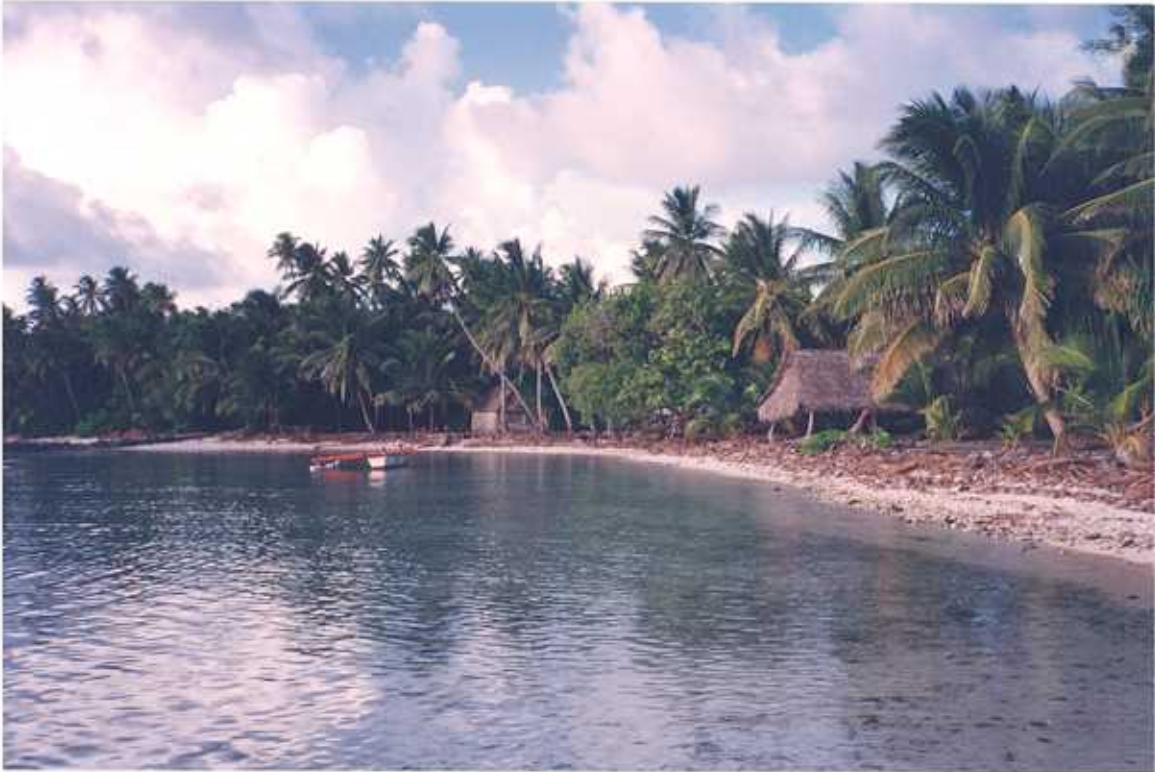
Figure 28. Teitiaki (Site 3), Temotu Island, Nonouti. View northeast along sand beach on west side of headland. The beach is relatively sheltered due to the effect of a natural breakwater (a conglomerate platform) to the left of the photo. A negligible amount of erosion was observed.

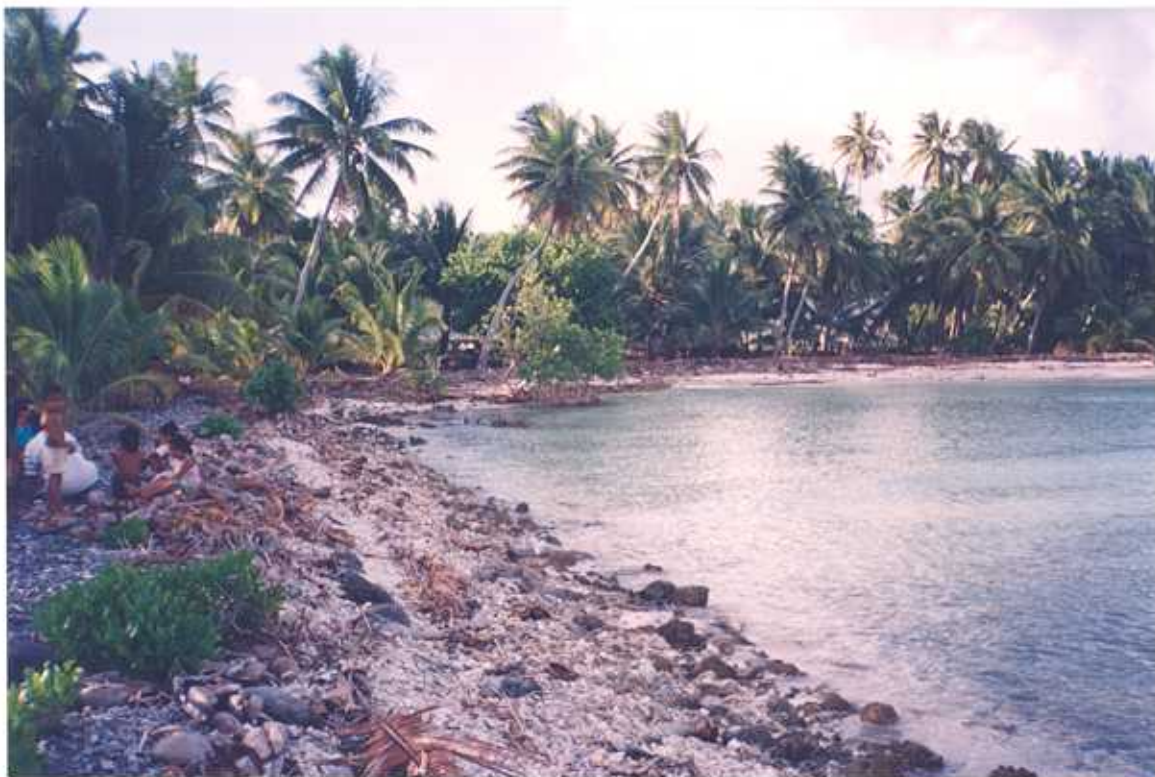
Figure 29. Teitiaki (Site 3), Temotu Island, Nonouti. View northeast along gravel beach on east side of headland. Minor erosion was confined to the corner of the bay.
