**COASTAL EROSION PROBLEMS IN THE
GILBERT ISLANDS GROUP REPUBLIC
OF KIRIBATI**

Richard D. Gillie

SOPAC Secretariat

SOPAC Technical Report 167

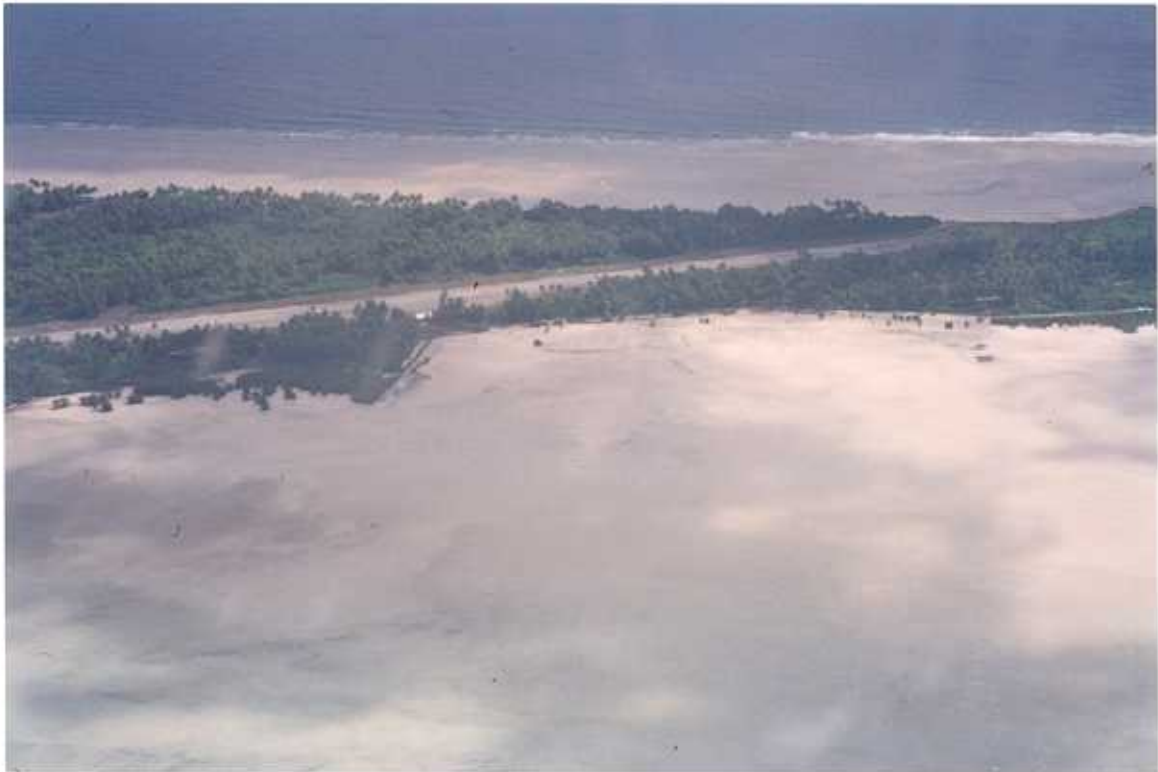
Figure 31. Rotima Island (Site 1: airfield road), Nonouti. Oblique aerial view northeast towards lagoon shoreline and airfield. Road along shoreline in middle of photo is being undermined by coastal erosion.

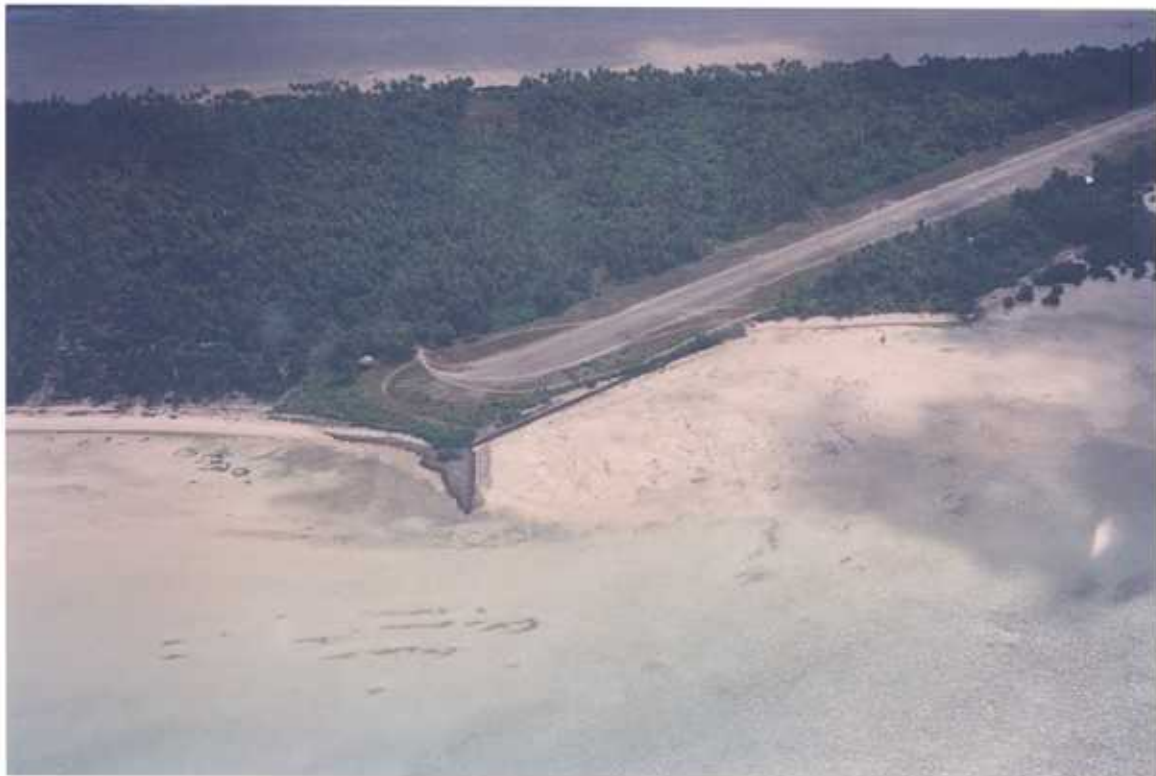
Figure 32. Rotima Island (Site 2: west end of airfield), Nonouti. View northeast of lagoon shoreline. Airfield shoreline reclamation with gabion basket seawall extends east (right) of conglomerate platform in centre of photo.

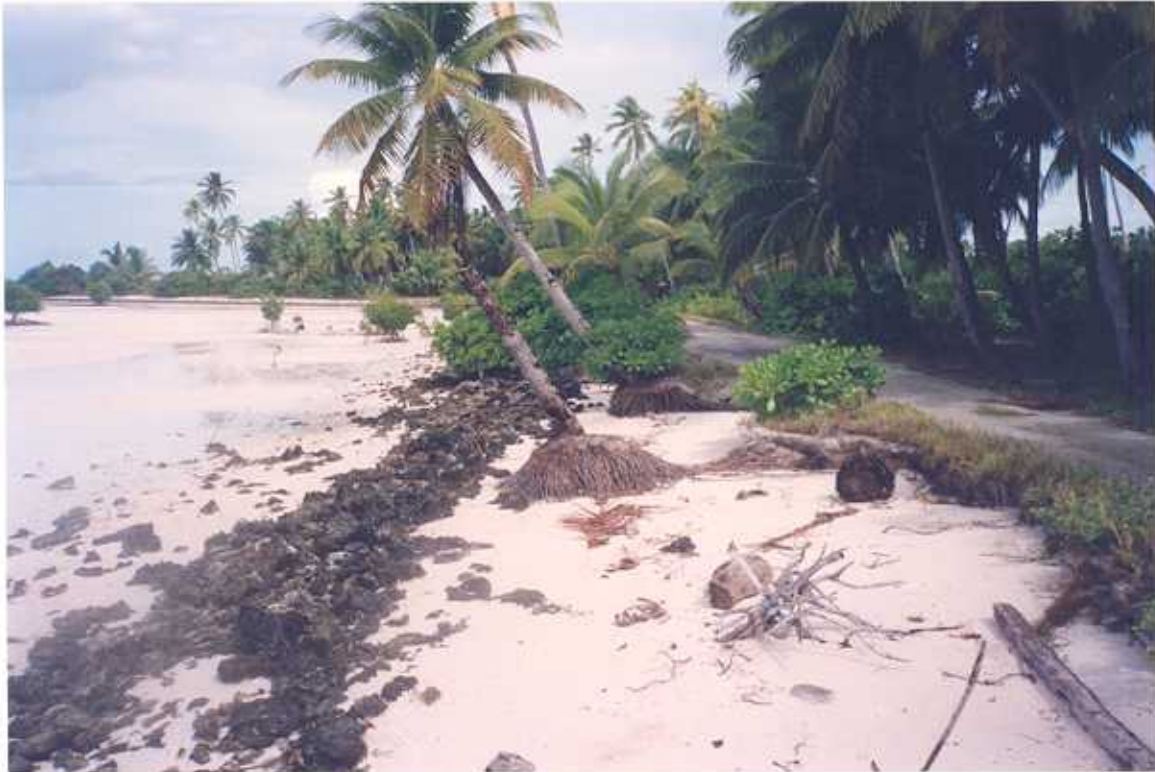
Figure 33. Rotima Island (Site 1: airfield road), Nonouti. View northwest along lagoon shoreline. Coastal erosion indicated by exposed roots of coconut trees, encroachment of beach on road and remains of seawall constructed at original position of shoreline.

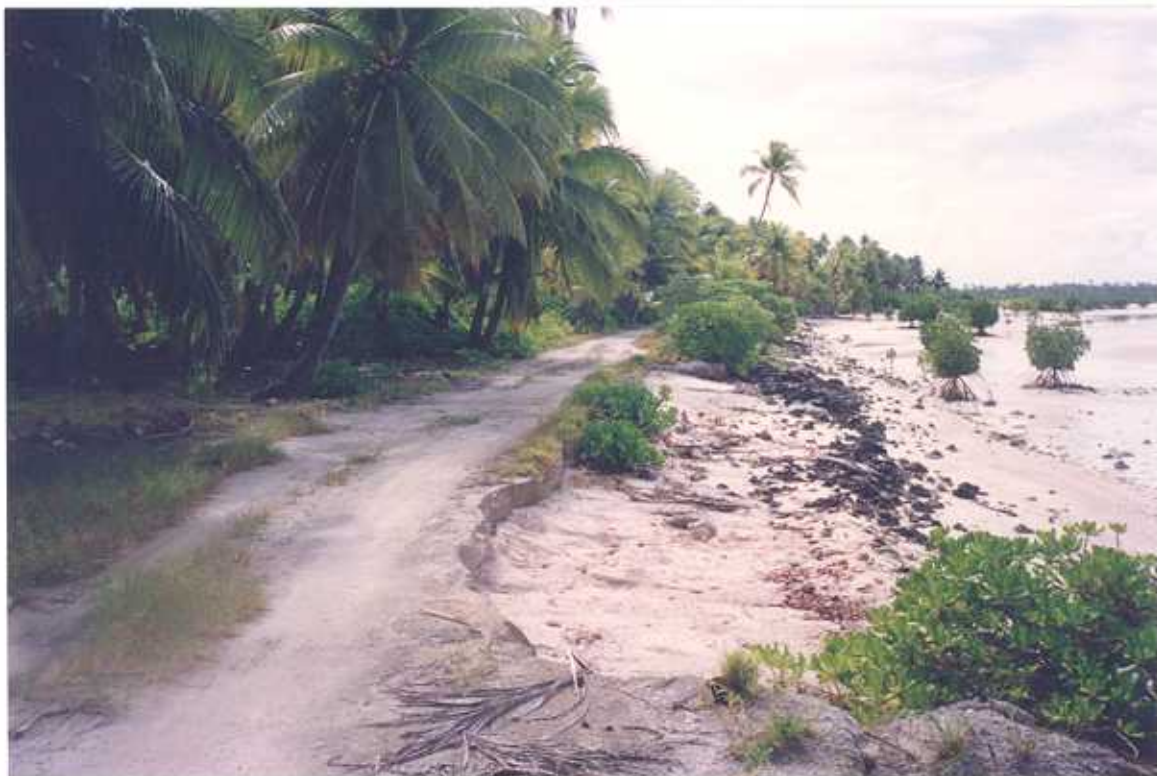
Figure 34. Rotima Island (Site 1: airfield road), Nonouti. View southeast showing erosion of airfield road approximately 30 m south of terminal under construction on date of survey.

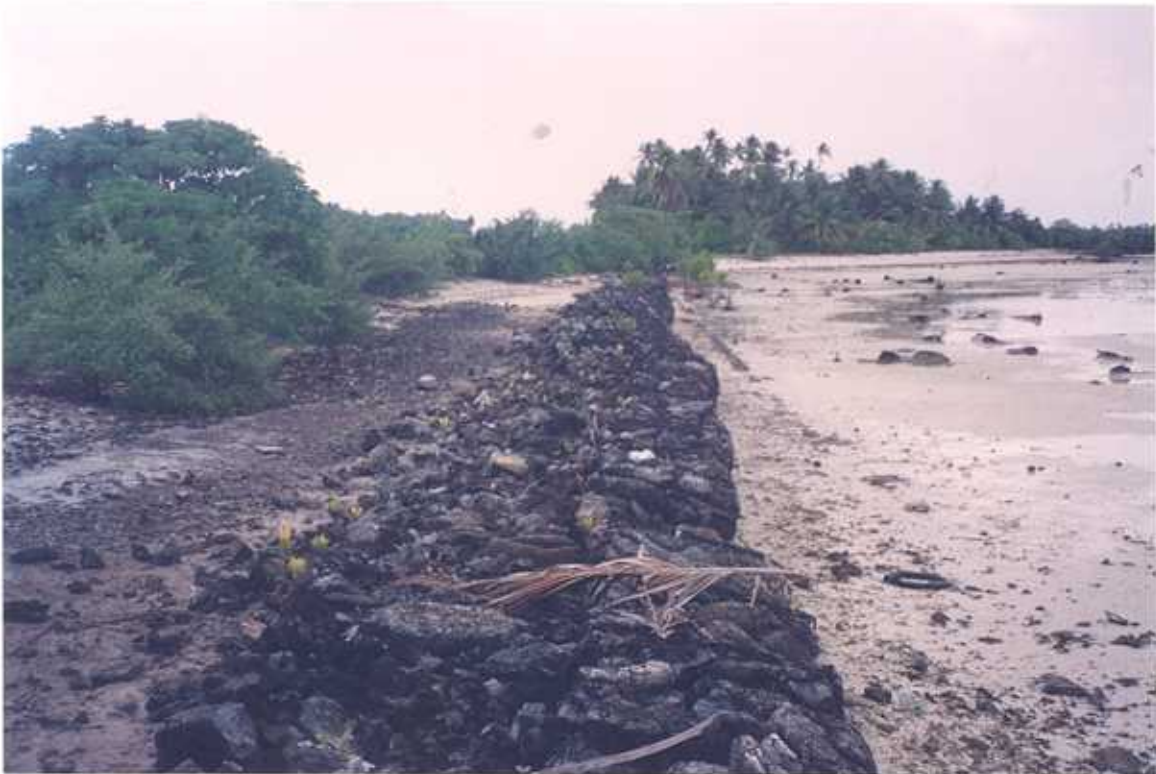
Figure 35. Rotima Island (Site 2: west end of airfield), Nonouti. View southeast along gabion basket seawall constructed to protect land reclaimed for airfield. According to local island sources the seawall was built in 1990.

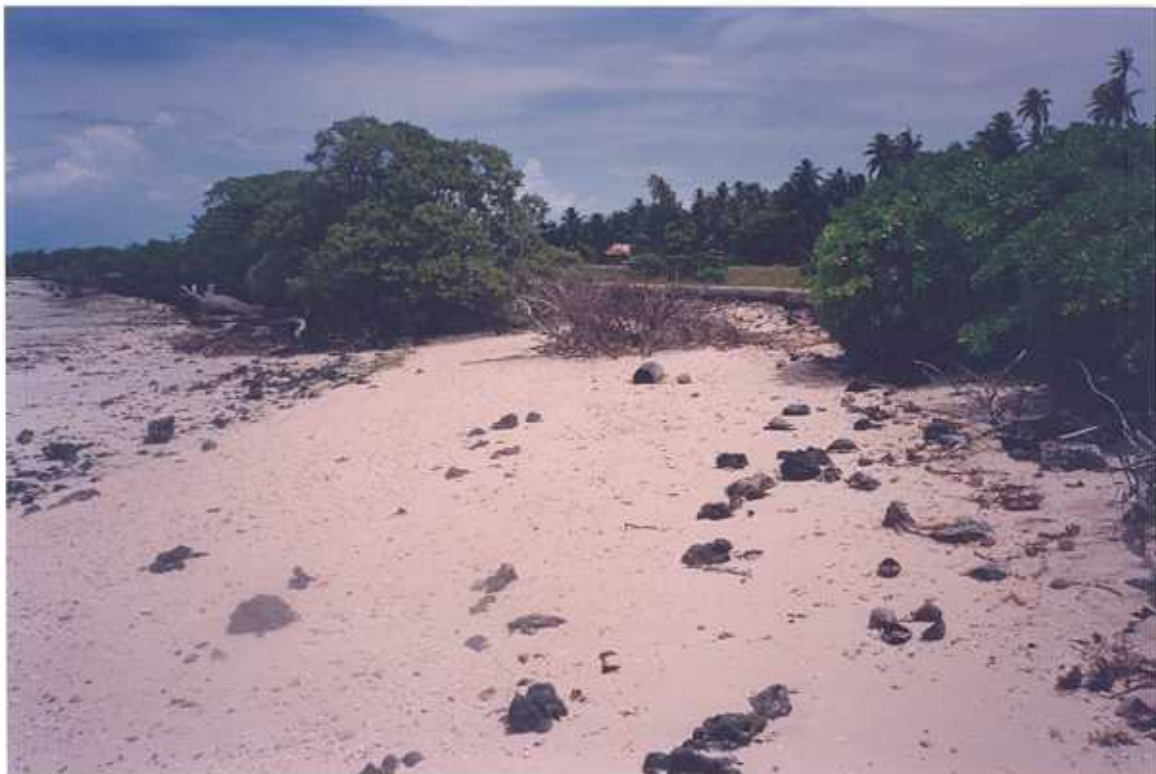
Figure 36. Rotima Island (Site 2: west end of airfield), Nonouti. View northwest at east end of gabion basket seawall shown in Figure 35. Erosion of shoreline is undermining existing road.

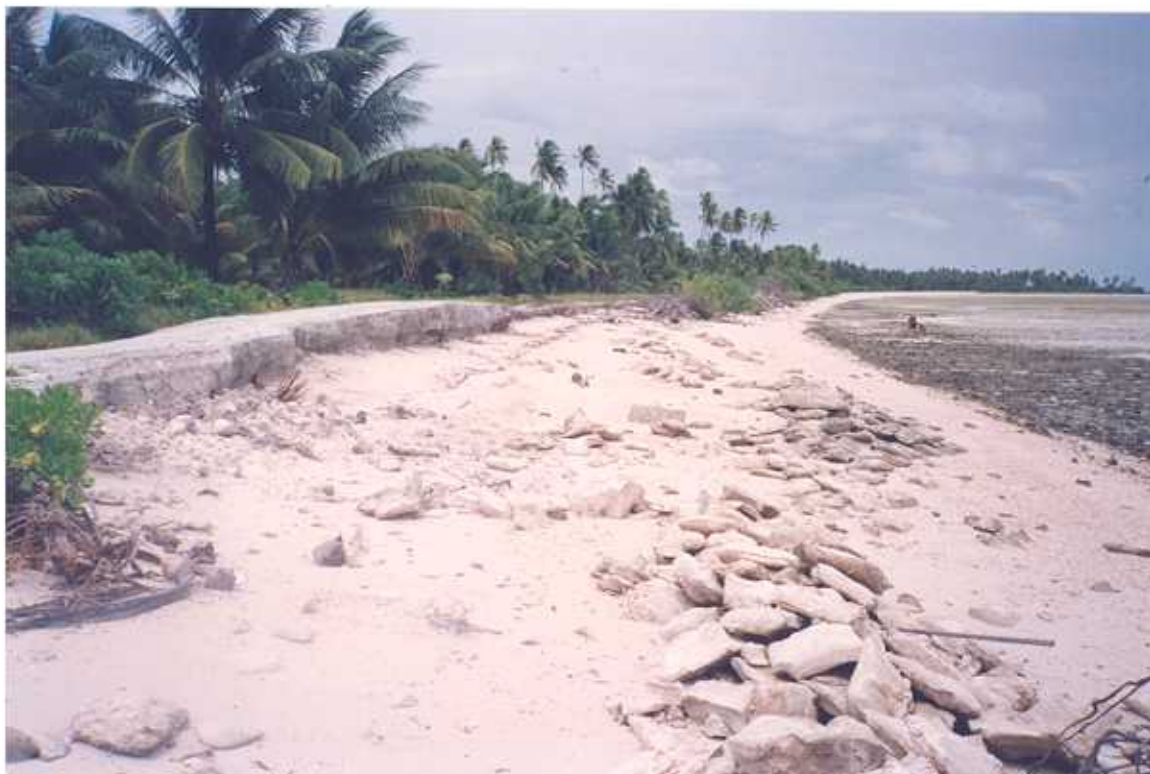
Figure 37. Buariki Village, Nonouti. View southeast along lagoon shoreline. Erosion indicated by beach scarp undermining road and remains of seawall constructed from concrete filled sandbags. Reef is covered by thin veneer of sand.

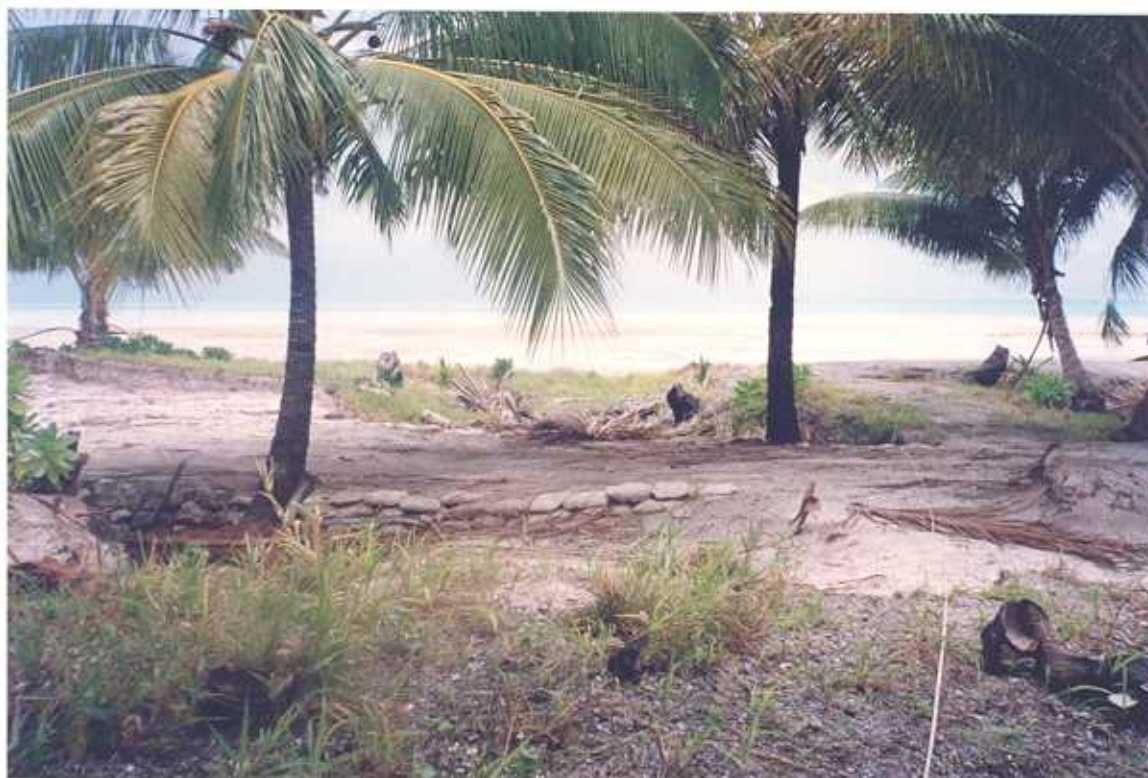
Figure 38. Buariki Village, Nonouti. View southwest along line of beach profile at site. Middle of photo shows new location of road, approximately 20 back of beach.

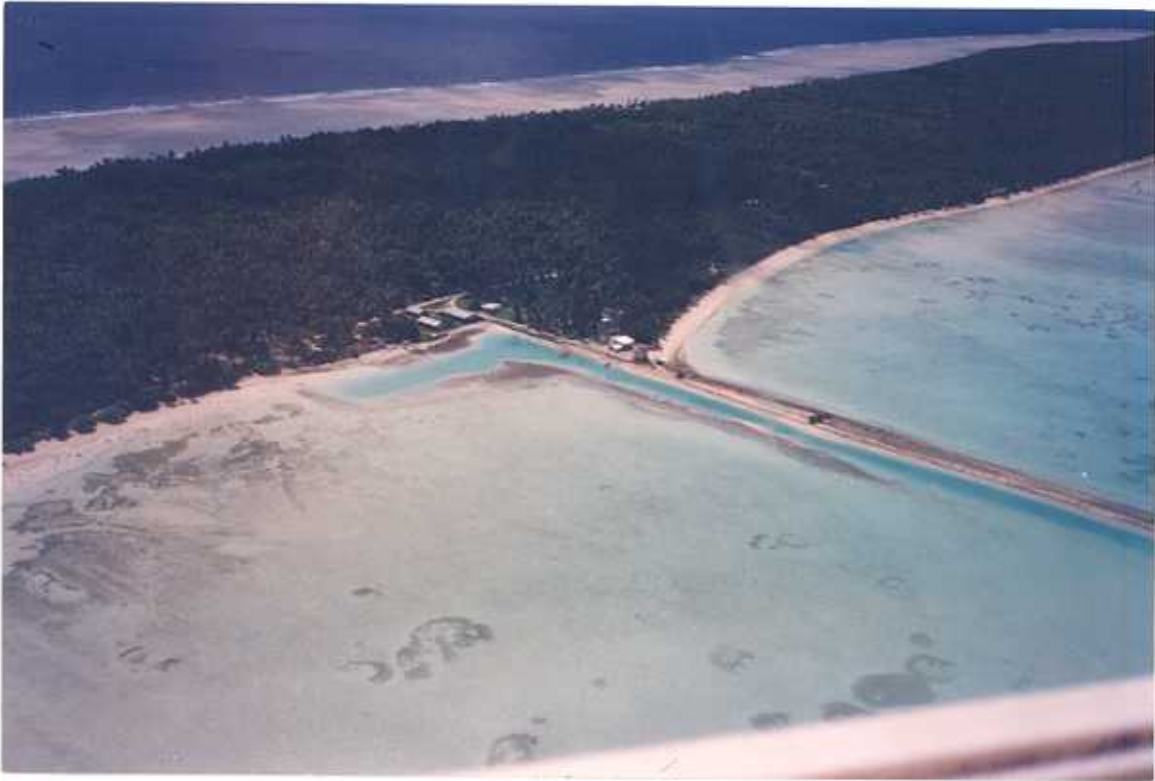
Figure 40. Tanimainiku, Abemama. Oblique aerial view to the southeast showing pronounced shoreline accretion on southeast side of coral rubble mole indicating net longshore transport to the northwest. As a consequence, shoreline erosion has occurred for approximately 300-500 m to the northwest.

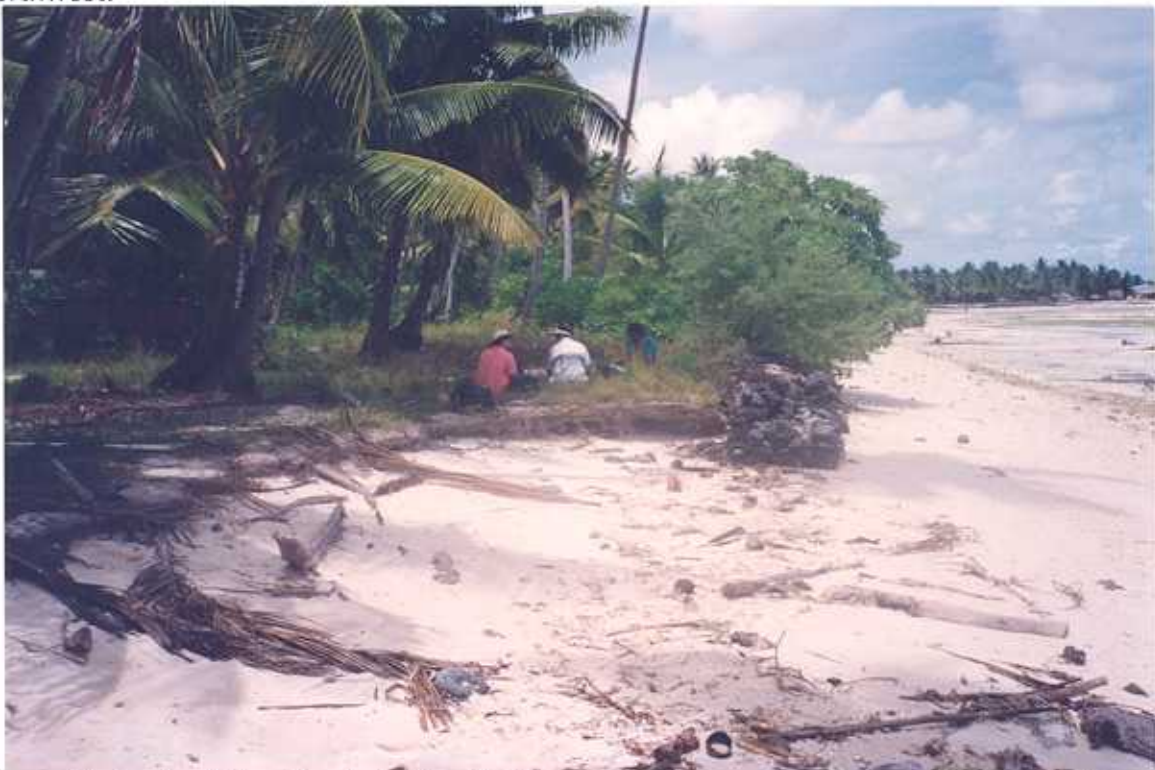
Figure 41. Tanimainiku (Beach Profile: 1), Abemama. View southeast along lagoon shoreline at location of beach profile. Note erosion of shoreline behind existing seawall position (right of photo centre).

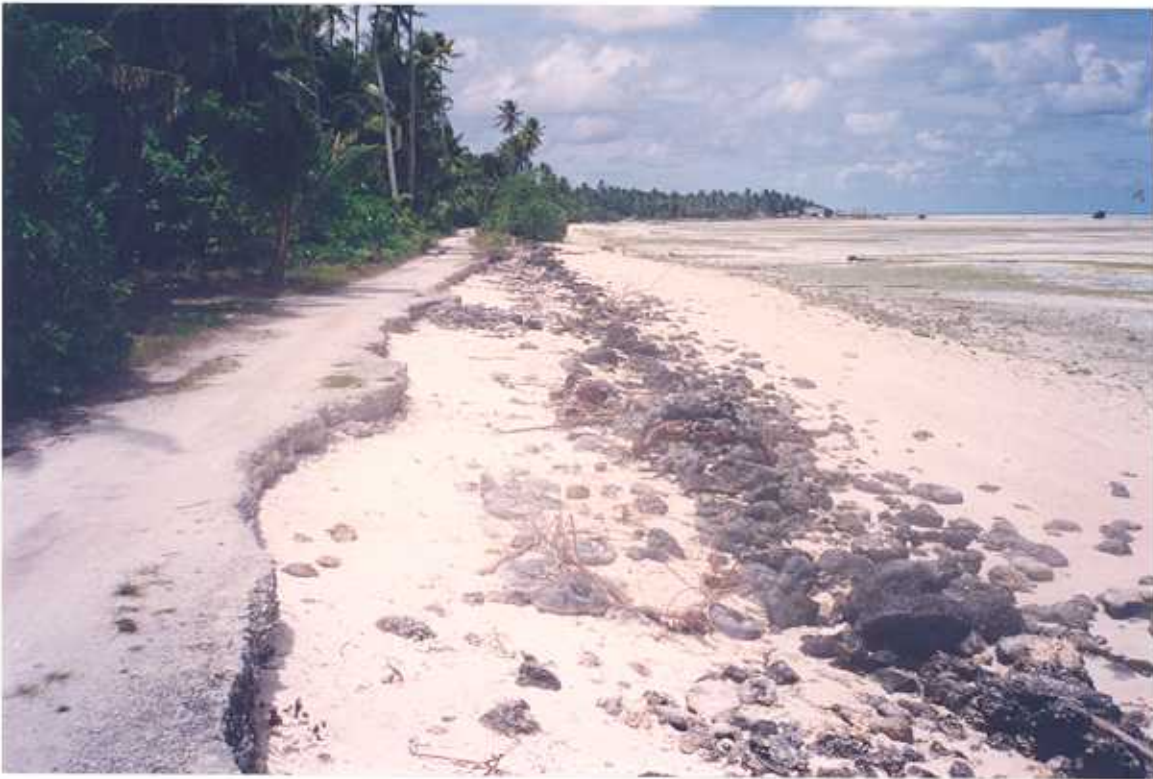
Figure 42. Tanimainiku (Beach Profile: 2), Abemama. View southeast past location of beach profile. Note severe erosion of road and remains of coral rubble seawall on beach.

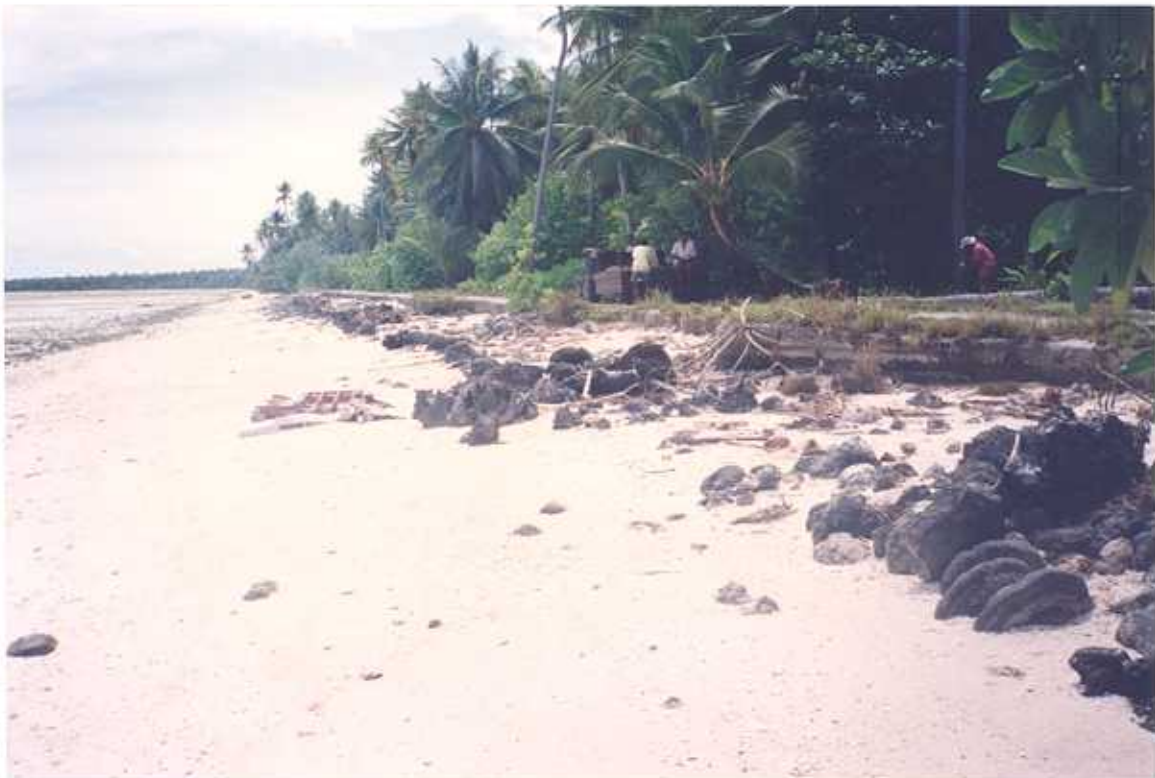
Figure 43. Tanimainiku (Beach Profile: 2), Abemama. View northwest past location of beach profile. Note severe erosion of road and remains of seawall constructed from coral rubble and boulders including whole micro-atolls.

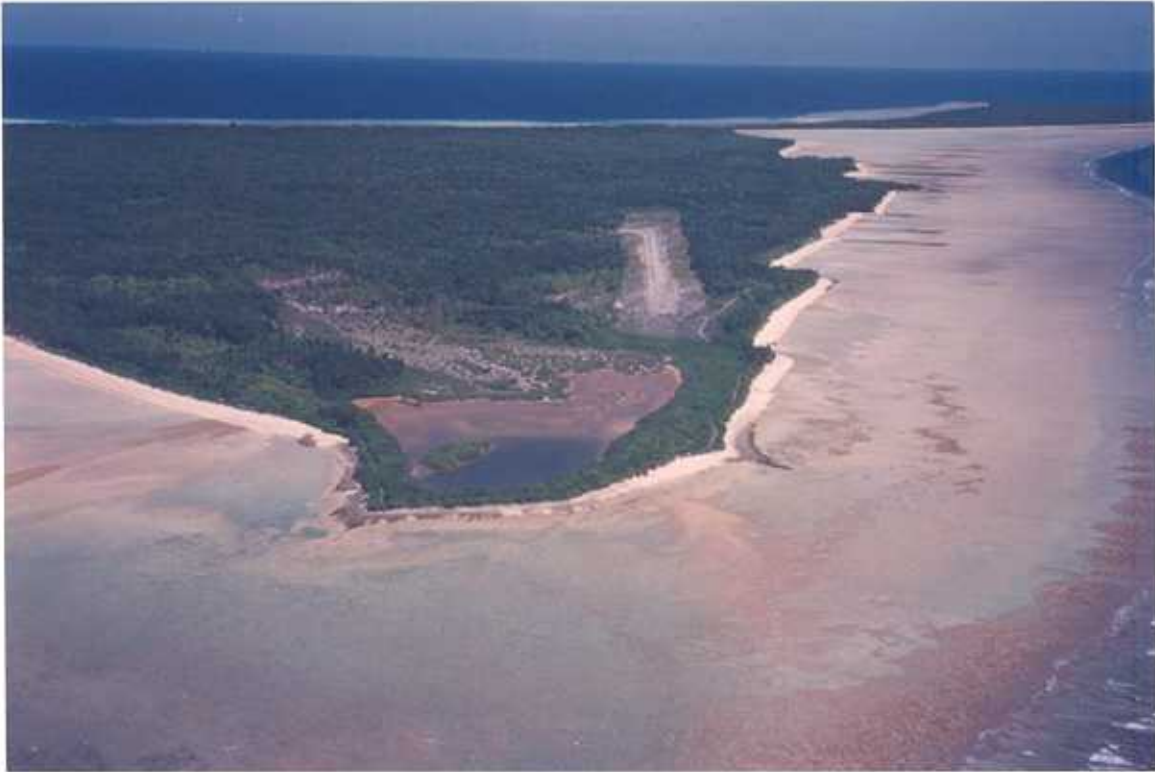
Figure 45. Taubukintekira (east of airfield), Kuria. View northwest along the northeast facing shore of Buariki Island. Area of erosion extends for about 500-600 m along north shore from point of land in the foreground (left centre of photo).

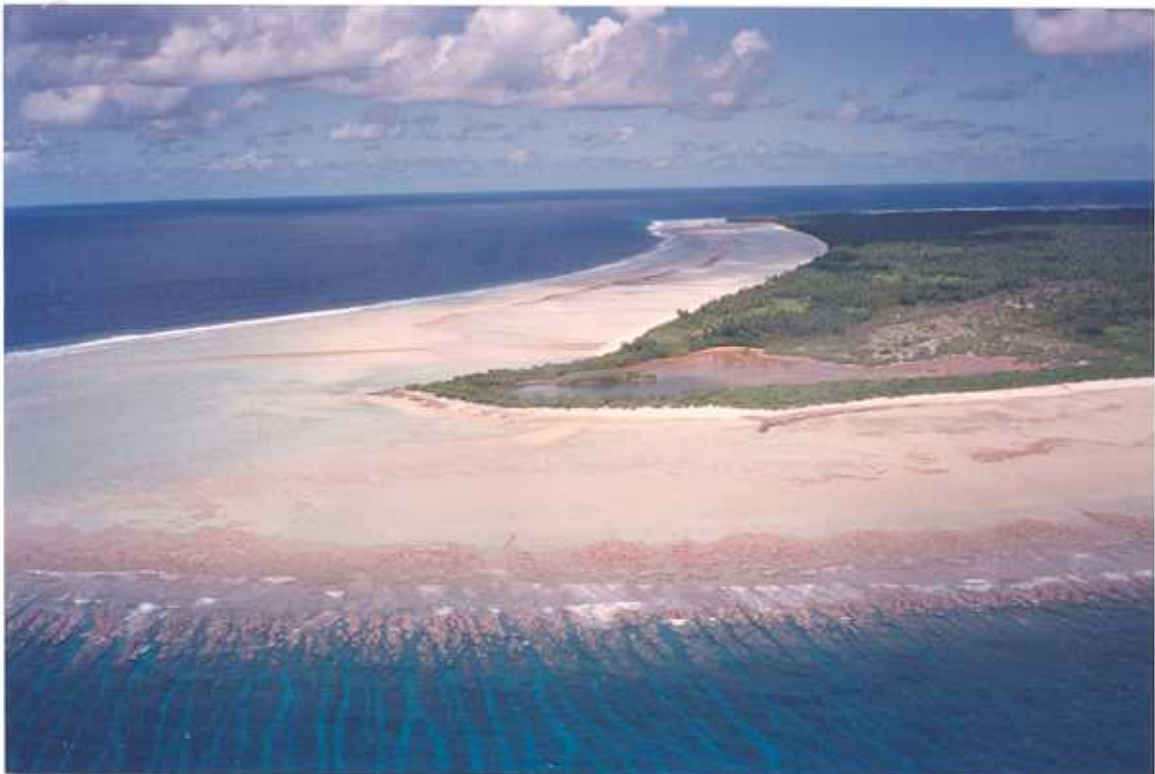
Figure 46. Taubukintekira (east of airfield), Kuria. View south showing area of erosion along shoreline. Erosion appears to be natural and is due to exposure to ocean waves and currents which transport sand and gravel to the northwest and southeast away from the point.

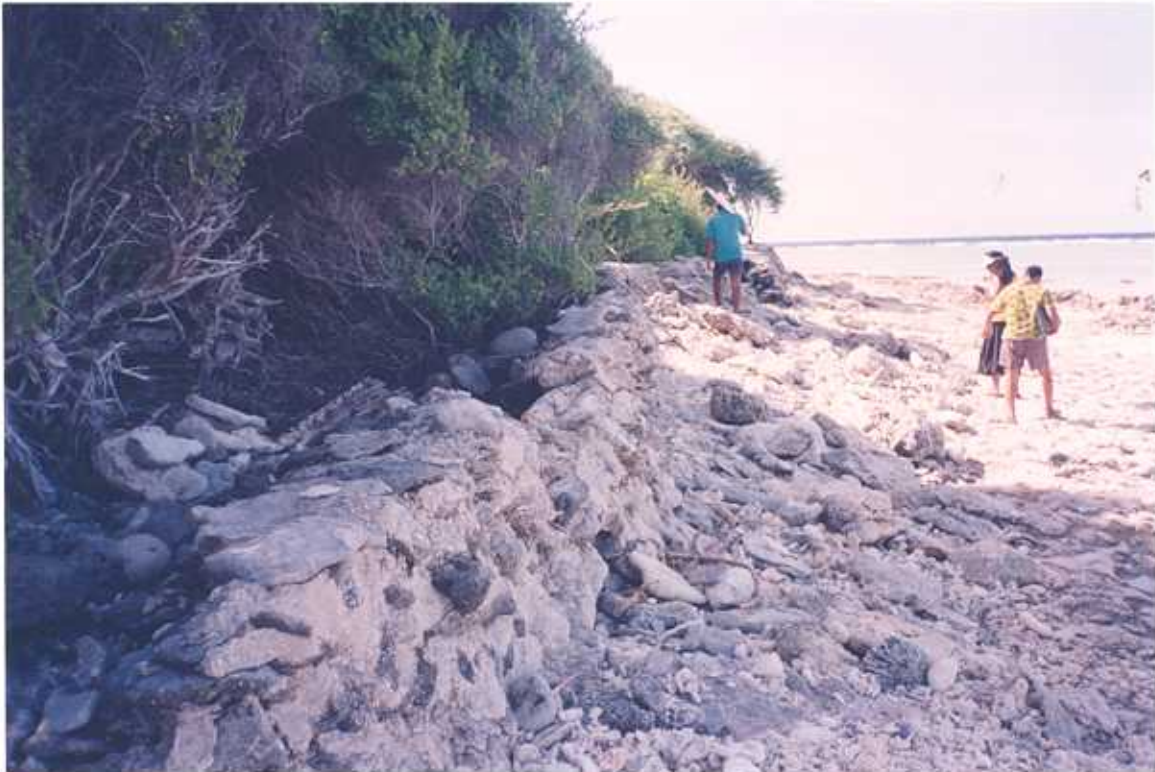
Figure 47. Taubukintekira (east of airfield), Kuria. View northwest near "east point" showing cemented coral rubble seawall. Seawall rests on a foundation of coral rubble overlying conglomerate platform.

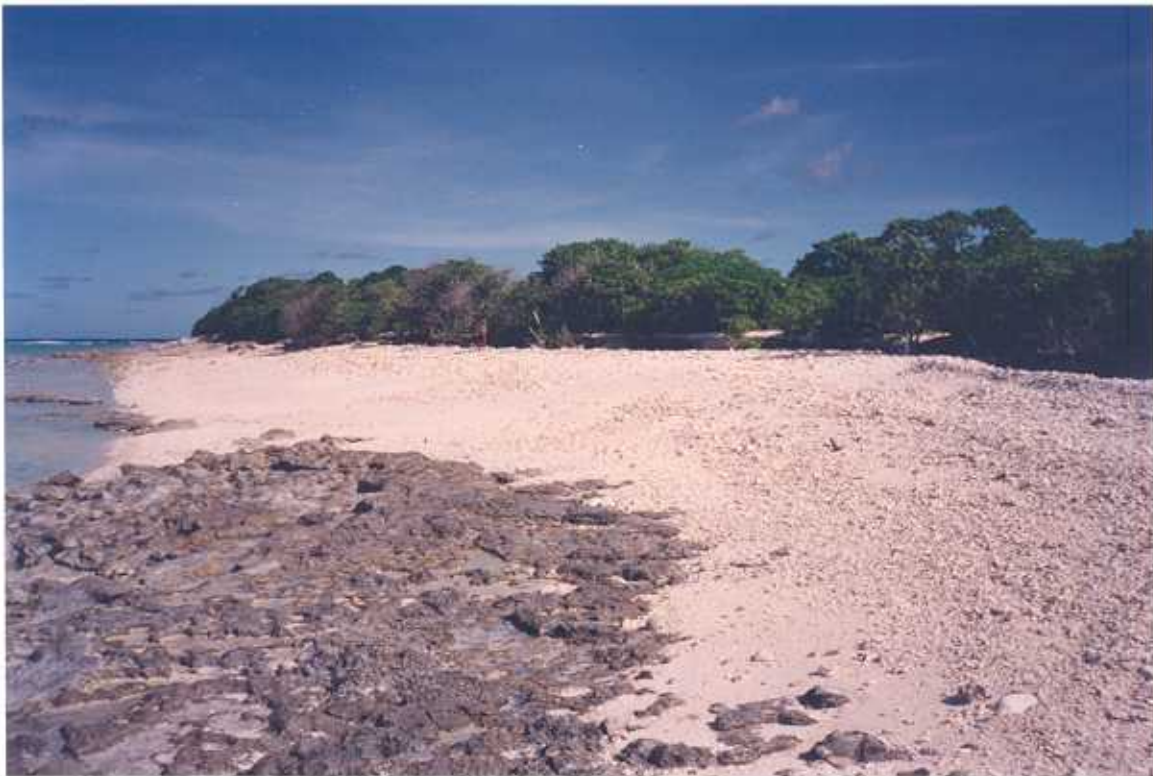
Figure 48. Taubukintekira (east of airfield), Kuria. View southeast in vicinity of beach profile. Coral rubble and sand beach overly a conglomerate platform which acts as a natural groyne. Note erosion scarp beneath scrub at back of beach.

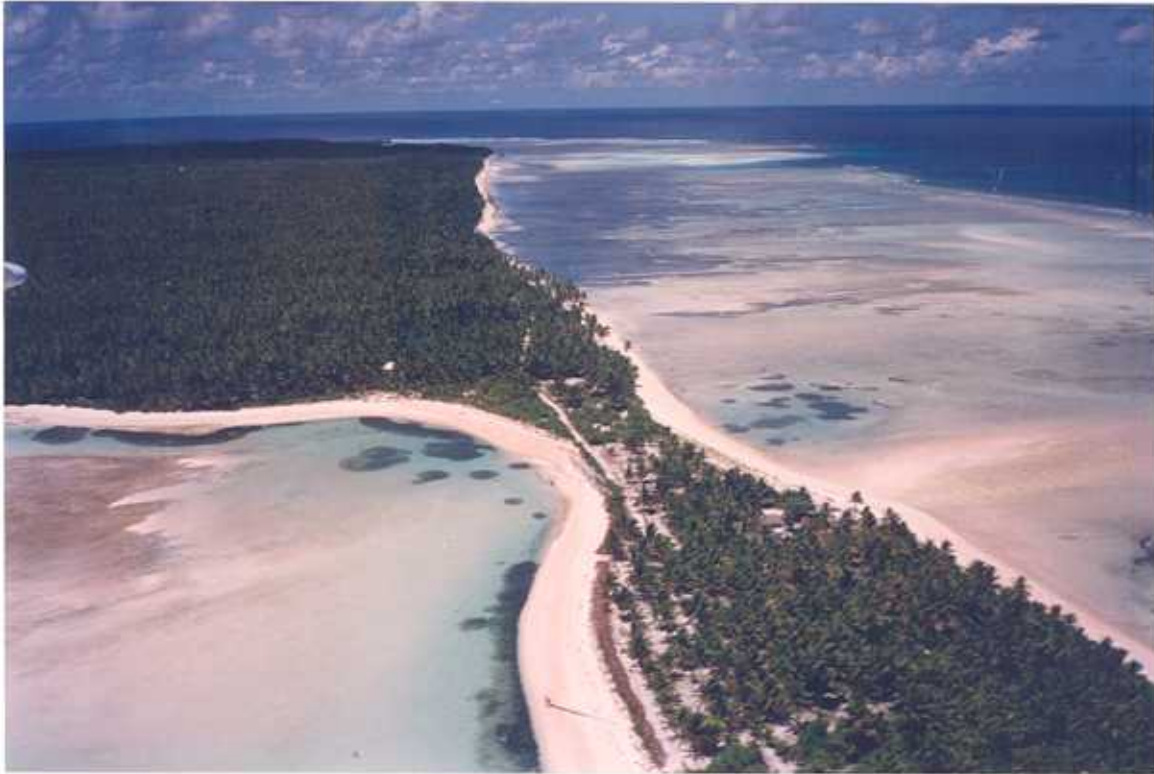
Figure 49. Tanginimake (causeway), Kuria. Oblique aerial view south over site of causeway. Original line of causeway indicated by road on left side. Since causeway completion extensive coastal accretion has occurred on both sides, especially to the west(right) side.

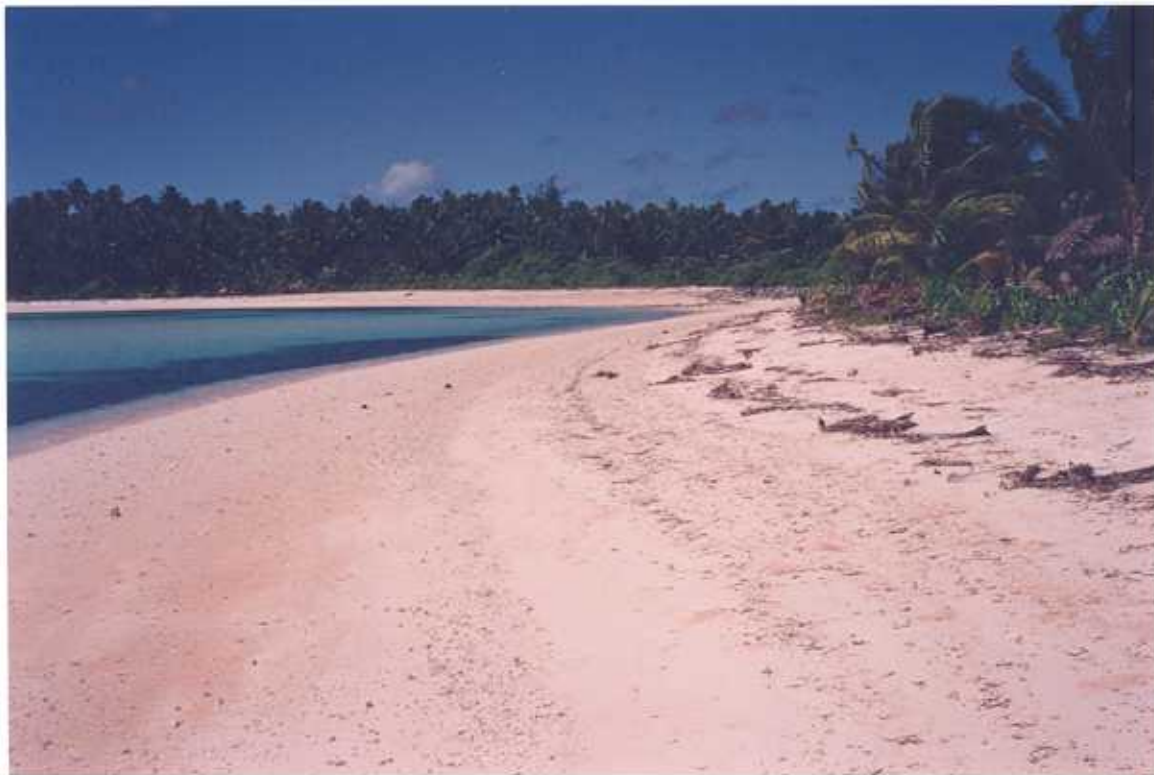
Figure 50. Tanginimake (causeway), Kuria. View south along east side of island immediately to north of causeway. This section of shoreline has experienced significant accretion since causeway construction as indicated by the wide beach.

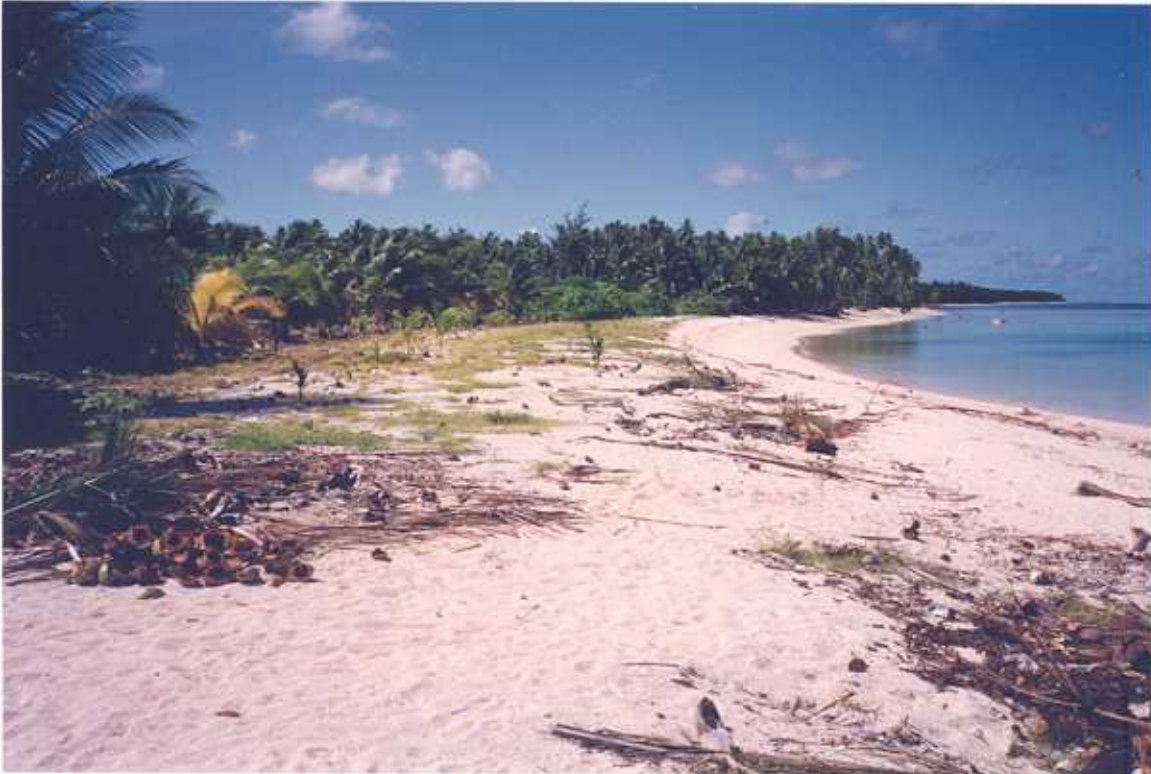
Figure 51. Tanginimake (causeway), Kuria. View south along west side of island immediately north of the causeway. Photo shows extensive area of coastal accretion (progradation of over 40 m) resulting from causeway construction.

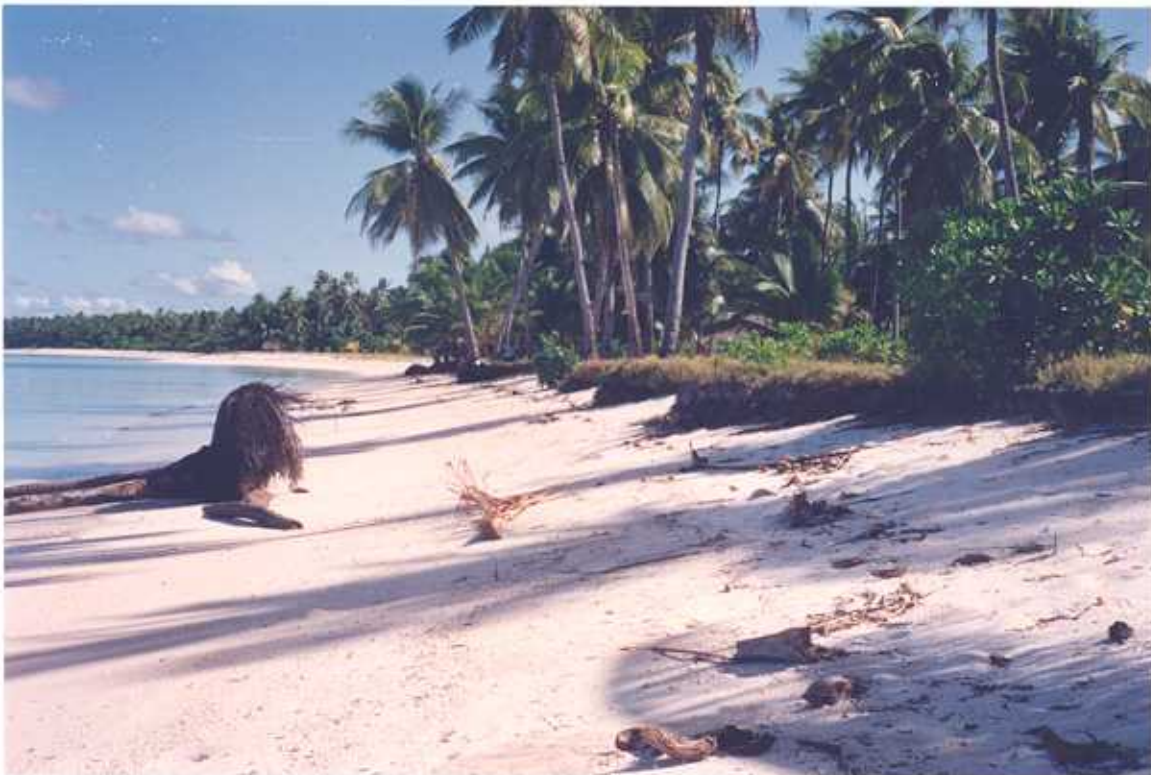
Figure 52. Tanginimake (causeway), Kuria. View north along west side of island approximately 300 m to the south of causeway. This is the only length of beach in the vicinity of the causeway which appears to have suffered any erosion.
