# Hurricane Ike

Nature's Force vs. Structural Strength

**Institute for  
Business &  
Home Safety®**

September 2009

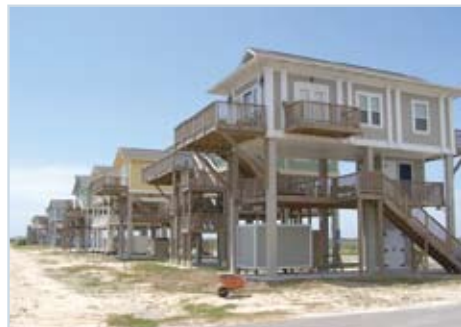
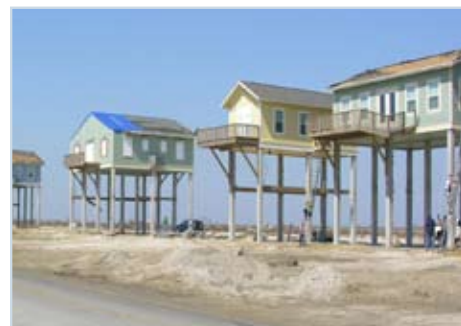
**Figures 29 and 30** Ground level views, looking west, of the *Fortified* houses before and after Hurricane Ike. It is clear that all storage areas and decks were totally destroyed by the storm surge.

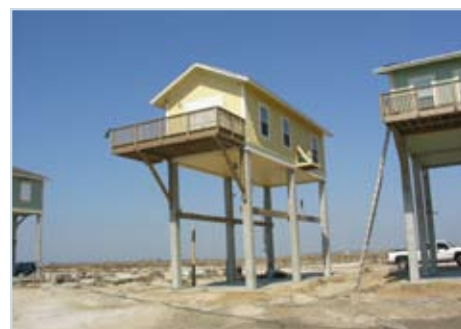
**Figure 31** While all of the decks did break away, it is clear that deck connections were not what typically would be considered a breakaway connection in the Coastal Construction Guidance from FEMA and the NFIP.

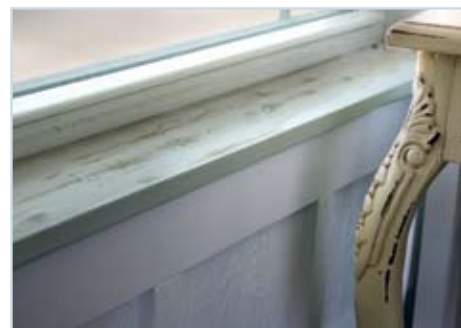
**Figure 37** Even during a Category 2 hurricane, where rainfall rates never exceeded a rate of about 1 inch per hour, wind-driven rain leaked into the house through windows and doors.

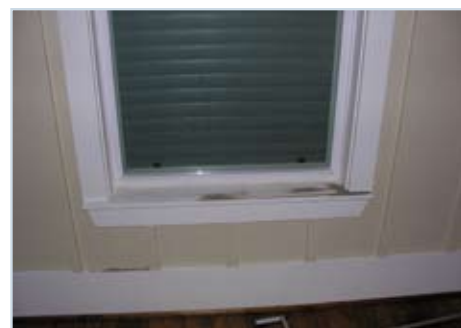
**Figure 38** Water got inside this window, despite the presence of a hurricane shutter and the use of impact-resistant glass.

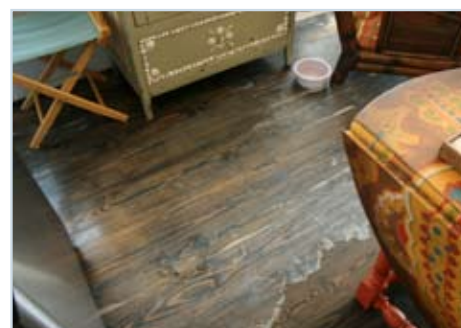
**Figure 39** The silt line on the floor on this home is evidence of just how much water got inside. The use of water-resistant materials, such as wood flooring, prevented widespread water damage.

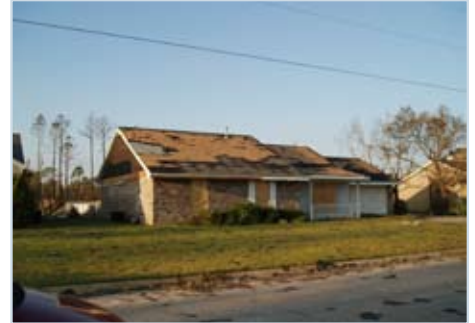
The loss of roof cover and underlayment can lead to significant water intrusion.

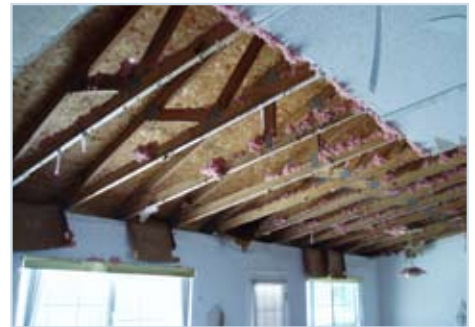
Collapsed ceiling due to water intrusion from roof cover damage.

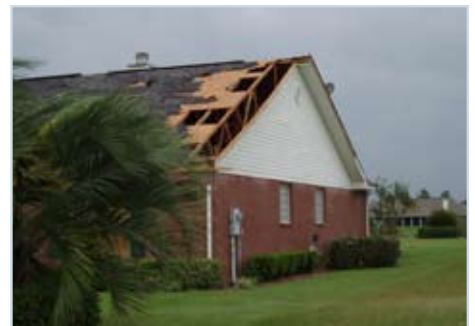
Loss of roof sheathing allows water and wind inside.
