Testing of GE2/1 & ME0 GEM detectors for CMS Phase-2 Muon System Upgrade

Bandar Alsufyani, Stephen Butalla, Marcus Hohlmann, & **Erick Yanes**
on behalf of the CMS Muon Group

Florida Institute of Technology
APS April Meeting April 2023

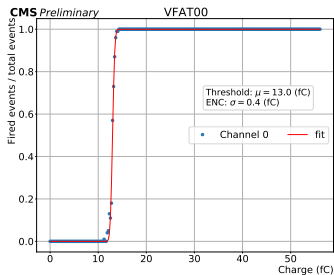
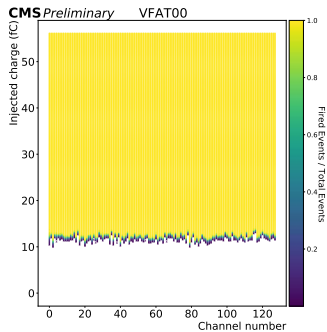
S-Curves and Missing Channels

- VFATs are tested by injecting charge into each of 128 channels, and fitting them into an S-Curve
- A voltage comparator should only respond when the injected charge exceeds a certain threshold
- Issue was seen at FIT, and later CERN, that channels will randomly go missing
- Missing channels always appeared in pairs, and mostly occurred on ASIAGO 2
- Found mismatch errors also appeared in pairs

- Forward Error Corrections (FECs) were also seen on ASIAGO 2
- The high light output of old optical transceivers modules is the cause of the FECs hence missing channels
- So the solution is to reduce the light output power coming from the optical transceiver
 1. Using an attenuator to reduce the light power on ASIAGO 2, see the table below.
 2. Using a low light output
- **No missing channels were found over 40 consecutive S-Curves for ASIAGO 2 or any other ASIAGO.**
- Backends at FIT and CERN now use special lower-power optical transceivers

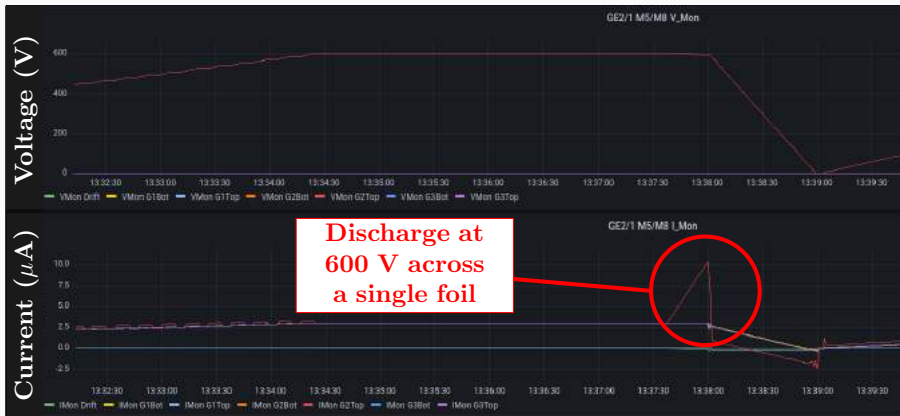
Voltage on the GEM Foils during a Discharge

- The stress test's purpose is to determine the highest voltage that can be applied to each GEM foil without damaging them (without discharges)
- No discharge upto 550 V
- However, start seeing some discharge at 600 V on a single foil
- Discharges can be seen in Grafana

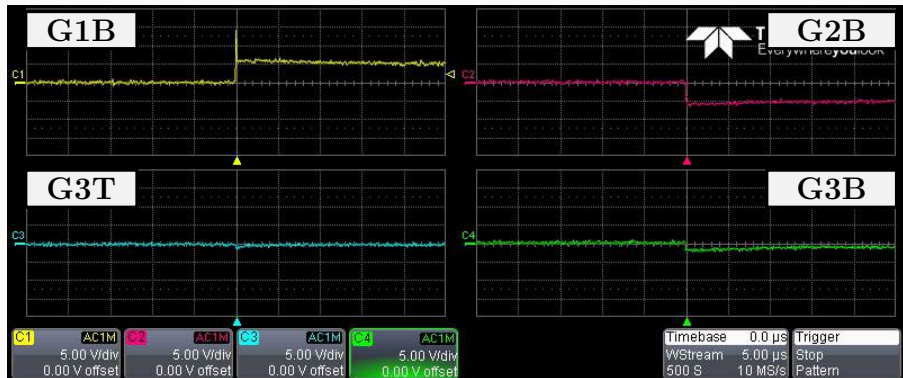
Discharge on G2T propagates to the other foils

- Detect a current flow through the grounding line when discharge occurs:
 - ◇ 20mA per division, -100mA at the peak
 - ◇ This current could possibly flow to the frontend electronics and potentially cause dead or reset the channels
- Also detected voltage on ROB probe due to that discharge:
 - ◇ Unfortunately, the scale is unknown for the ROB probe

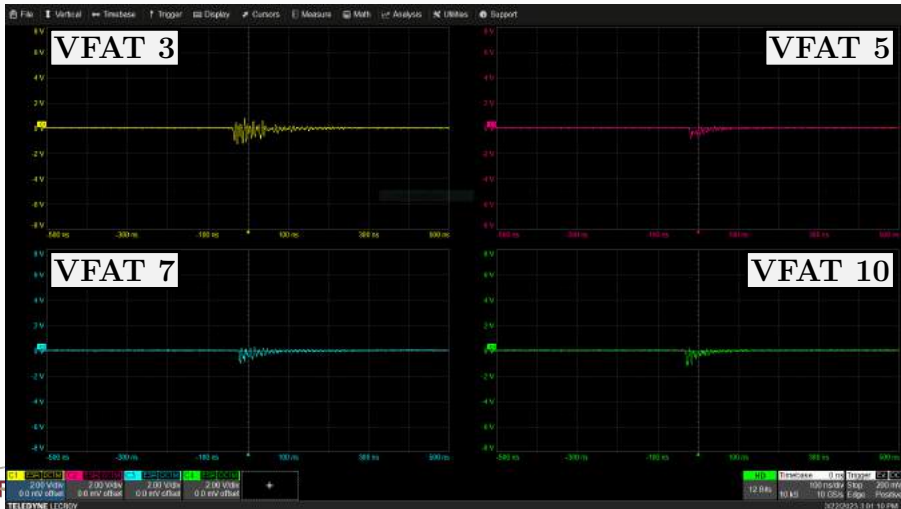
- Output voltage when discharge occurs on the ROB:
 - ◇ As we see one discharge effect many ROB sectors
 - ◇ Still do not know under which VFAT the discharge happens

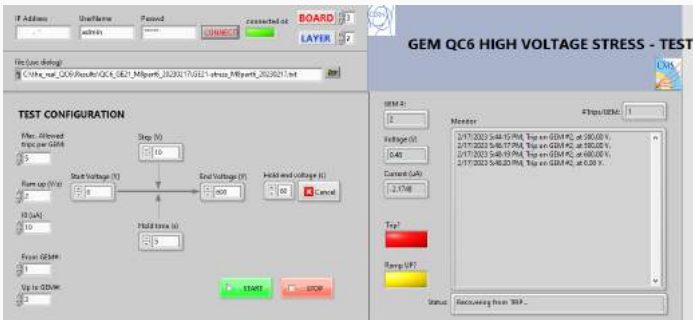
Stress Test Detect Discharges (trips)

- **Purpose:** The stress test's purpose is to determine the highest voltage that can be applied to each GEM foil without damaging them
- **Procedure:**
 1. Scan the voltage range from 0 to 600V in 10 V steps for top GEMs, then hold the step for one minute, then back to zero.
 2. Writing down the number of trips
 3. A successful test is when first the max voltage is greater than 500V, and the recorded trips are less than 5 trips.
