EIC Prototype GEM rebuild

Jared Hadley
December 11, 2020
PHY 4902

A Chronological Record of the Disassembly and subsequent rebuild of the EIC GEM prototype

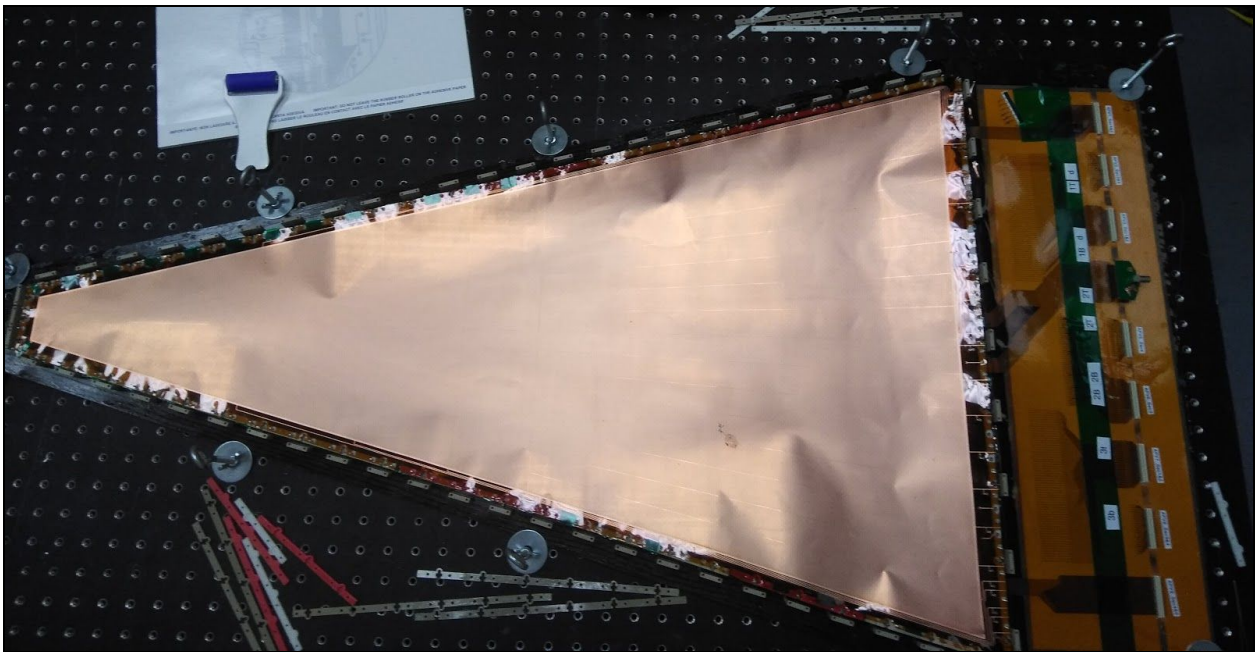
Figure 1: The detector as I first saw it, Partially disassembled. Pictured here is GEM2. some of the old red and white 3d printed frames can be seen in the bottom left.

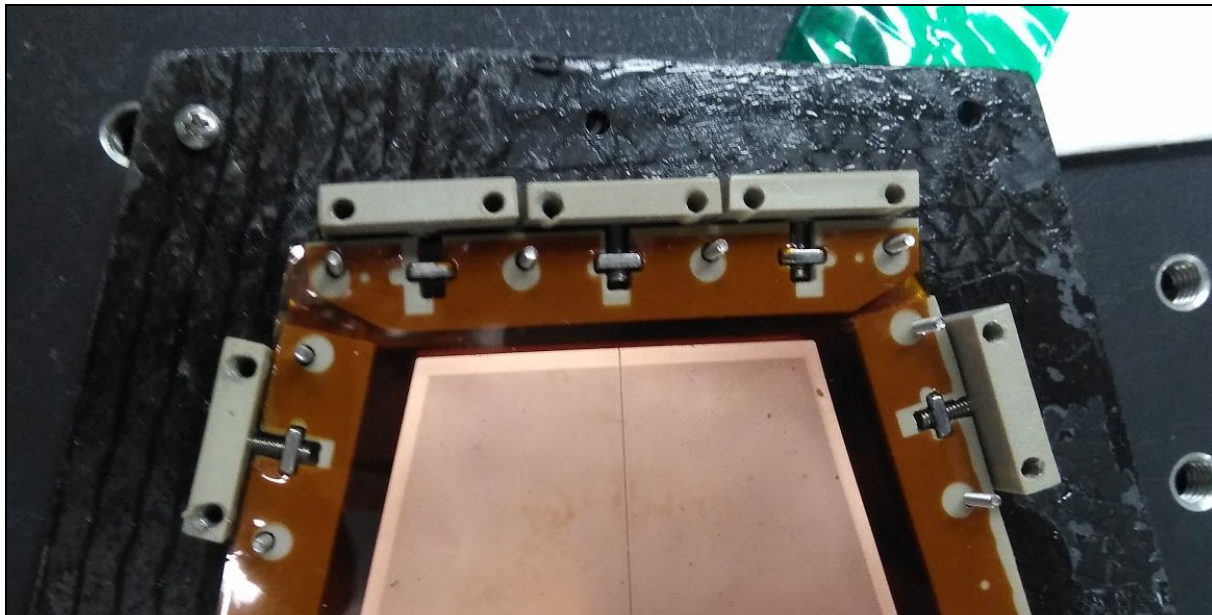
Below is a picture of the narrow end of the detector, notice that the GEM foil does not align perfectly with the slots for the pullout screws and bolts, in our second rebuild I opted to omit the leftmost pullout bolt, and it led to a radical improvement in the tension of this section of the gem, see figure 15 for a comparison.

Figure 6: Misaligned pullout

- Investigate the misaligned pullout at the top of the detector.
- Allow more space for the pullout screws; pretensioning the foils is an art, and the effect of the artists skill could be minimized by allowing for a longer range of motion with the pullout screws.
- Use a more rigid material in the frame construction.

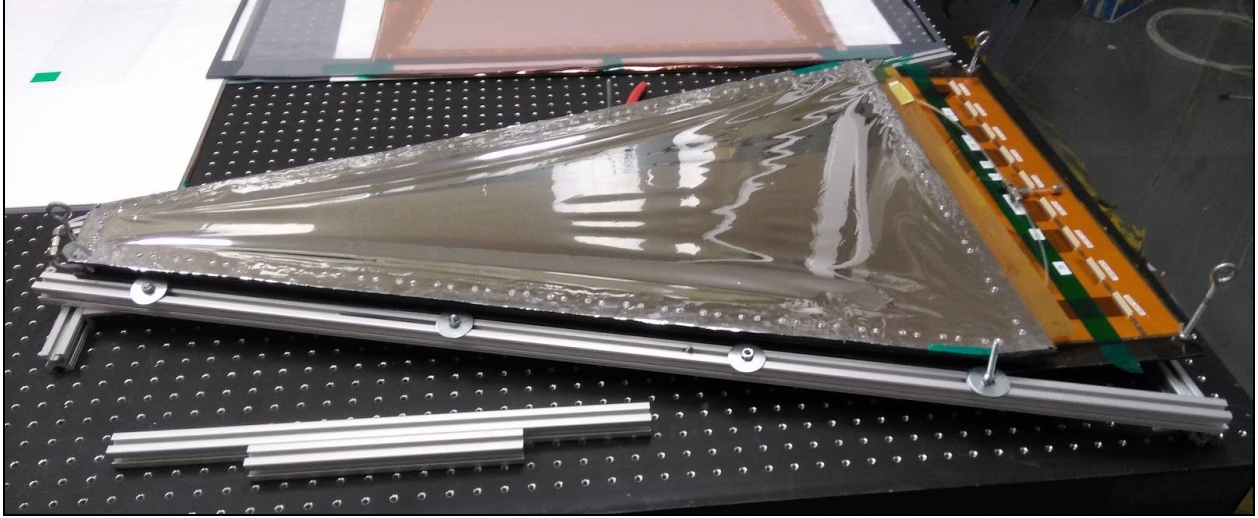
Figure 10: First frame attempt (first rebuild)

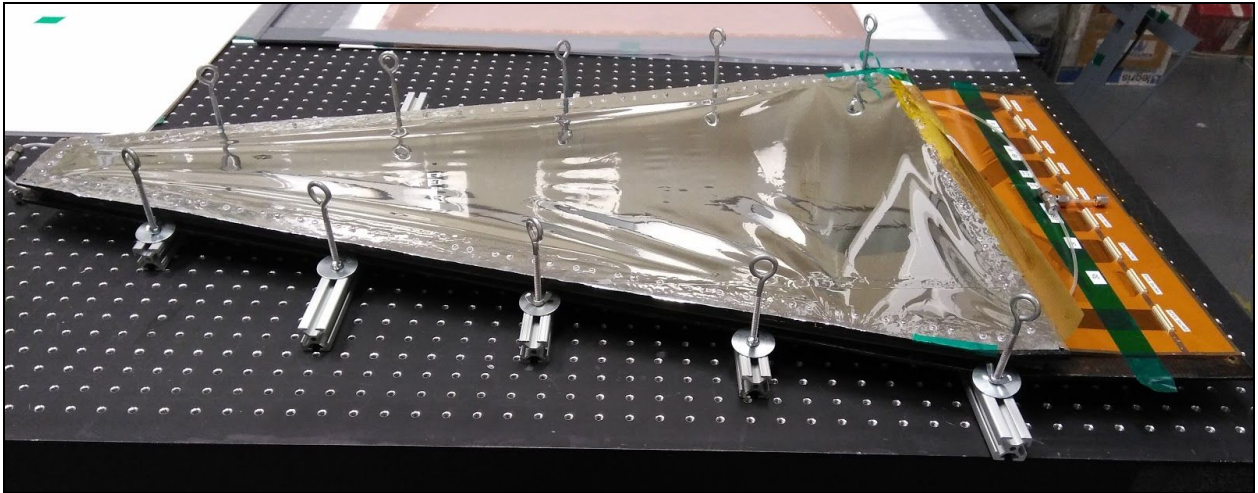
Figure 11: Second frame attempt (first rebuild)

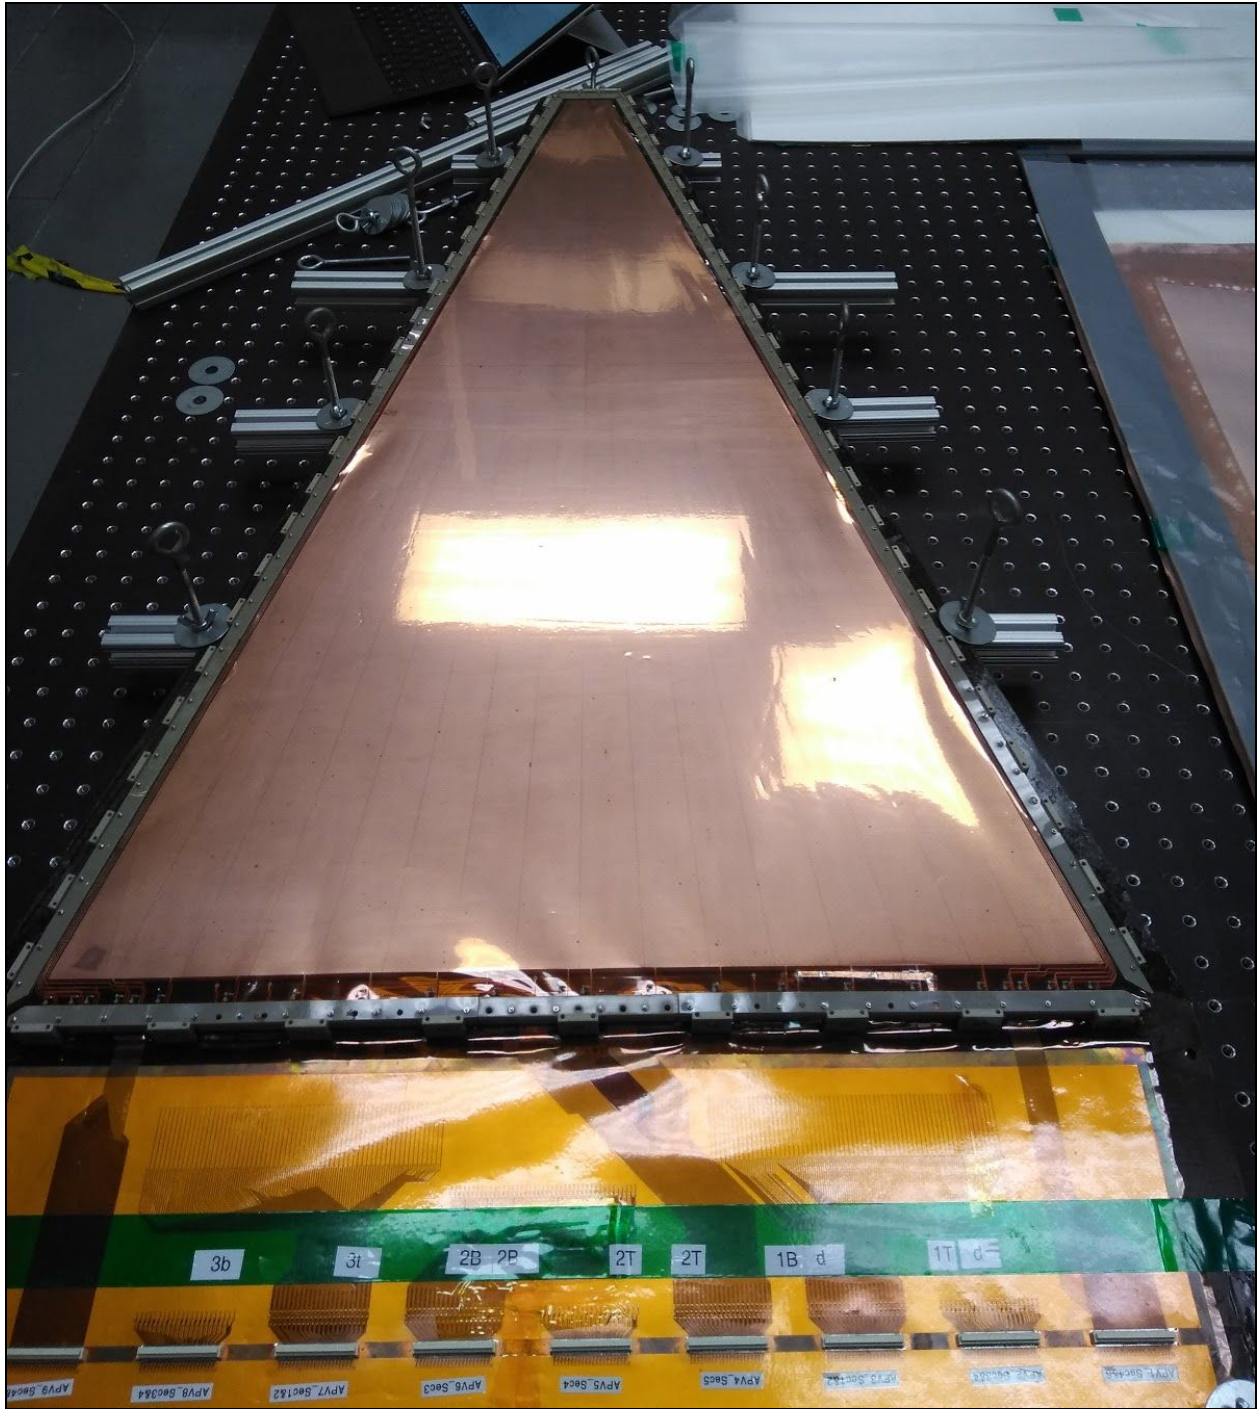
Next, we fully sealed the detector with nylon washers and screws, and released it from the optics bench. Meggering the detector now revealed shorting in both transfer gaps (See the 9/30/2020 data in Table 1). This led to the construction of several support structures in an attempt to replicate the tensioning effect produced by securing the detector to the optics bench. These were built primarily with 80/20 aluminum frames, bolts, and large metal washers. The first of these frames was not successful in removing the shorts, and several other arrangements were built. I will spare the reader time, and reveal that there was never a support structure that could remove the shorting in the sealed detector, though we did have some short lived success working on the frame with the detector reopened (See Figure 12, and the 10/26/2020 data in Table 1).

Figure 12: Frame that was briefly successful in removing shorts (first rebuild)

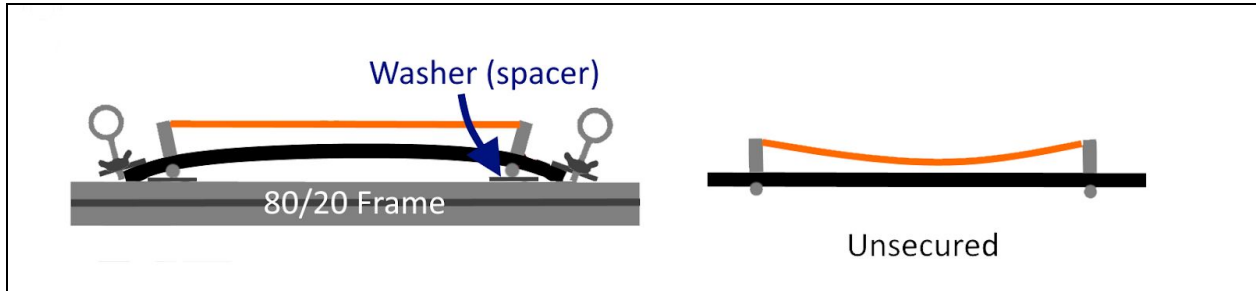
The trick that I adapted to apply extra tension to the foils was to use washers as shims under the pullout screws, and then wing nuts to pull down on the outer edge of the carbon fiber frame. I've included a diagram below to show the theory of this technique.

Figure 13: Washer tensioning trick, with unsecured frame for comparison

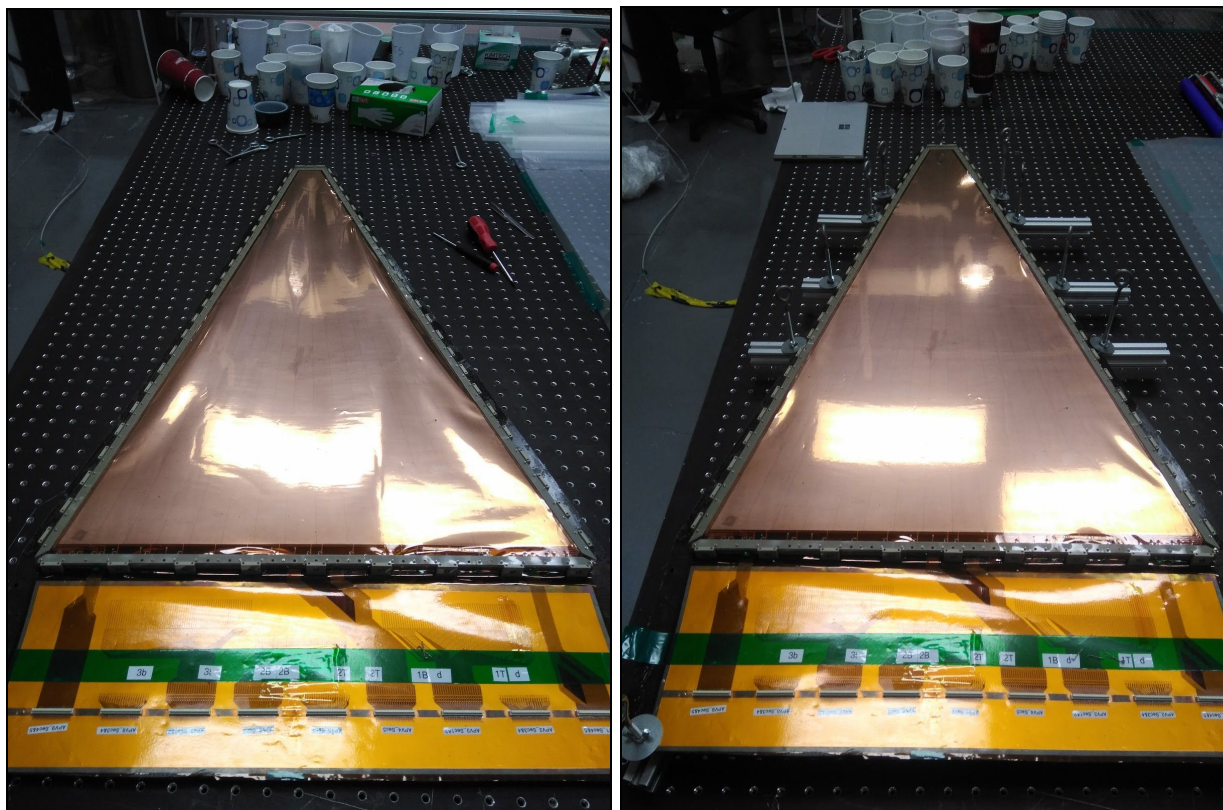
To show the tensioning effect that this method can have, I've included a side by side comparison below. It is worth noting here that this trick necessarily makes it very difficult to attach the window because the pullouts are pushed away from parallel, as is evident in the diagram above.

Figure 14: Unsecured frame (left) and secured frame (right) both from the second rebuild

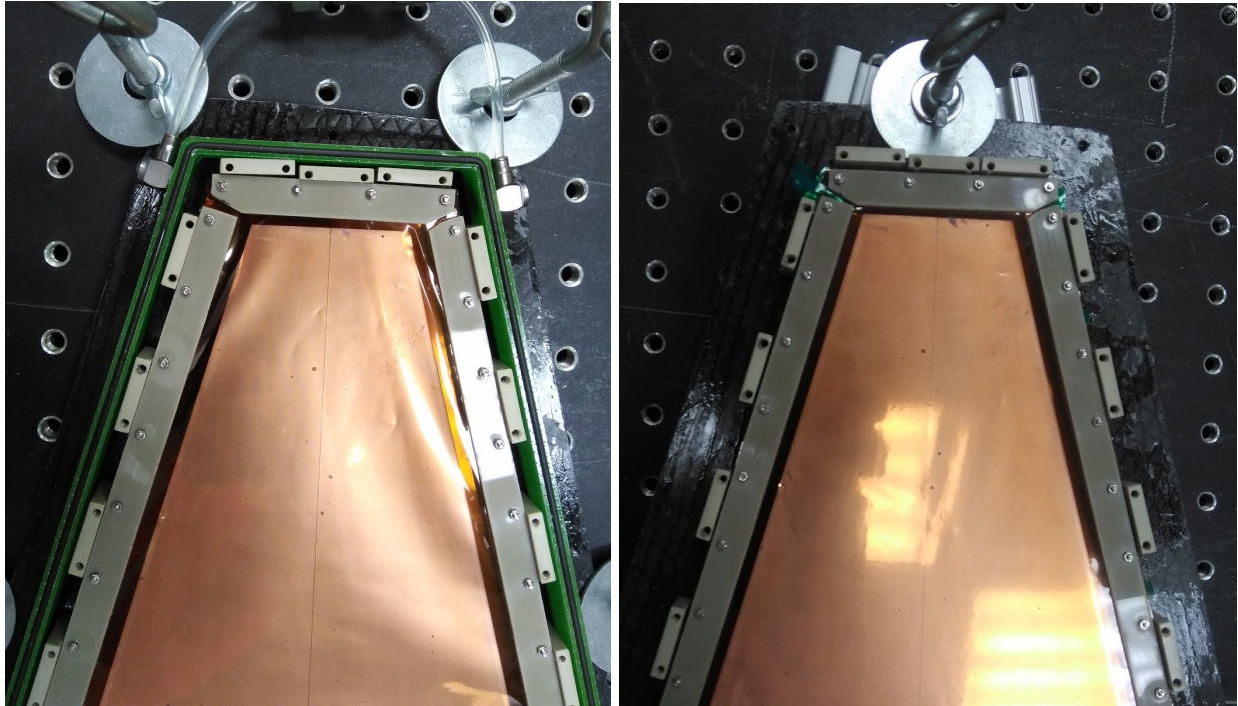
The frame constructed after the second rebuild made the largest cosmetic improvement to the detector, but neither designs fully removed the shorting. Below is a side by side comparison of the narrow end of the detector that was improved by the second rebuild. The structure used to apply extra tension to the frame can be seen in Figure 16

Figure 15: problematic region at the narrow end of the detector after the first rebuild (left) and the improvement made after the second rebuild (right)

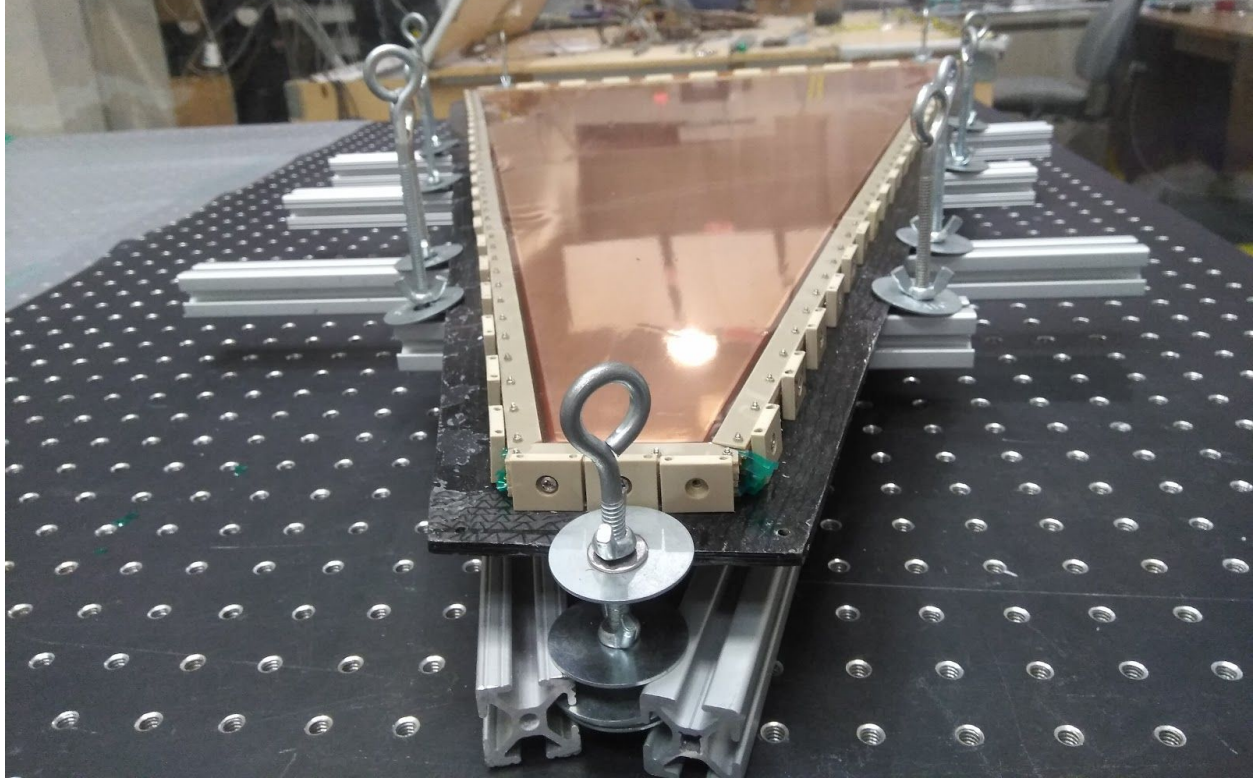
Figure 16: 80/20 frame design that could apply extra tension to any side of the detector. You can also see where a pullout screw was omitted at the narrow end of the detector (second rebuild)
