# EIC GEM Detector Prototype - Spring 2020 Progress Report

Brendan Steffens

April 2020

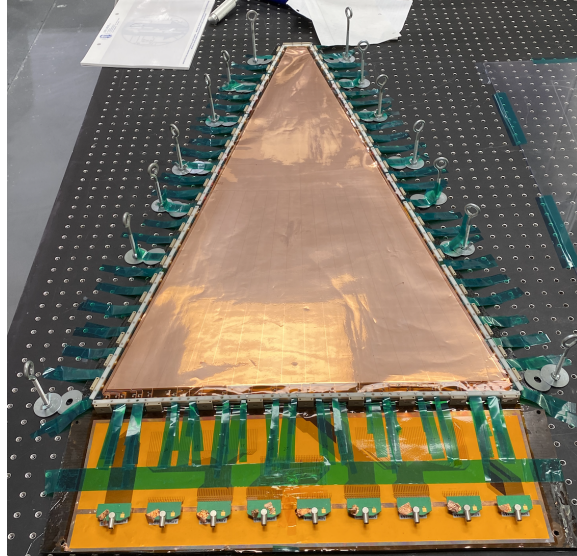
The initial state of the detector at the beginning of the semester can be seen in Figure 1. Note that the detector is un-closed, the foils are only pre-stretched with green tape (and not tensioned with screws). It is also worth noting that the top foil (the drift foil) exhibits some noticeable wear and tear.

Figure 1: The prototype at the beginning of the semester. Unclosed, foils not tensioned but pre-stretched with green tape.

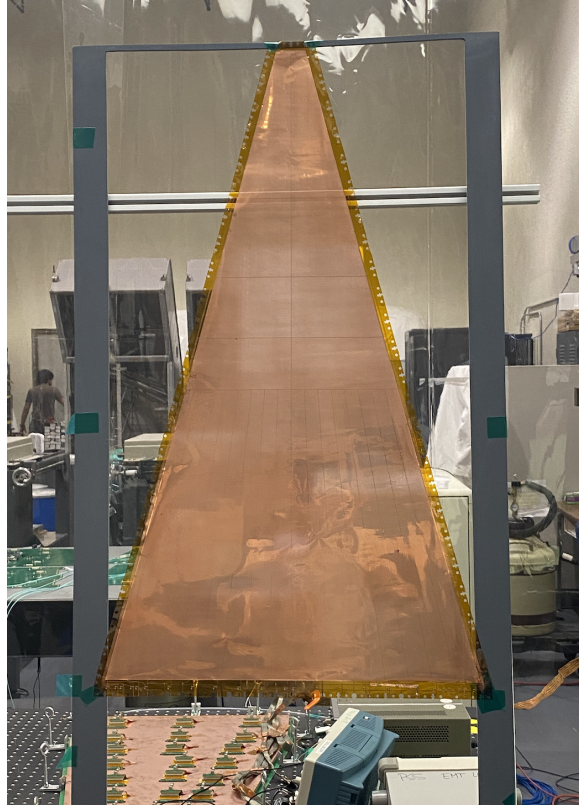
Figure 3: Drift foil removed and hanging on the wall. Unfortunately, an accident occurred at this stage of the work: the drift foil was left hanging on the wall overnight and was found to have come loose from its green tape at the top the following morning. This caused the foil to sag down and bend in half. Fortunately, the bend was gentle and un-creased, causing no additional damage to the foil. It should be noted that the foils need to be extremely well secured when hanging vertically on the wall to prevent this from happening again. Also, leaving foils hanging overnight is to be avoided, if possible.

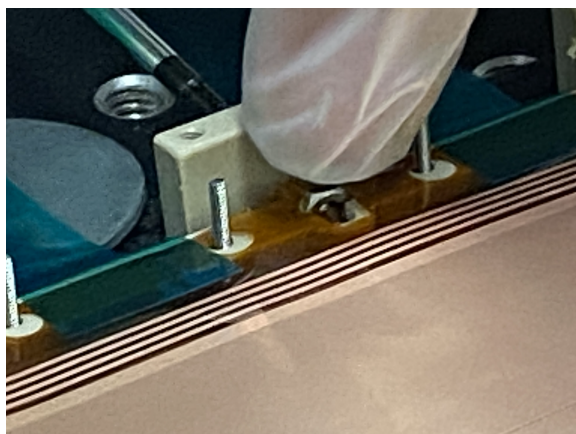
With the drift foil removed, we were able to see that many of the nuts were sinking too low within the pullouts, causing the screws to land above them. To fix this, we simply held the nuts in place using gloved hands and tweezers, and we got the screws started in them just enough for them to be engaged. We were then able to reapply the drift foil, and screw down the top level of internal frames once again. Before doing so, however, we took this opportunity to re-stretch the exposed GEM foil by removing the original tapes and installing new tapes, applying gentle tension.

Figure 4: With the drift foil removed and hanging on the wall, the nuts for the pull out screws could be manually held in place with gloved fingers and tweezers, allowing us to get the screws started.

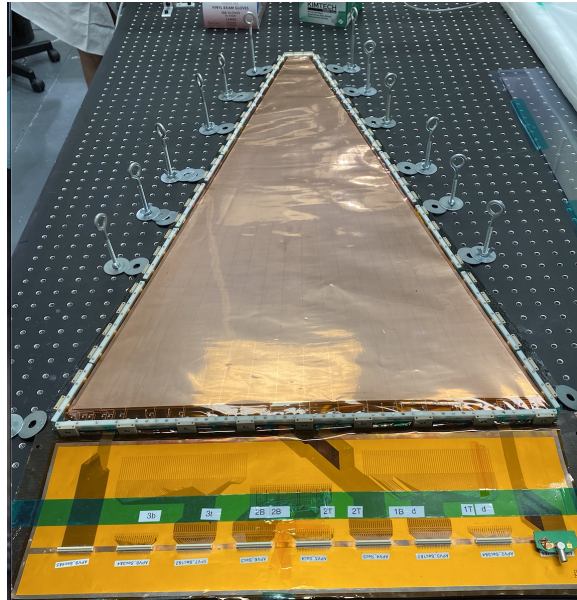
After all of this work was completed, we then proceeded to tension the foils, which went smoothly. It should be noted that the torque screwdriver cannot be used in this process, as no adapter seems to exist that allows it to engage metric screws. This causes the tensioning of the EIC GEM prototype foils to be rather haphazard, and may be a problem when it comes to foils being shorted. The uneven tensioning can be seen in Figure 6, which shows the state of the detector after this phase of work.

Figure 6: A picture taken of the detector after the tensioning of the foils. The lack of consistent tensioning is clearly evidenced by the ripples that remain in the drift foil.

It seems that a lot of the problems with the detector, in particular shorts in the transfer gaps, could be solved or mitigated by more consistent tensioning of the foils. As mentioned earlier, the torque screwdriver cannot be used with the metric screws that tension the foils, and for this reason, the tensioning process for the EIC prototype is rather haphazard, and probably results in uneven or asymmetric tensioning of the GEM foils. Obviously, this can lead to shorts, as we have observed.

I spent a fair bit of time looking into adapter pieces that could allow either of our two torque screwdrivers to be used with the metric screws, but I was unable to find anything, unfortunately. Thus, I think the only solution here is to manufacture an adapter either via machining or via 3D printing. 3D printing would probably be the easiest and most time-effective approach. I would recommend printing the adapter on the highest resolution available, as the adapter needs to be able to sustain substantial torque without deforming.

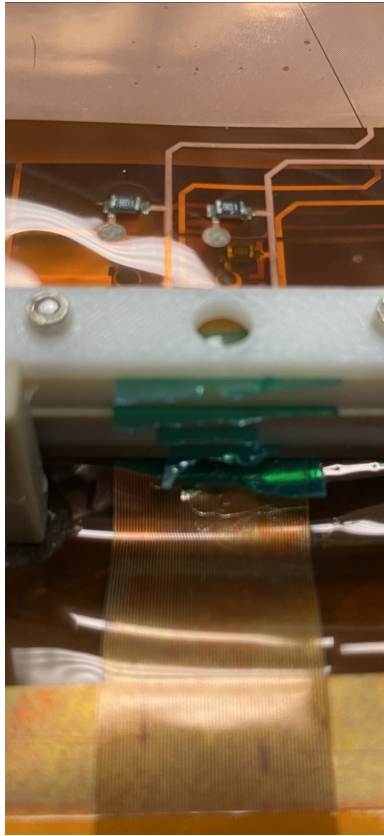
As can be seen in Figure 6, the pre-stretching tapes were cut after this phase. An accident occurred during this stage of the work: a knife slipped and severed several of the traces leading to right-most readout panasonic. An image of this damage is shown in Figure 7. Currently, the results of this damage, if any, on detector performance, are unknown, and will need to be investigated moving forward. This will be addressed in the final section of this report.

Figure 7: Damage accidentally caused to some of the traces leading to the right-most readout panasonic, labeled "APV1 - Sec 4-5". Several of the traces appear to be severed. At this time, the exact effect of this damage is unknown.

Another immediate problem that should be addressed moving forward is the damage to the HV traces on the readout, mentioned previously, and shown in Figure 7. Presently, it is unknown what effect, if any, this damage will have on detector performance in the future. This should be investigated by the next HEP member working on the EIC prototype. The short exists with respect to Sectors 4 and 5. The significance of these labels can be seen in the schematic provided in Figure 10.

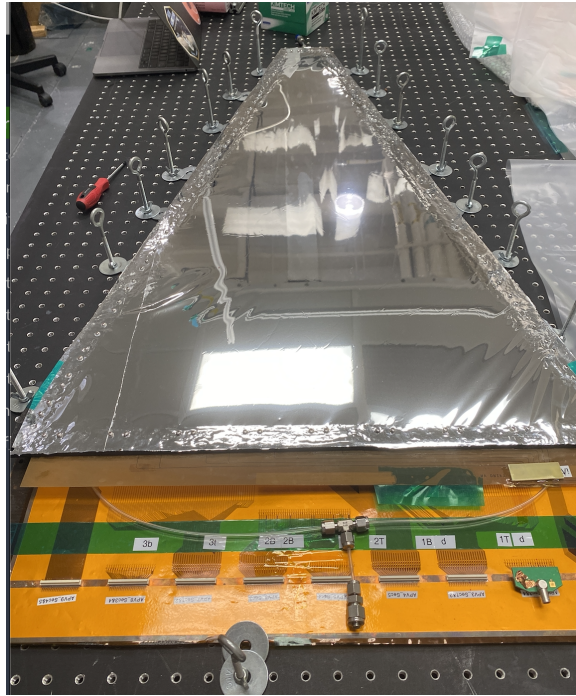
Figure 9: The detector has been closed using brand new 14mm closing screws and nylon/plastic washers 'borrowed' from the CMS GEM construction.

Even at max flow of  $N_2$  gas, no outflow of gas was detected coming out of the other side of the detector. This is taken to be an indication of the lack of gas-tightness of the prototype. This is something that could be addressed in future work on the prototype.
