Cooling Circuit for GE2/1 Front Chamber Feedback

Stephen D. Butalla

October 1, 2021

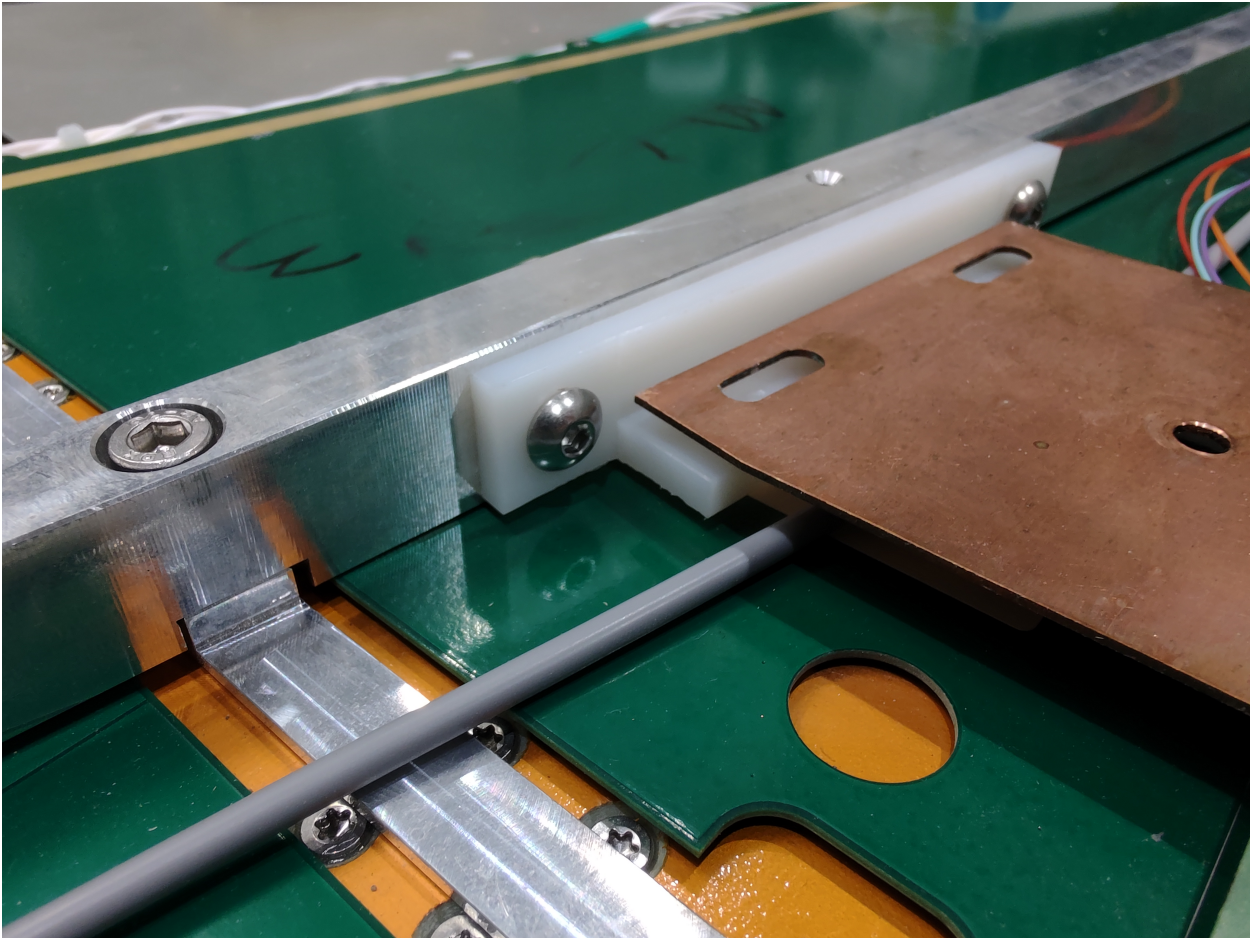
- There are no issues with the mounting brackets fixed to the longitudinal bars; all of the holes are within the tolerances given by the holes on the cooling circuit mount points (see Figs. 1 and 2).

Figure 1: Brackets mounted on the longitudinal stiffeners.

- Through holes drilled in the longitudinal stiffeners according to schematics (Fig. 1).
- Through holes drilled and tapped in the M5 and M8 crossbars (manually located); see Fig. 8.
- Elongated/enlarged holes on the copper plates for the FEASTs (see Fig. 9).
- Resoldered the cooling plate for the 2V5 FEAST on the M6 module (see Fig. 10).

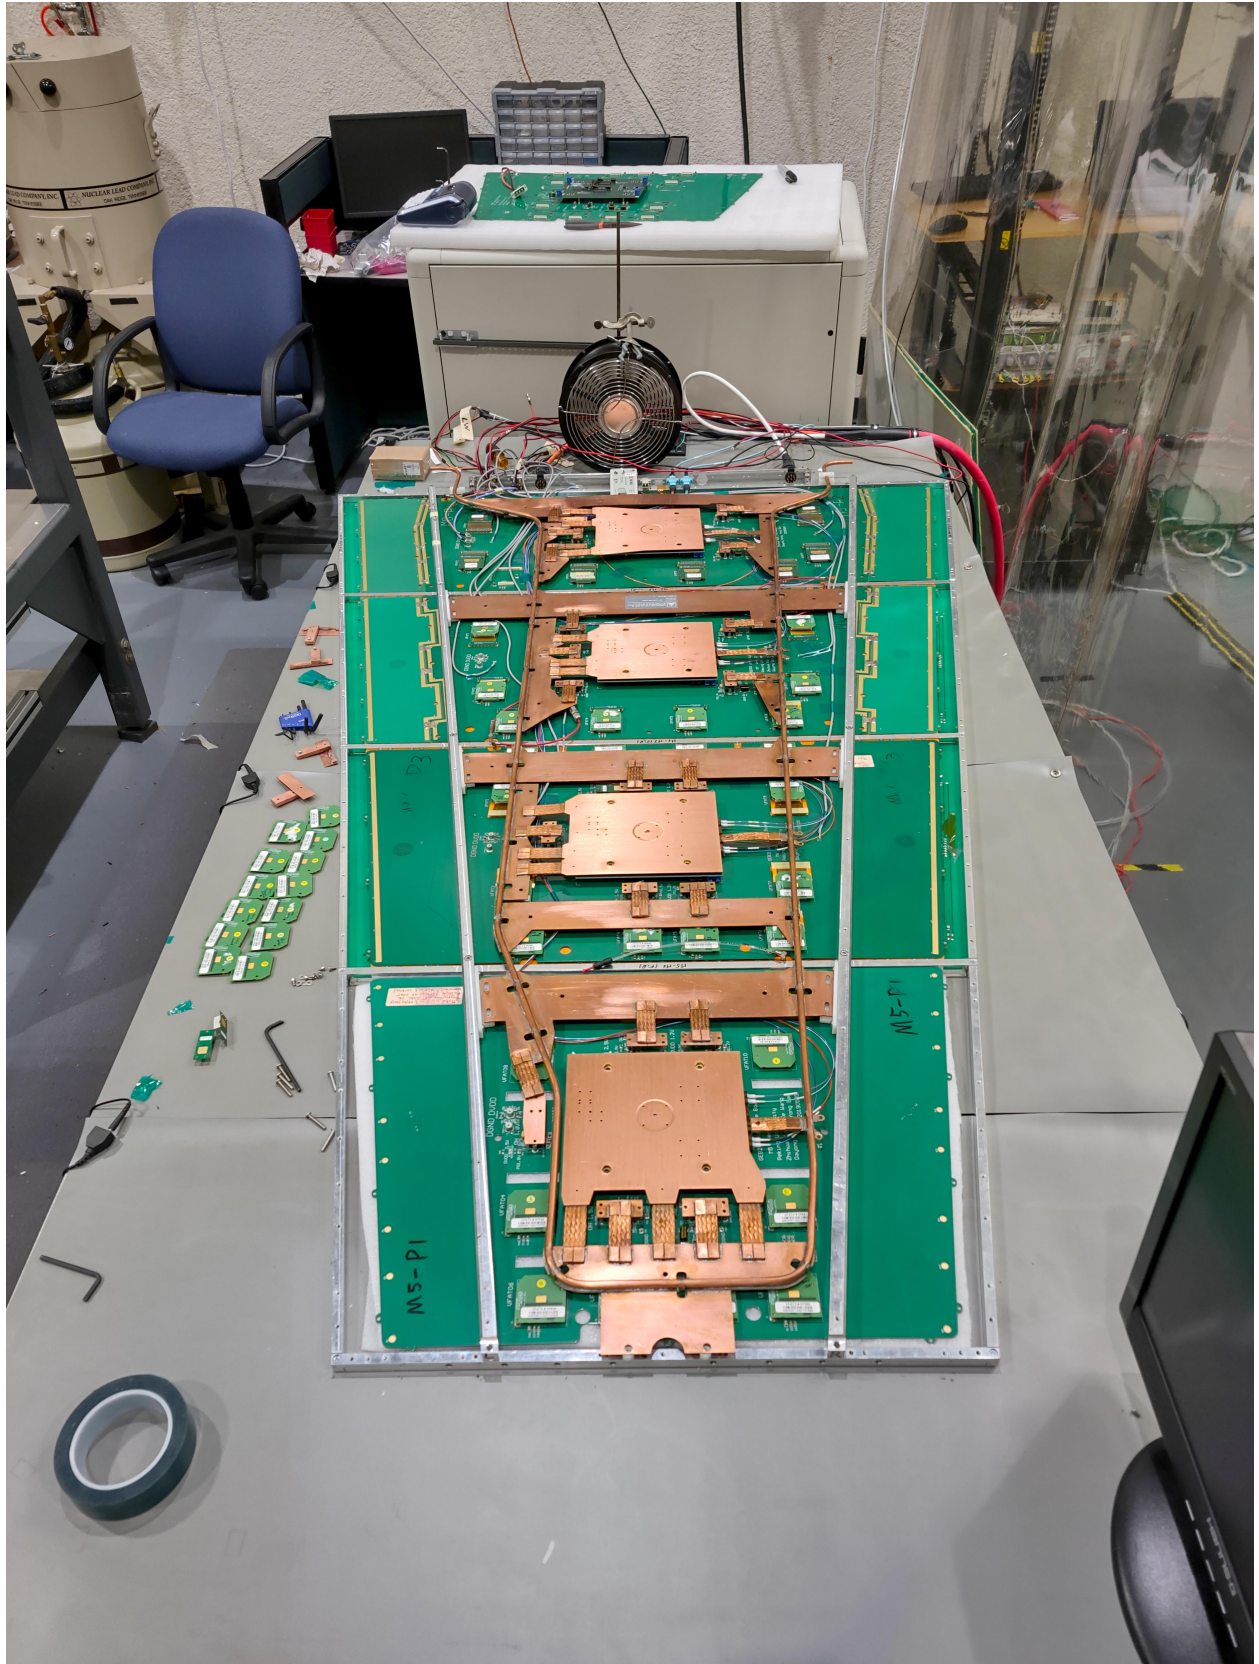
Figure 2: Cooling circuit mounted on the GE2/1 front chamber.

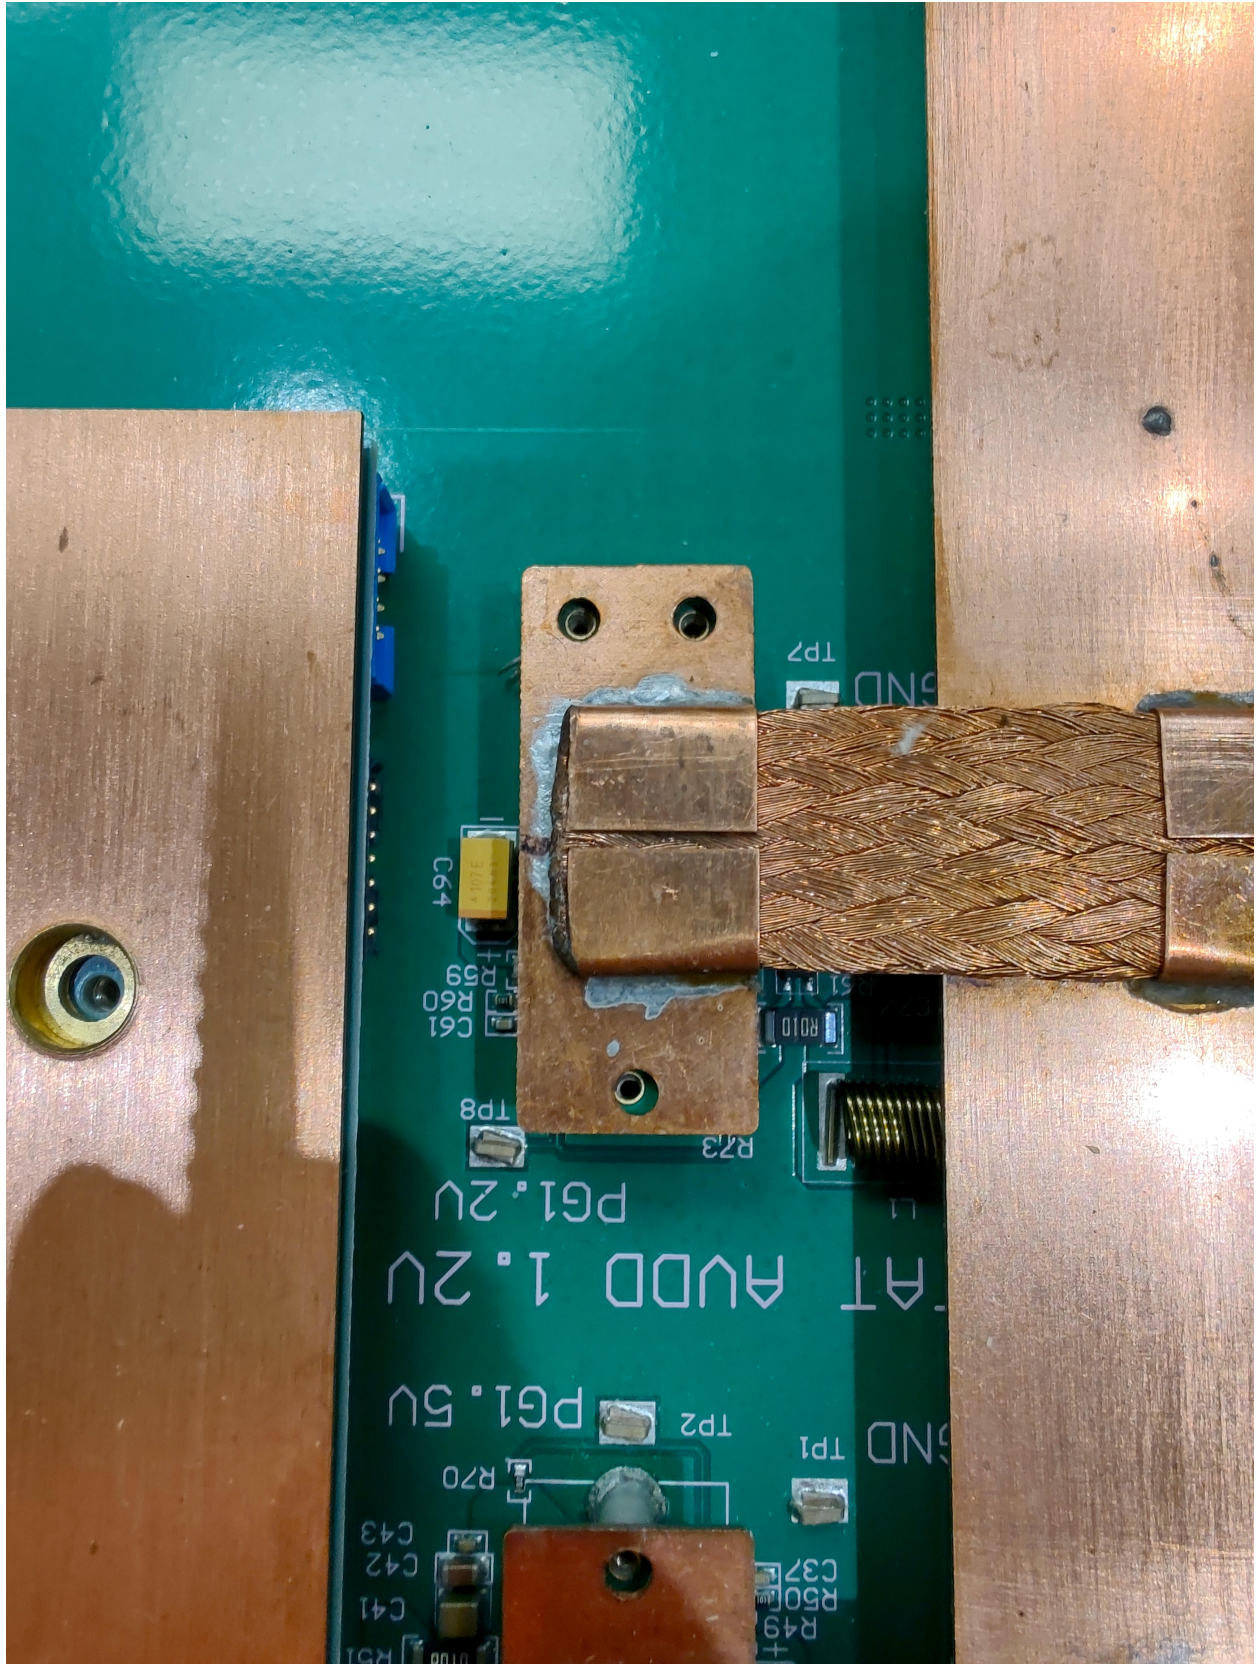
- There are some problems with aligning the copper plates with the FEASTs. E.g., once the copper plates for all FEASTs on one GE2/1 module are aligned (Fig. 3), all of the other copper plates for the FEASTs on other modules are misaligned (see Fig. 4).

Figure 3: Example of good alignment for the FEAST cooling copper plates on one module.

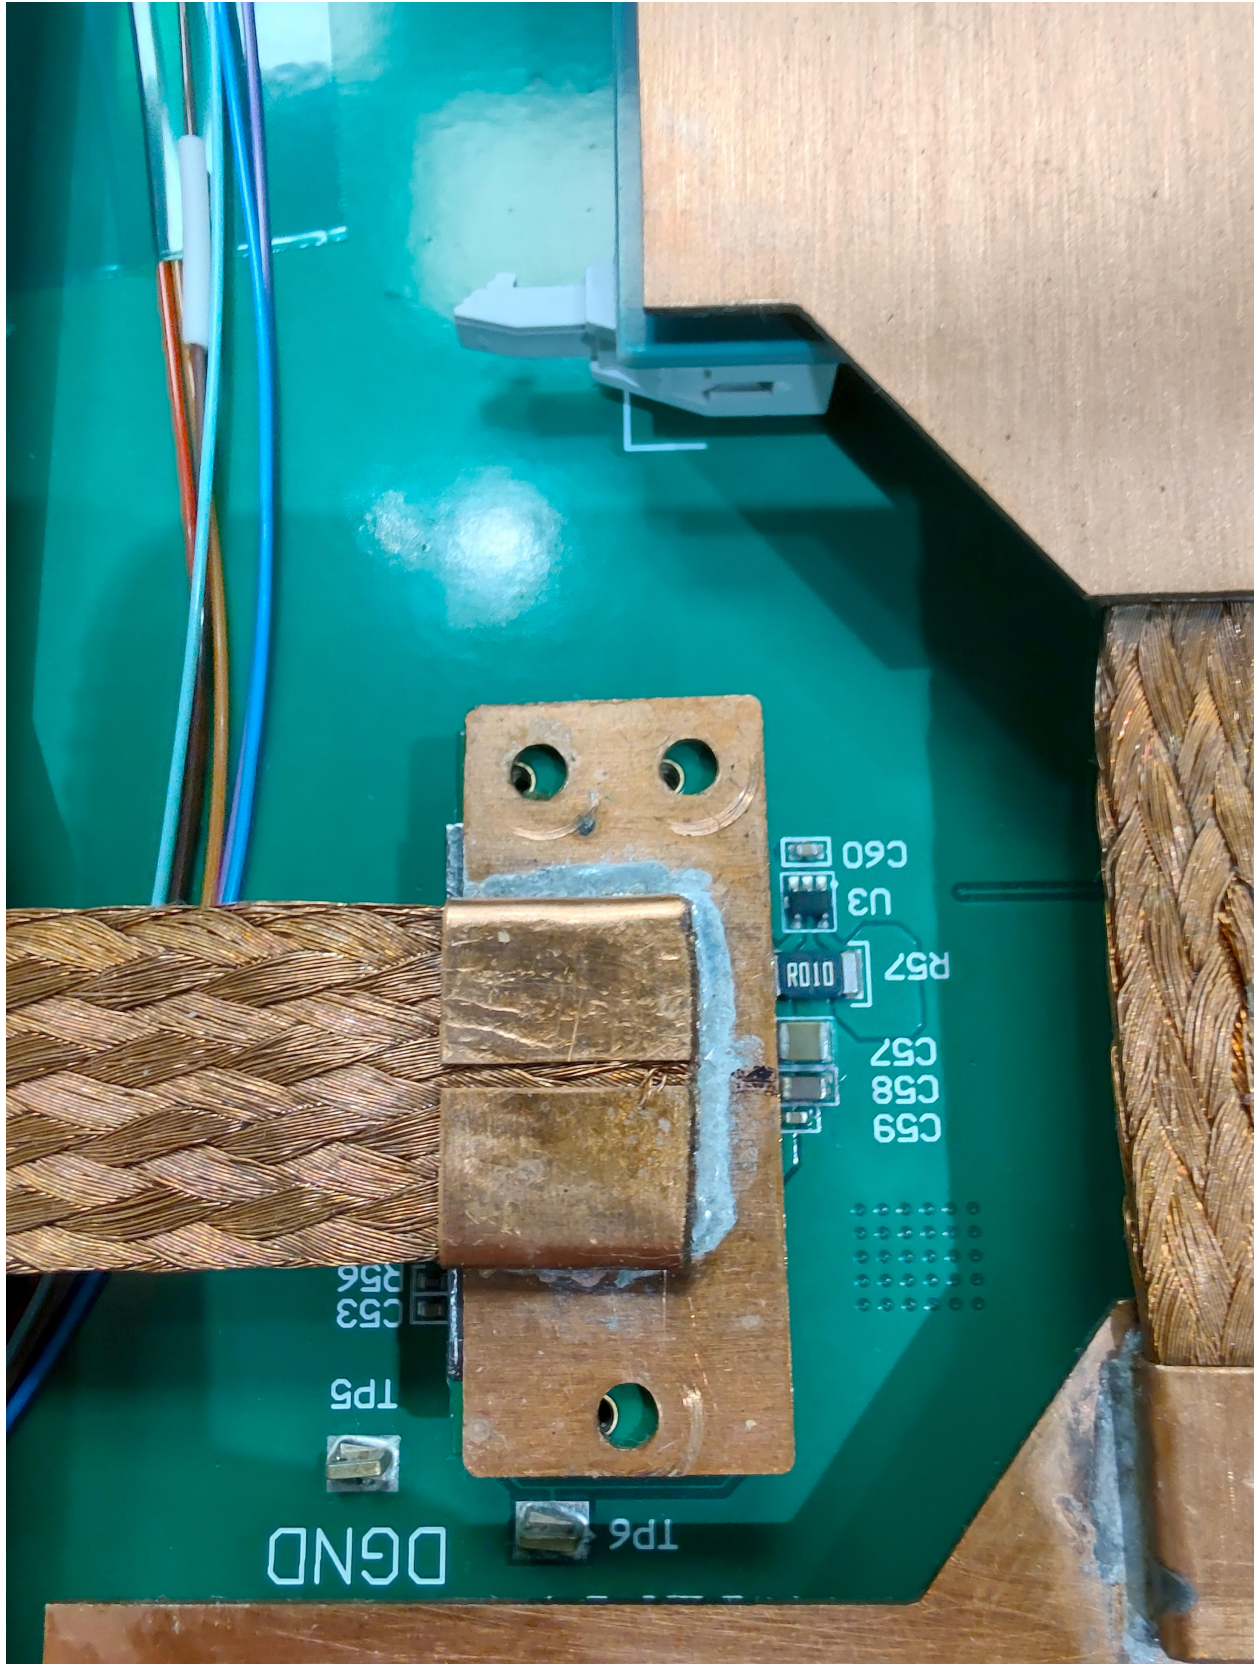
Figure 4: Example of poor alignment for the FEAST cooling copper plates for the other three modules.

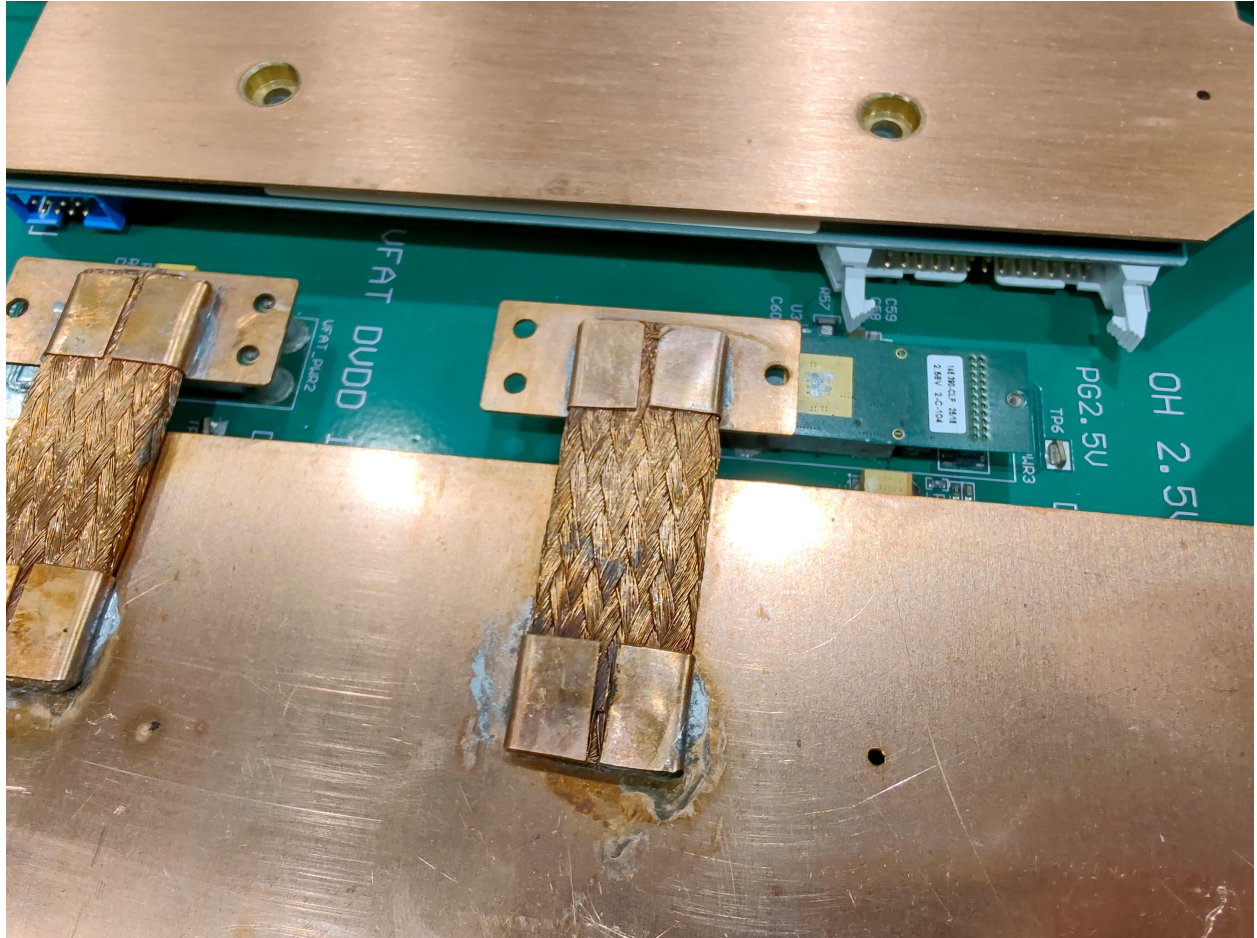
- The 2V5 FEAST on the M6 module is not aligned at all (see Fig. 5).
- Overall, the OH copper plates are well aligned with the OHs (see Fig. 6).
- Good alignment for the VTRx/VTTx cooling plate attached to OH (Fig. 7).

Figure 5: The copper cooling plate for the 2V5 FEAST on the M6 module.

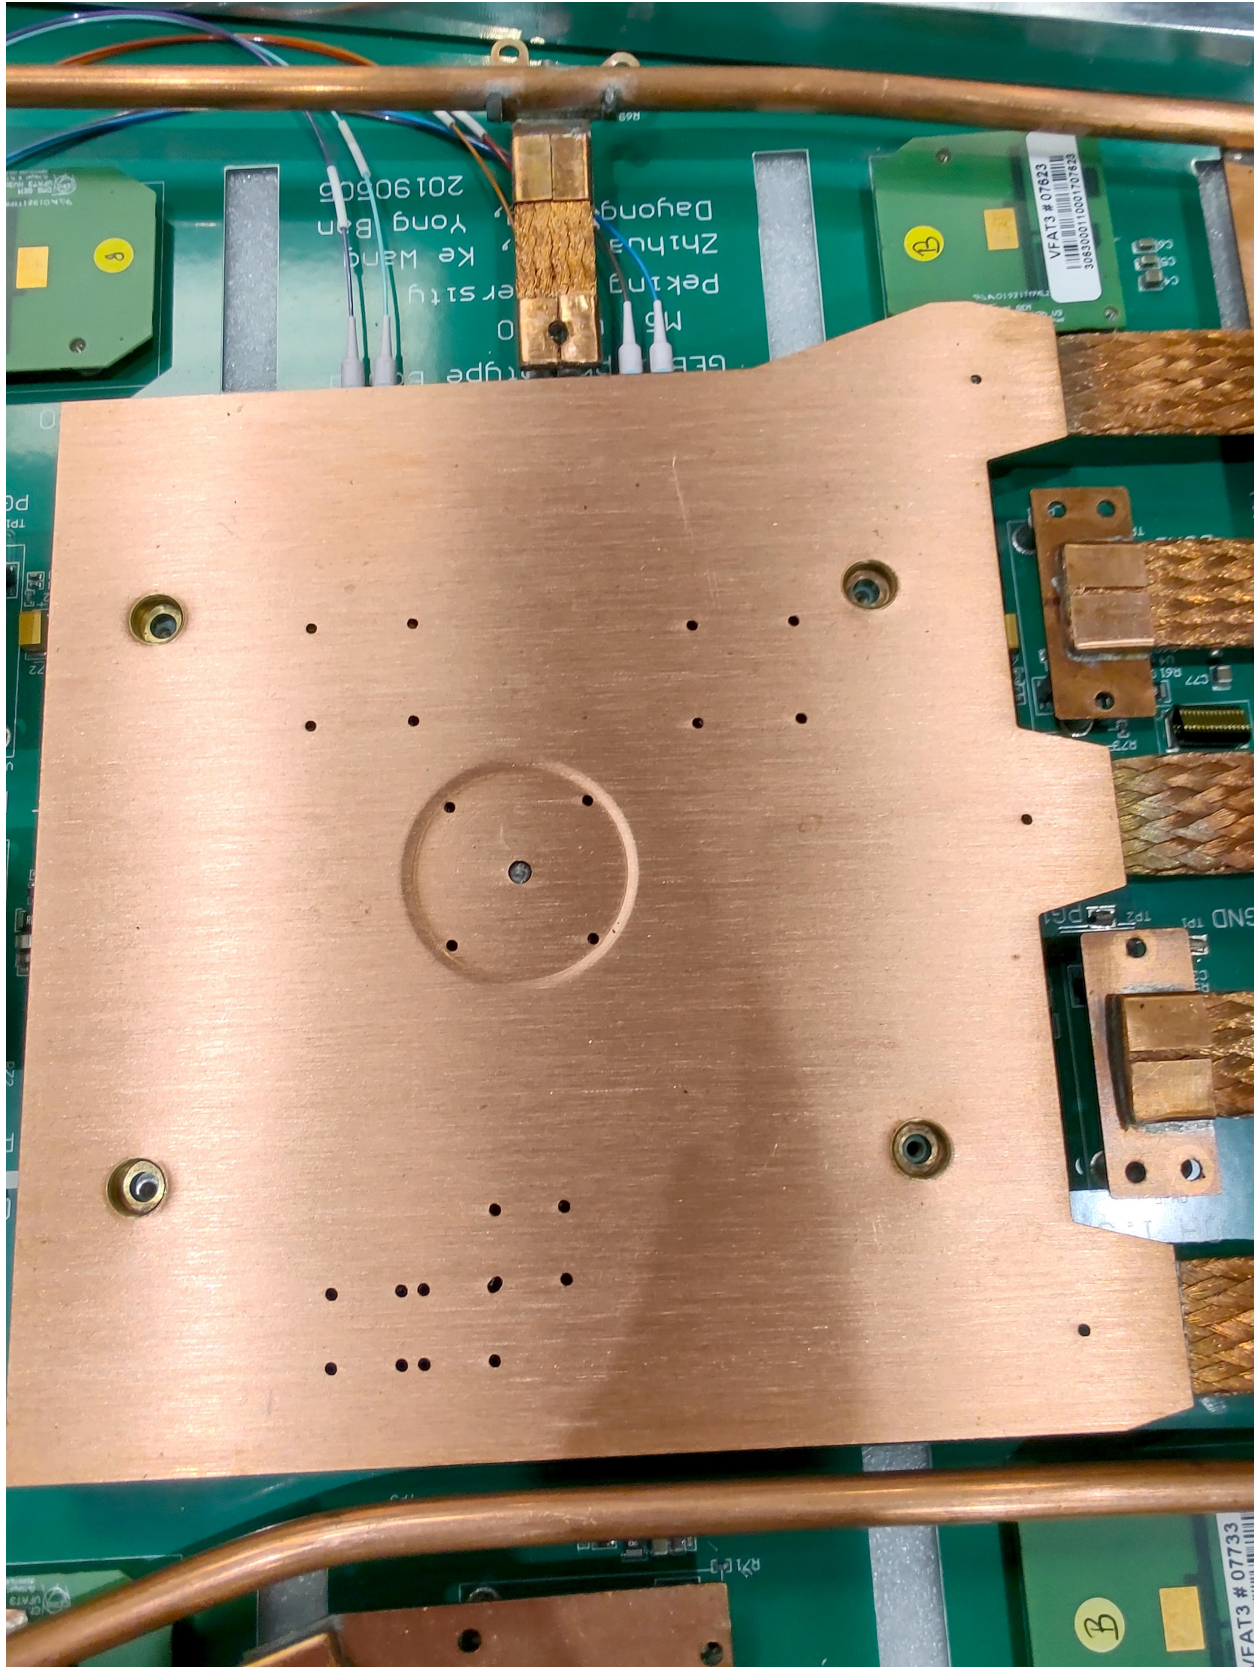
Figure 6: Example of the alignment of the copper cooling plate for the OH.

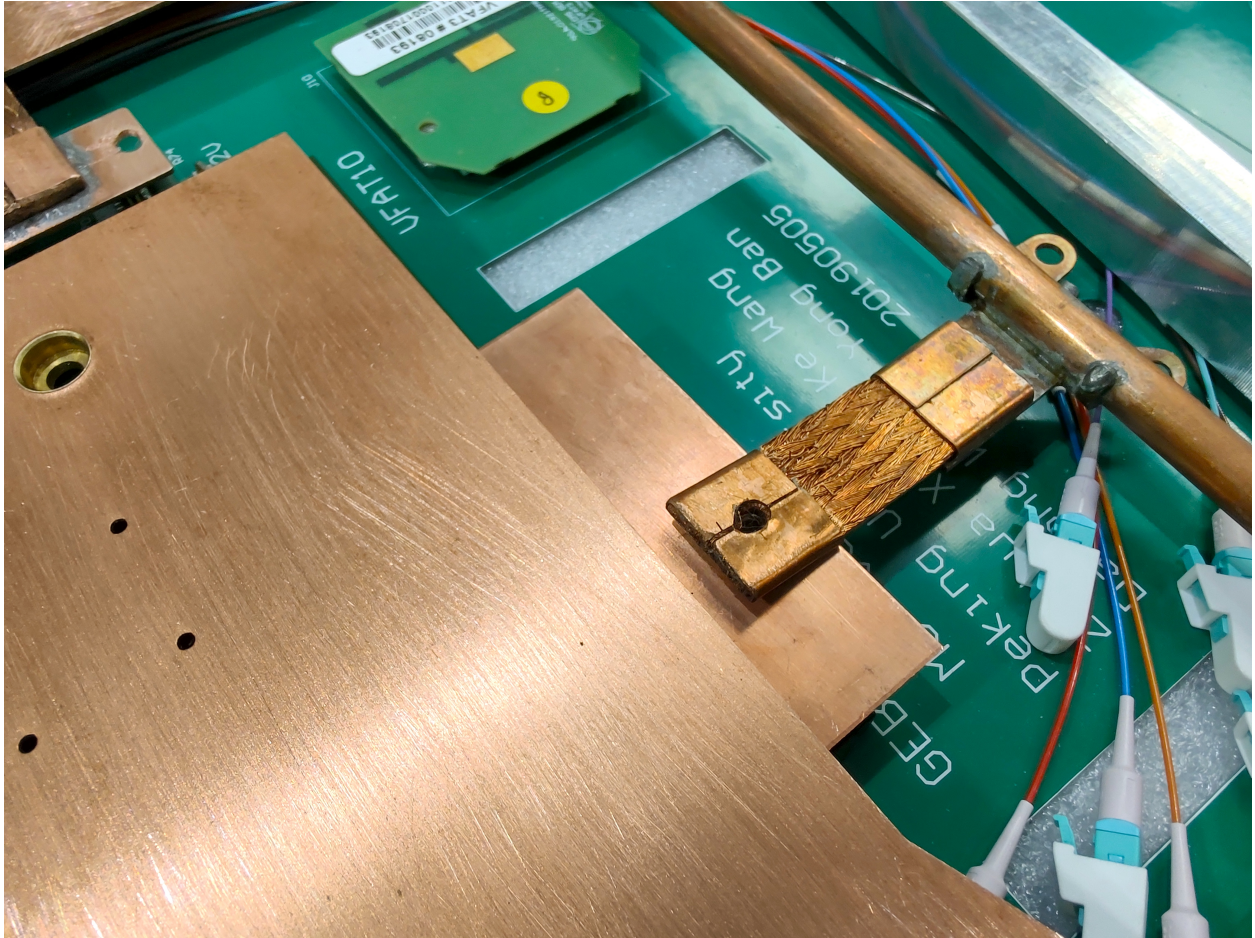
Figure 7: Cooling plate for the VTRx/VTTx.

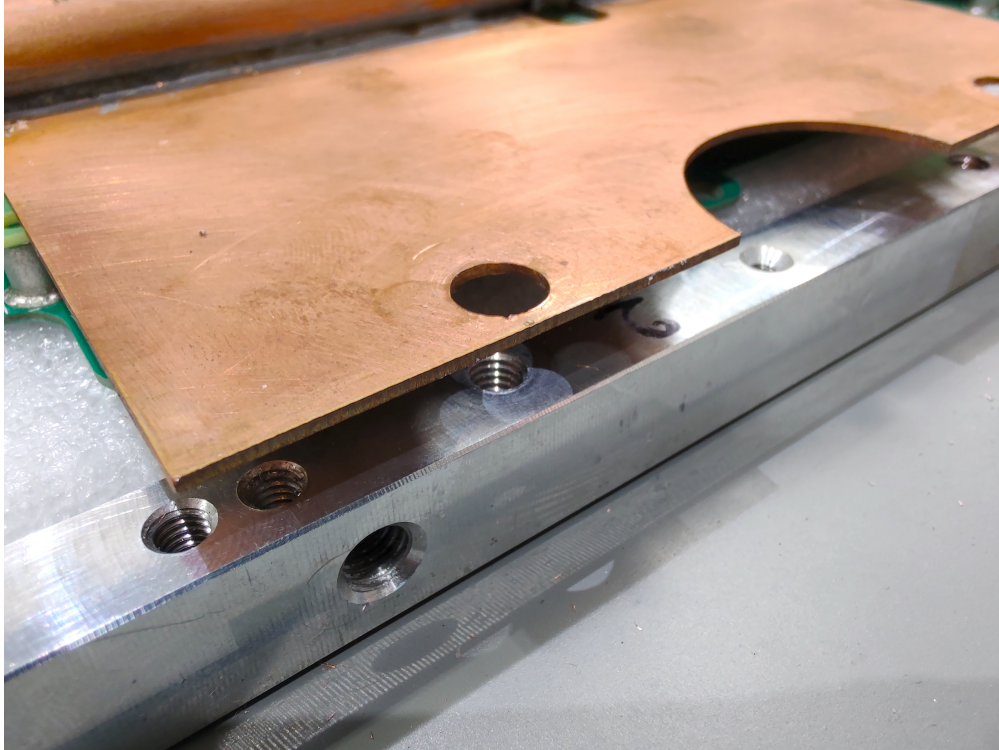
(a) Drilled and tapped holes in the M5 cross bar.

Figure 8: The drilled and tapped holes in the M8 and M5 crossbar. Note that these were not positioned according to the schematics.

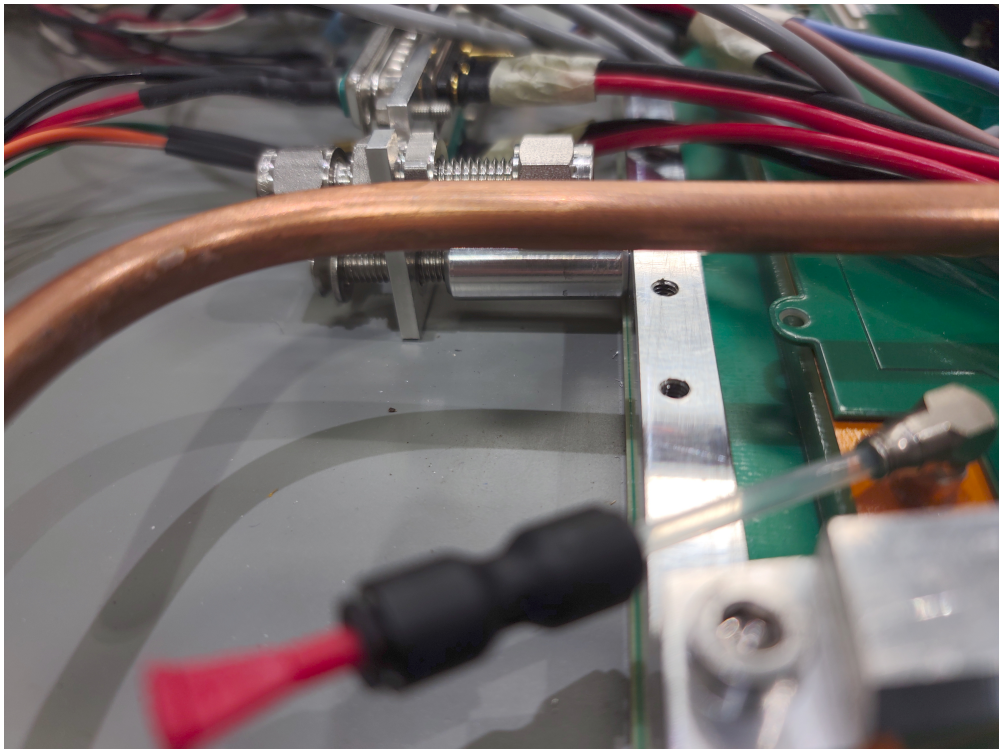
(b) Drilled and tapped holes in the M8 cross bar.

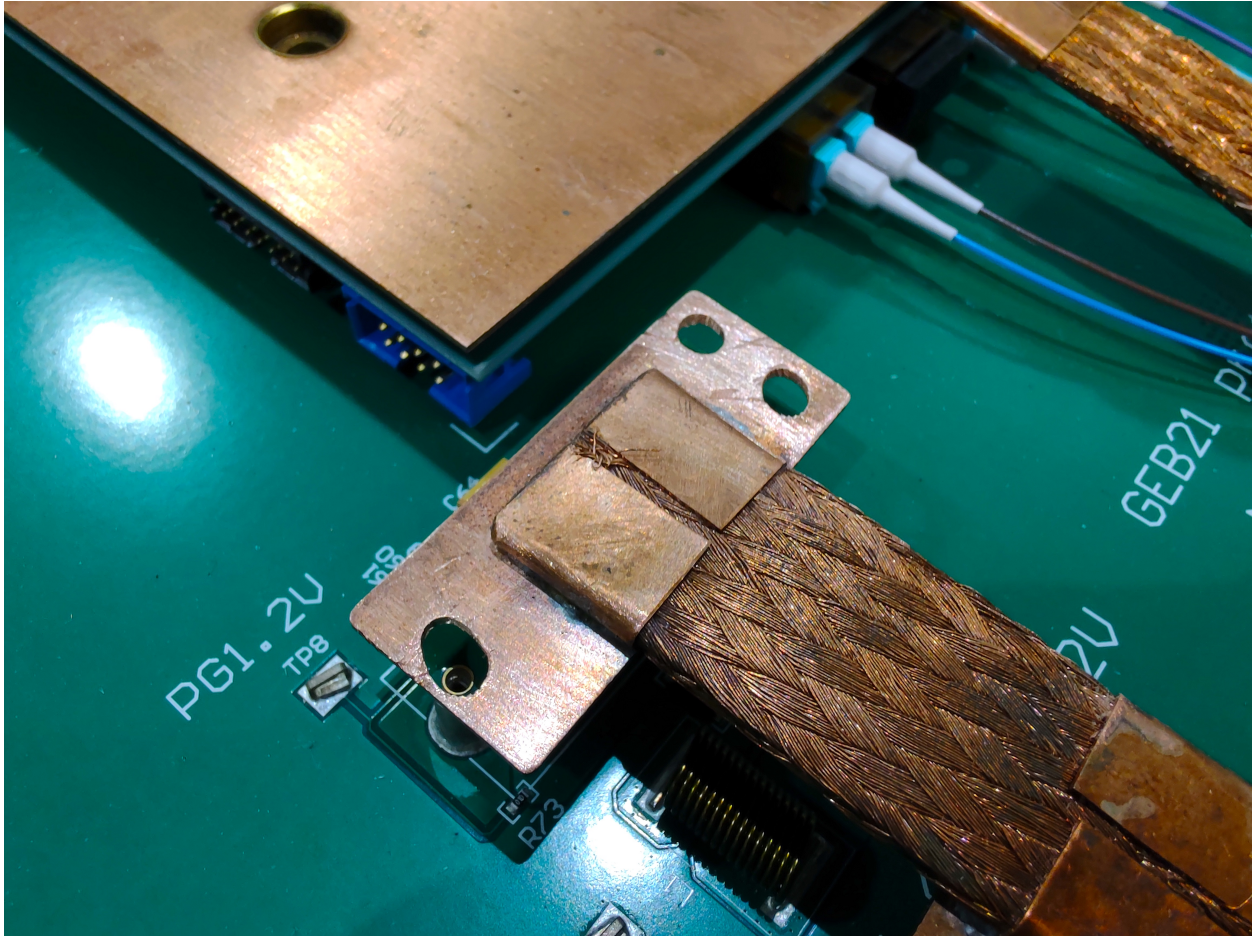
Figure 9: Example of the elongated holes in the FEAST cooling plates.

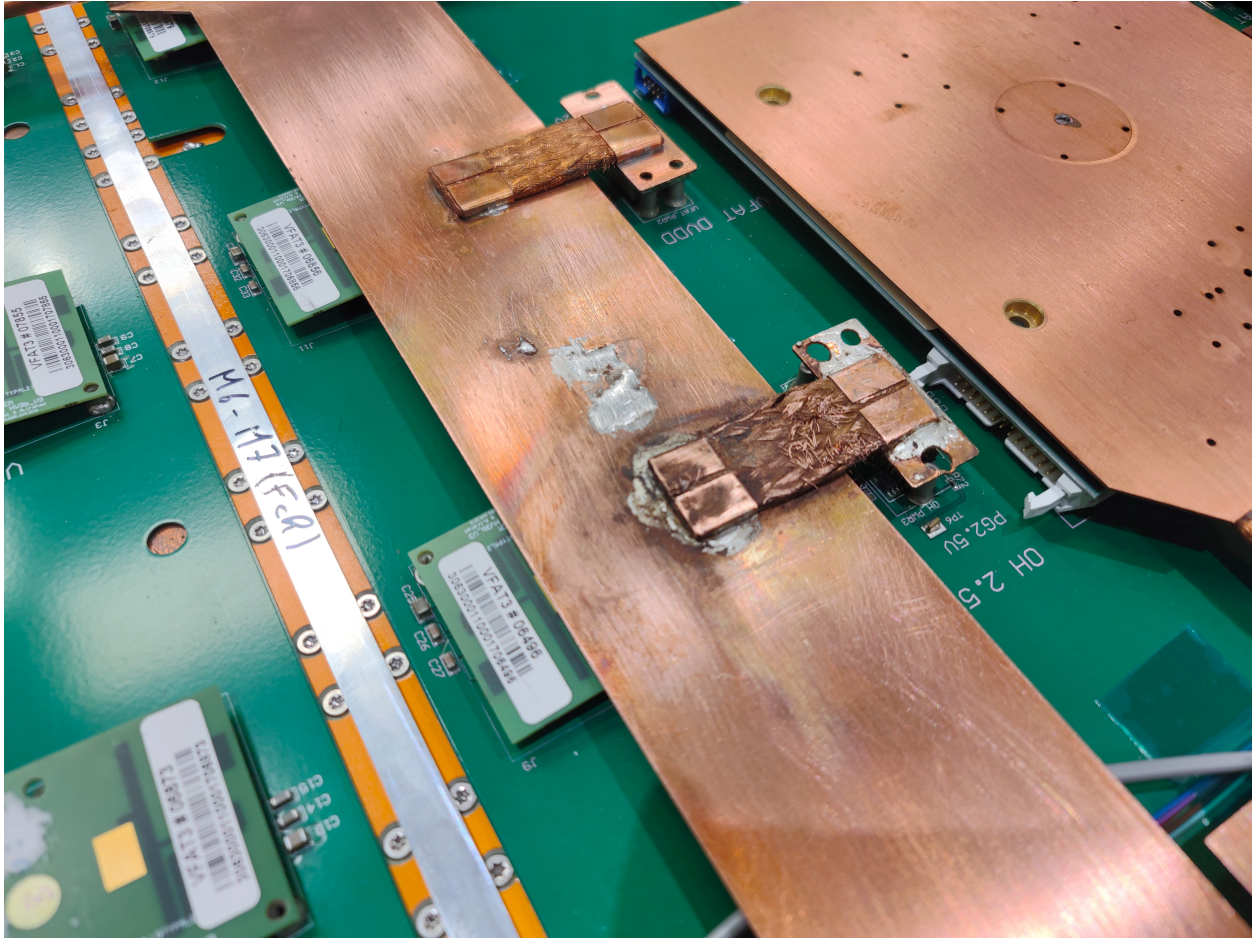
Figure 10: The resoldered 2V5 FEAST cooling plate for the M6 module.
