# **Experimental Hardware Development and Testing**

Eric Hansen Senior Undergraduate Research Report Summer 2013 Faculty Advisor Dr. Marcus Hohlmann High Energy Physics Lab A Department of Physics and Space Sciences Florida Institute of Technology

# **1m Acrylic Box Commissioning**

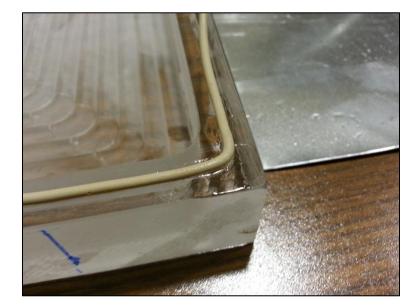
The gum-rubber O-ring was cleaned thoroughly with soap and water and the groove in the box was cleaned extensively as well with 91% isopropyl alcohol prior to installation. After cleaning, the O-ring was initially glued into place with ~1" segments of the two-part O-ring superglue spaced ~5" apart, but was then completely glued down after it fell out of placed every time the lid shifted.

Figure 2: The gum-rubber O-ring being glued into place at a corner of the box bottom

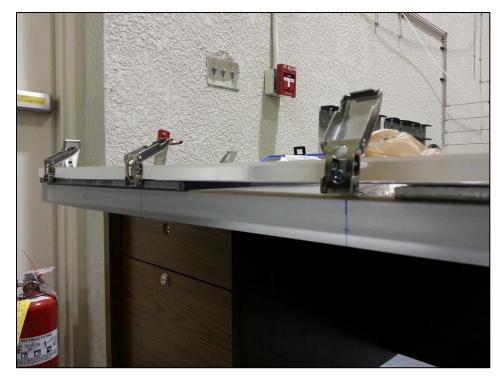
Figure 5: Determining the position of the catch plate holes with the completed fake lid

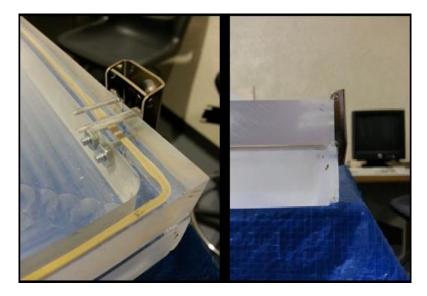
The process of using scrap acrylic for a dry-run of installing the latches revealed many potential material damages that could result from improper machining techniques, including: the need for drilling and tapping to take place exactly perpendicular to the acrylic surface, the extremely fragile nature of taps and drill bits and their tendency to break off inside a hole, the possibility of torqueing a screw too much and completely shearing off its head in a hole, and the property of the latches to bend and become unusable if they were forced to close with too much force. All of these errors were prevented to a much greater extent when working with the actual lid and bottom. The dry-run was completed, so four test latches and catch plates were attached to the four corners of the box to see if the latch system would, in fact, work. The four test latches worked very well and provided excellent O-ring compression as shown in Figure 6.

Figure 6: Close up of O-ring compression during first successful closing of the four test latches

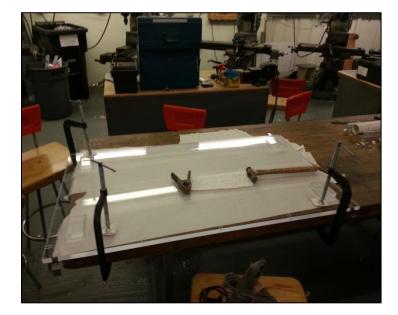
With the test latches successful, the actual lid was taken to the machine shop and drilled and tapped to specification; steps were taken to keep the lid as clean as possible for the given environment. A drill bit and tap broke off into the lid, but an additional drilled holed into the latches in question solved those problems and did not change any properties of the lid or the latches.

Figure 7: The lid in the machine shop with paper towels shielding it from the dirty table

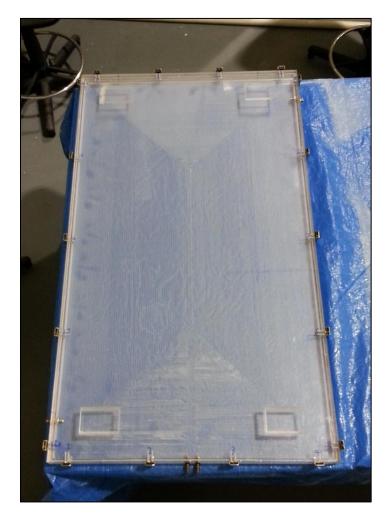
All but three latches closed securely on the first complete closure of the latches; they were too tight and the force required to close them might have damaged the box. The problem latches were taken off, and after inspection of their curved hinge-like component revealed that each was bent, they were beaten back into working order with a hammer on a wood block. This solution helped one of the three close, but the other two were still too tight to close safely, so their catch plates were removed and a drill was used to shave away the inner top of the catch plates' screws' holes. This was done gradually and carefully to prevent cracking of the acrylic. After reinstalling the latches, all latches closed properly for the first time and the O-ring was completely compressed.

Figure 8: All latches closing for the first time

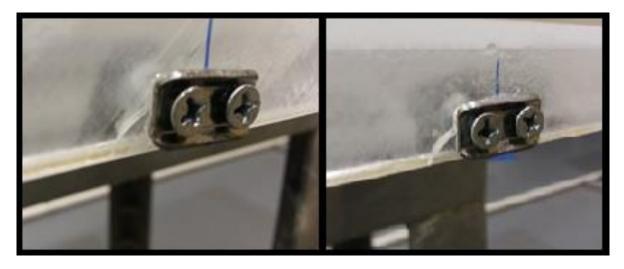
Sealing the now working catch plate holes with Stycast went smoothly. Both screws for each catch plate and the inside of each through-the-wall hole was coated extensively in wet Stycast; screws were put into their holes and then had their nuts tightened to hold them in place. The latches all closed again after the epoxy fully cured for 24 hours. At this time two cracks were found by two different catch plates' now sealed holes; they were monitored from then on very carefully.

Figure 9: Small cracks found by two different catch plates

After taking off the lid to inspect box after its first unintentional inflation, the two small cracks that had been found previously were found to not be any larger, but pressure testing was still suspended. Since the box had held its inflated shape for several minutes after the gas was turned off, it was deemed to be air tight enough for our applications. At this time a rule was established that the acrylic box should never be sealed and pressurized if the output gas line did not vent to the outside or if it was significantly blocked in any way.

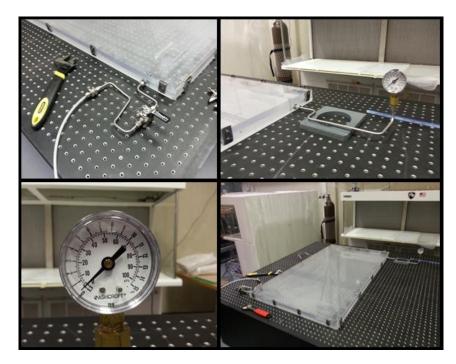
By attaching a ball value to the gas input and pressure gauge to the gas output of the latched, sealed, and closed acrylic box, its gas tightness was to be determined.

Figure 10: Pressure testing setup

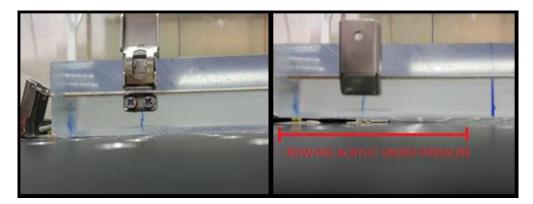
Pressure testing started around 20kPa, but soon showed problems. Even though gas was flowing into the chamber, the pressure gauge did not move past 2-3kPa. Before any kind of long term observation could take place, the box was observed to have begun inflating; the thin bottom of the box was bowing under the pressure and lifting the edges of the box up off the optic table. The nitrogen gas was shut off immediately and several minutes were allowed to pass to let the box deflate to where the lid could be taken off.

Figure 11: Left panel is the normal box, right panel is the inflated and bowing box

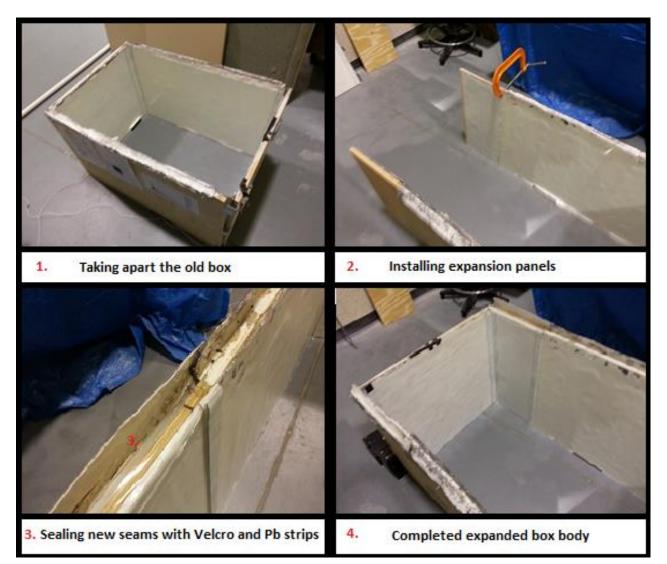
Figure 14: Box body expansion steps

The only tricky part about Figure 14 was gluing the lead sheets to the plywood sheets using the polyurethane construction adhesive. Since the lead was non-porous, water had to be misted over the area of the lead where adhesive was applied. The panels were then compressed and let dry for at least 24 hours. The top edge strips were nailed at their bottoms in 3-4 different places to allow them to act as flaps that will let the hinged lid move freely when needed. All other parts of this process were simply drilling and screwing repeatedly.

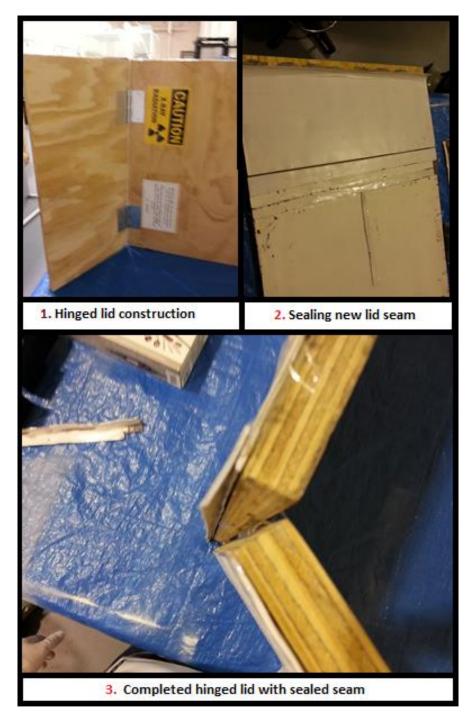
Figure 15: New lid construction and sealing in steps

Some wood had to be sanded away with the Dremel's sander attachment so the hinges would allow the pieces of wood to close flush. Some lead had to be glued to the inside of the lid, just as for all panels of wood. Shielding was completed along all seams.

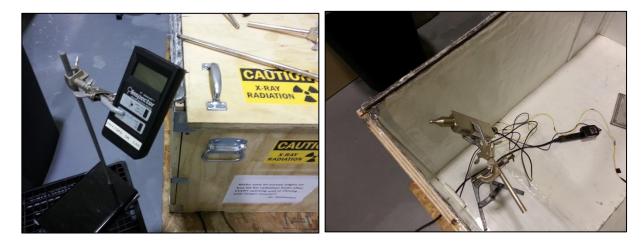
Figure 21: Radiation leak testing setup

As the data show, the corners leaked small amounts of radiation above the measured background levels, but no levels went over or even near 0.12 mR/hr (dangerous levels) for the tested locations. Not shown in Table 1, but diagramed in Figures 19 and 20 are the two rectangular holes that were used as cable feedthroughs. The only measurement taken for these holes was taken at a distance during which the Geiger counter beeped furiously and was observed to read 25+mR/hr. As soon as this measurement was observed (at an angle out of the source's cone of radiation), the Mini-X was shut off. Further testing was not safe. This one measurement was taken with the source pointed down at the

hole on the 2' wide side of the box. A rule that was already a standard was reinforced by this one data point: never point the source directly at or even near either of the box's cable feedthrough holes.
