Source: *Journal of Coastal Research*, Vol. 14, No. 1 (Winter, 1998), pp. 37-46

# Trends of Beach Erosion and Shoreline Protection in Rural Fiji

Nobuo Mimura and Patrick D. Nunn

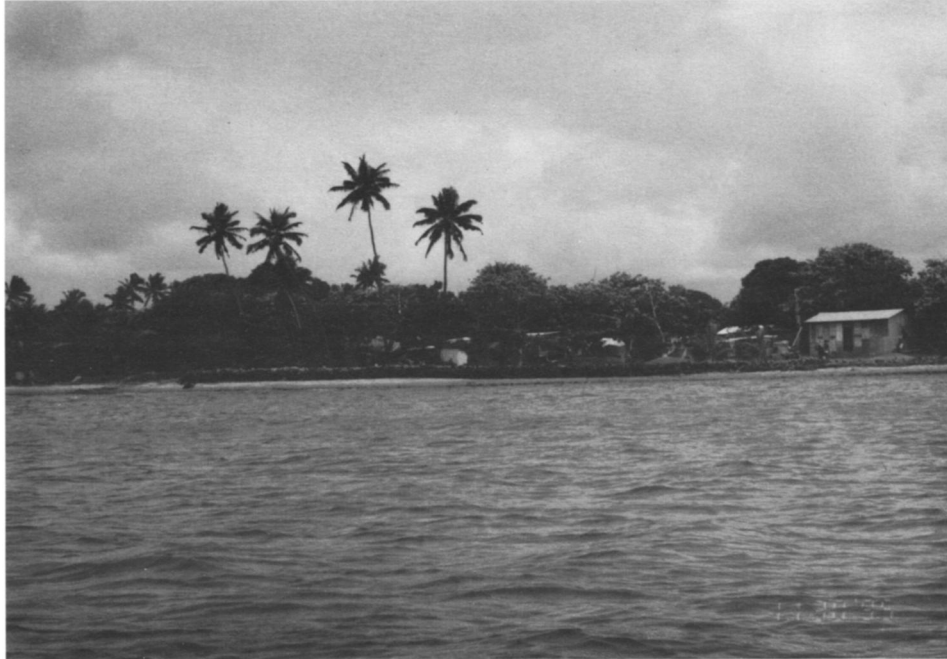
Plate 1. The sea approach to Nukui village.

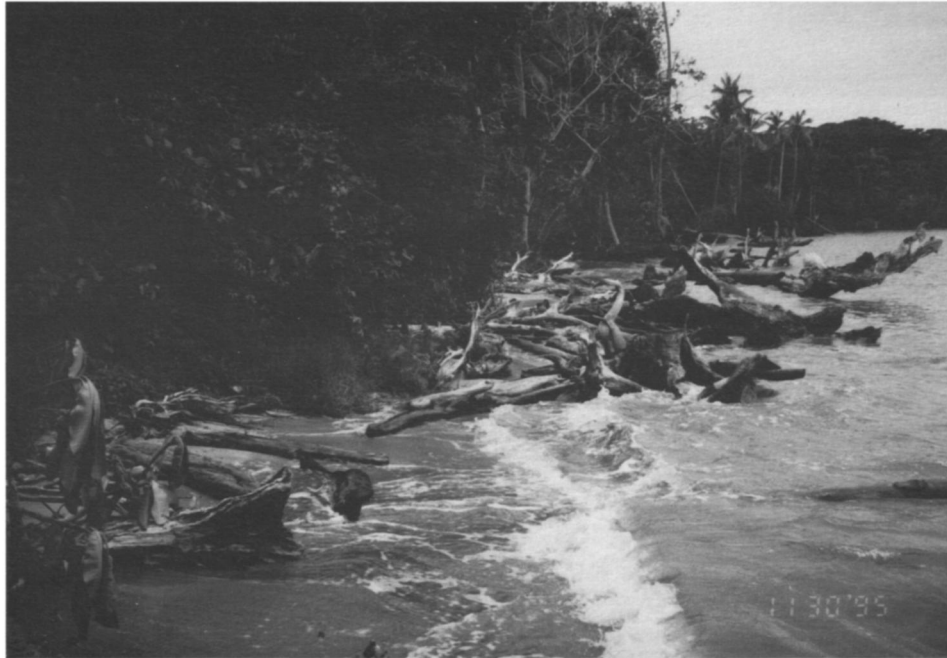
Sea encroachment is a very big problem in Nukui. The village headman, Timoci Baserawa (61 years old), who has held this position for 30 years, mentioned that there is no other place to go. The sea is encroaching on nearly all sides of the village. Coastal vegetation like *yevuyevu* (*Hernandia peltata*), *voronibebe* (*Tournefortia argentea*), *dilo* (*Callophyllum inophyllum*) and coconuts have been slowly washed away. Some houses have also had to be relocated.

Plate 2. Erosion and trees washed away near Nukui.

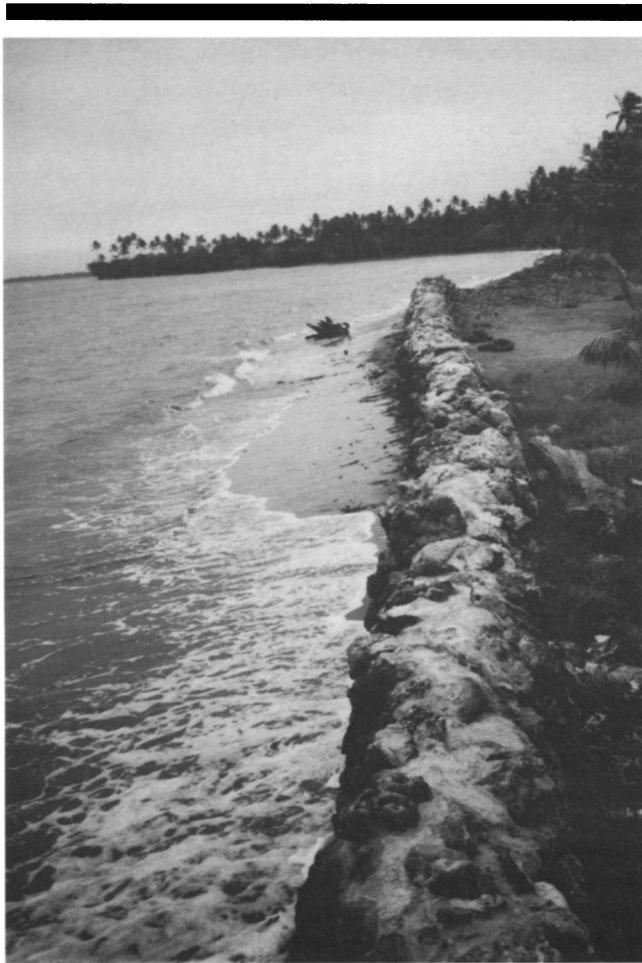
After the collapse of this seawall in 1972, another engineer came. He also used cement and rocks from the reef but not iron rods. He instructed the villagers to use a different design where the basement was dug down into underlying beach-

rock. The basement is about 1 m wide and narrows towards the top which is about 1.75 meters above the beach now. According to Mr Baserawa, this seawall is much stronger and more effective than the first one. The seawall is constructed about 5 m seaward of the very recent shoreline so that the villagers could reclaim parts of their lost land.

Plate 3. Seawall in front of Nukui village.

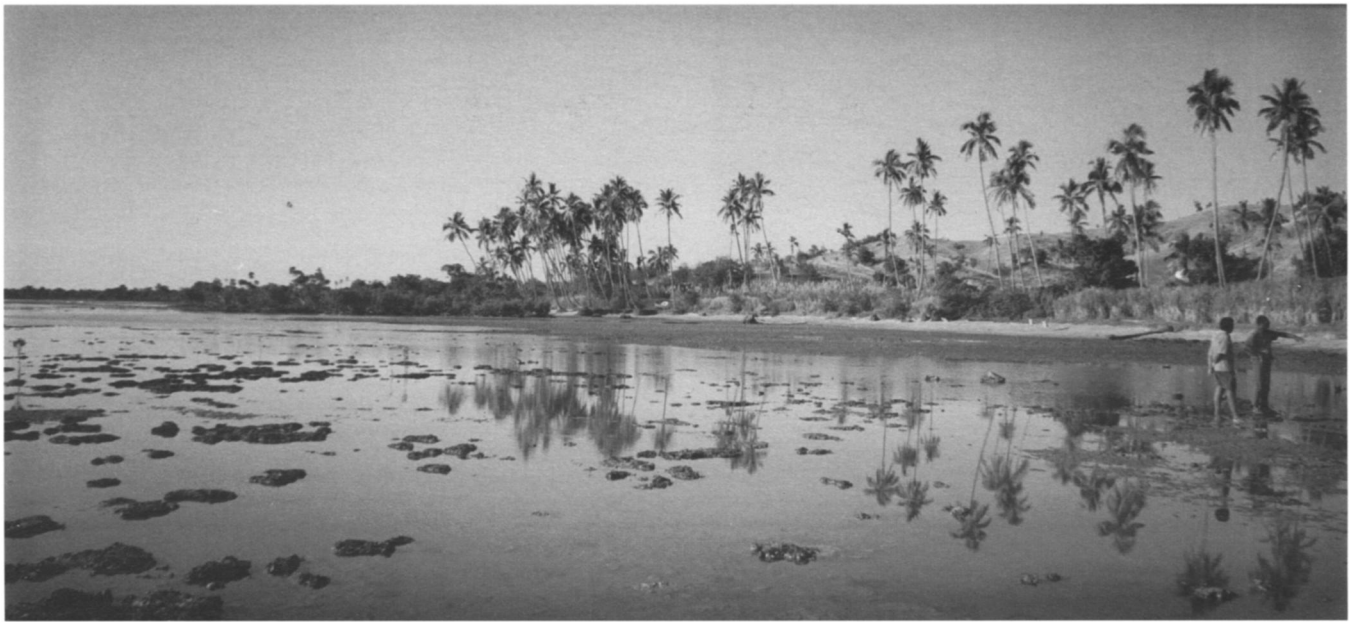
mangrove swamp was cleared on medical advice. This exercise allowed the coast to be eroded quickly (Plate 4). According to Timoci, sea encroachment and coastal erosion became even more of a problem when the land near the shore was cleared for sugar-cane farming. It is evident that the ploughing of the land makes the soil more vulnerable to erosion.

Plate 4. Part of the shoreline at Nabila village which has been cleared of mangroves and other vegetation. The shoreline was once to the left of the photo.

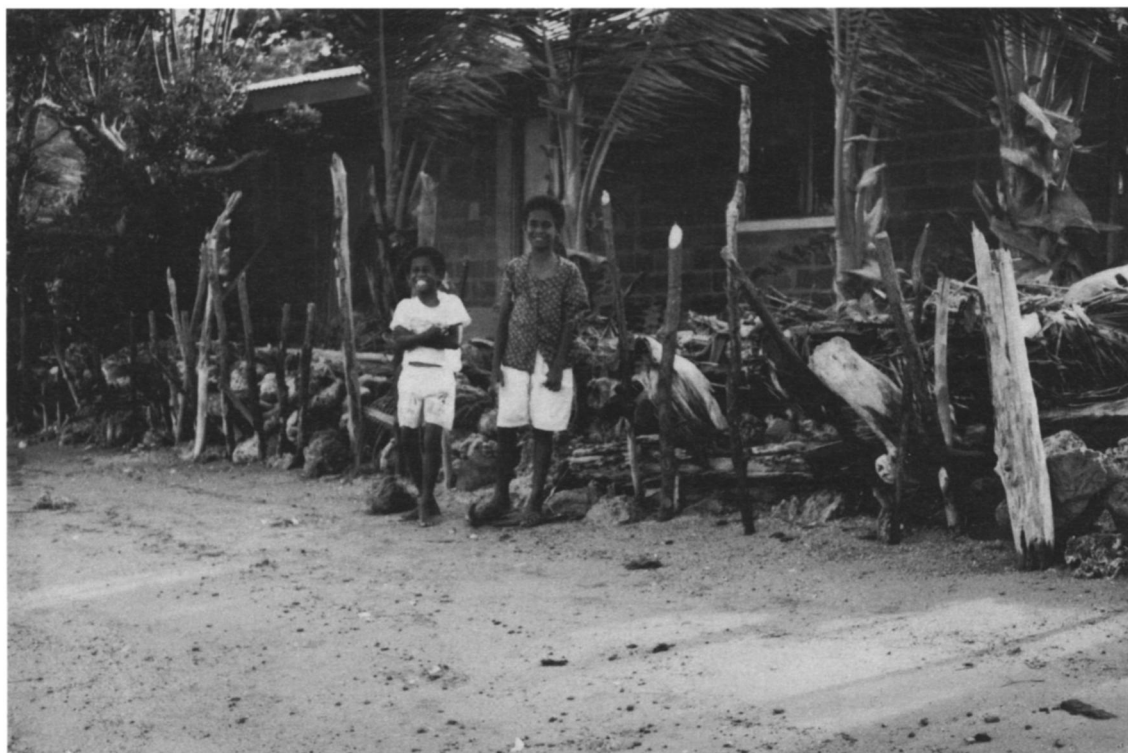
In the distant past, people piled up sediment or stones in unconsolidated piles along the shoreline, or placed sticks along the beach to form a fence behind which debris could be piled. They can be seen even now as shown in Plates 5, 6 and 7. Such structures are likely to be severely eroded during storms, perhaps even under high-tide conditions but, as long as the labour was freely available to rebuild these structures as often as needed, people sought nothing more sophisticated. The change to seawalls and similar structures can thus be seen as a response, not only to the availability of new materials, but also to changing cultural conditions. Labour-intensive solutions of the kind employed in the past would be unlikely to find favour among many rural dwellers today.

Plate 5. Traditional coastal protection by wooden poles poked into the sand with sand and rubbish piled behind them.

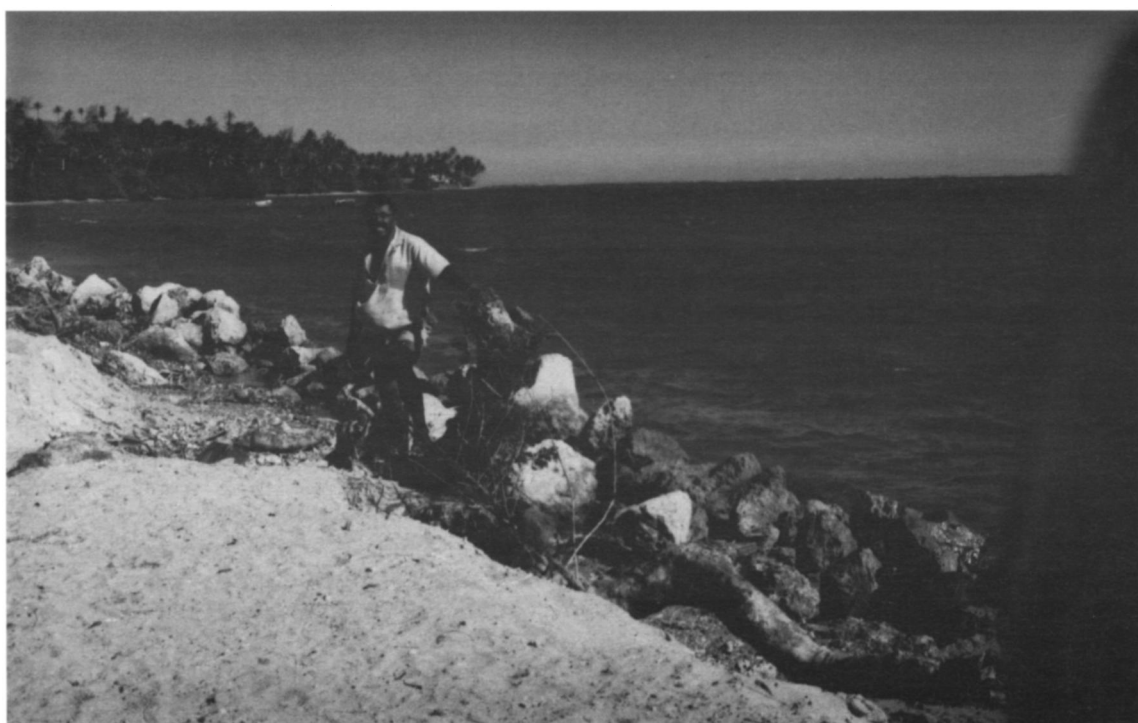
Plate 6. Piled stones along the shoreline.

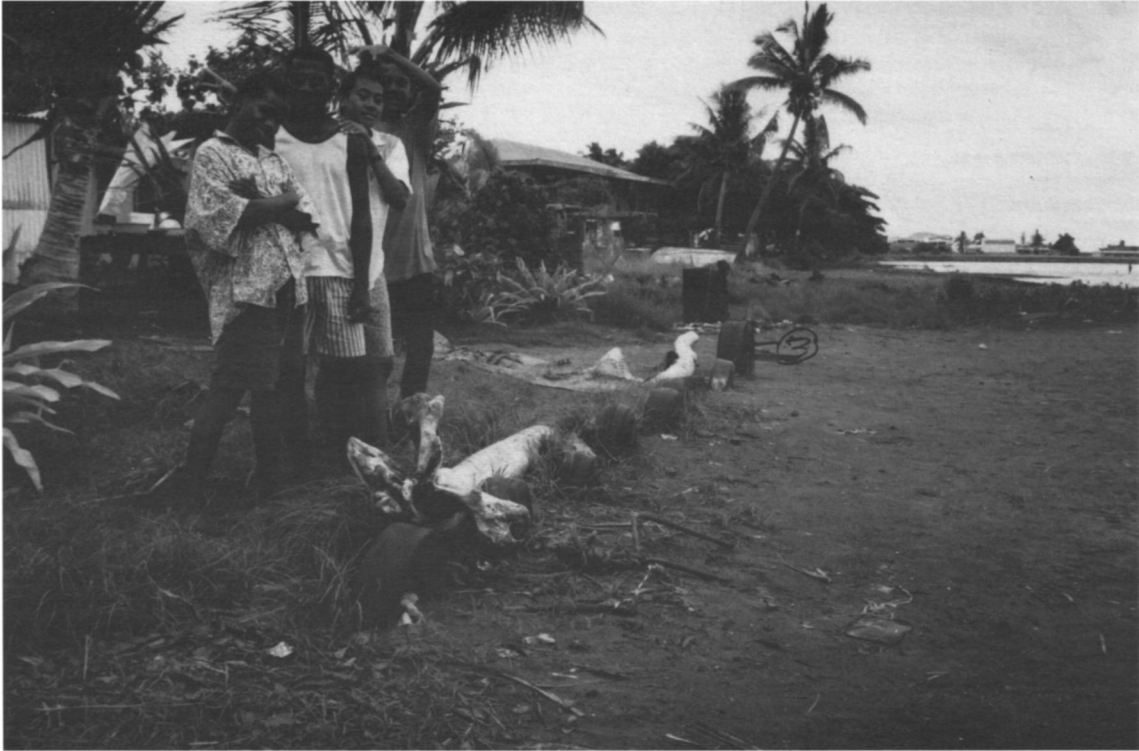
Plate 7. Protection using old tires.

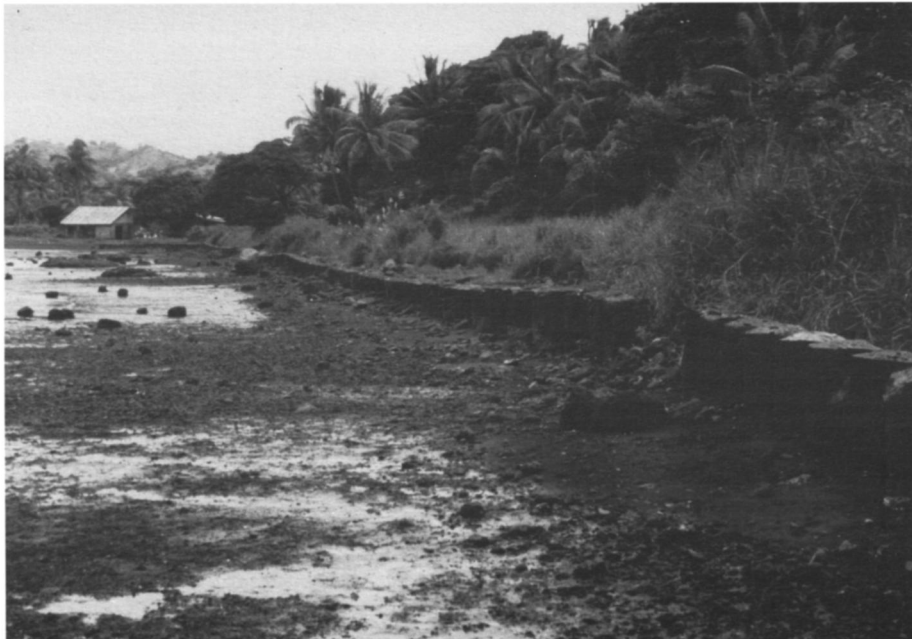
Almost all concrete seawall structures constructed in Fiji are vertical walls; examples are shown in Plates 8, 9 and 10. The prevailing idea is to build a barrier against the sea and wave action along the shoreline to protect the inland. However, vertical hard impermeable structures often generate unfavorable effects, such as strong reflection of waves, scouring of the foot of the seawall, and sucking out of the fill material. These often lead to seawall collapse. Release of sediment from nearshore areas can result in its being relocated on nearby reefs adding to the detrimental ecological impacts of seawall construction.

Plate 8. Vertical seawall of drums with concrete inside.

- (3) From the engineering viewpoint, there are additional suggestions. In order to absorb the energy of incident waves, gently-sloping structures are much more effective than vertical ones. In addition, the structures face the most dangerous situation when their bases are scored. Therefore, toe protection by stones or concrete blocks with necessary weight is essential for the safety of the protection of the seawall itself.

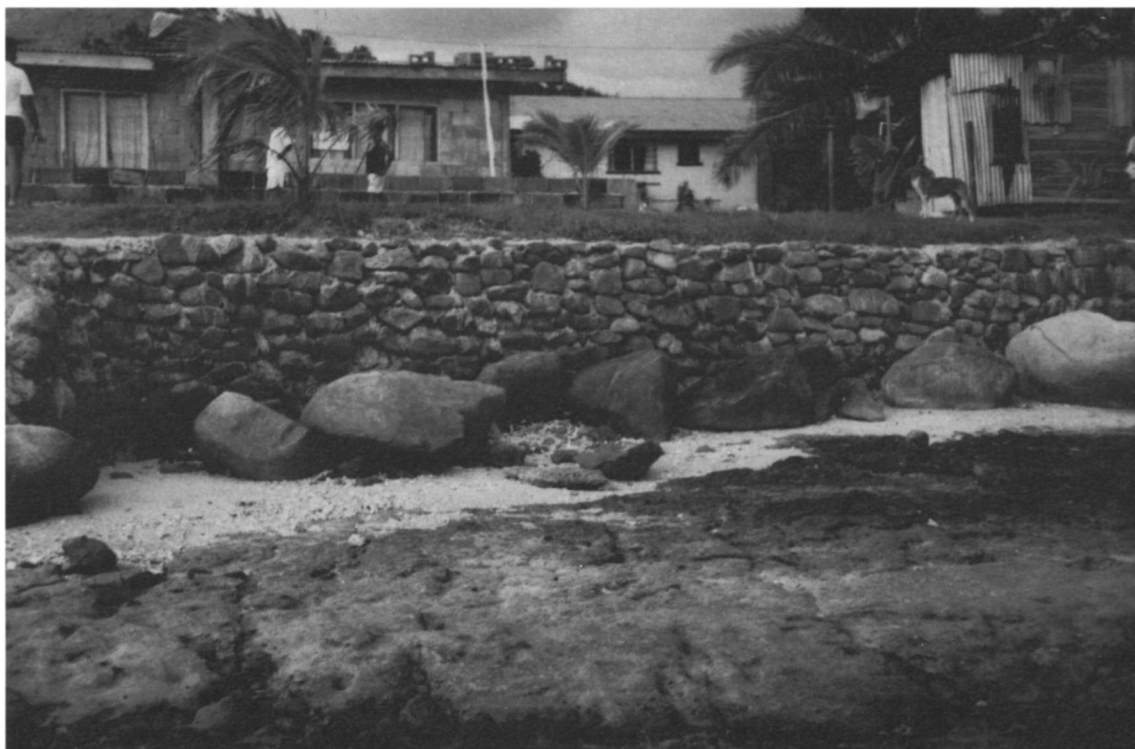
Plate 9. Vertical seawall with toe protection by large stones.
