Community driven coastal management: An example of the implementation of a coastal defence bund on South Uist, Scottish Outer Hebrides

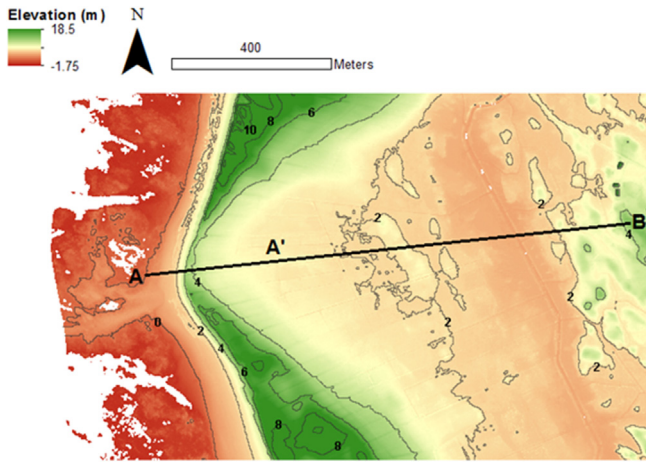
Fig. 2. LiDAR derived topographic map of Kilpheder. LiDAR data ©SNH on behalf of Western Isles Data Partnership.

Both the machair front and the machair grasslands are very low lying at Kilpheder. Elevation decreases from the coast to the seasonally waterlogged area around the machair lochs. Although there are higher dunes to the north and south, the maximum natural elevation of the machair front at the centre of the headland is ~ 4 m above OD. Elevation decreases gradually to a minimum elevation of ~ 1 m OD about 900 m inland (Fig. 4). The low coastal topography makes Kilpheder particularly susceptible to breaching of the machair front or over-wash during storms.

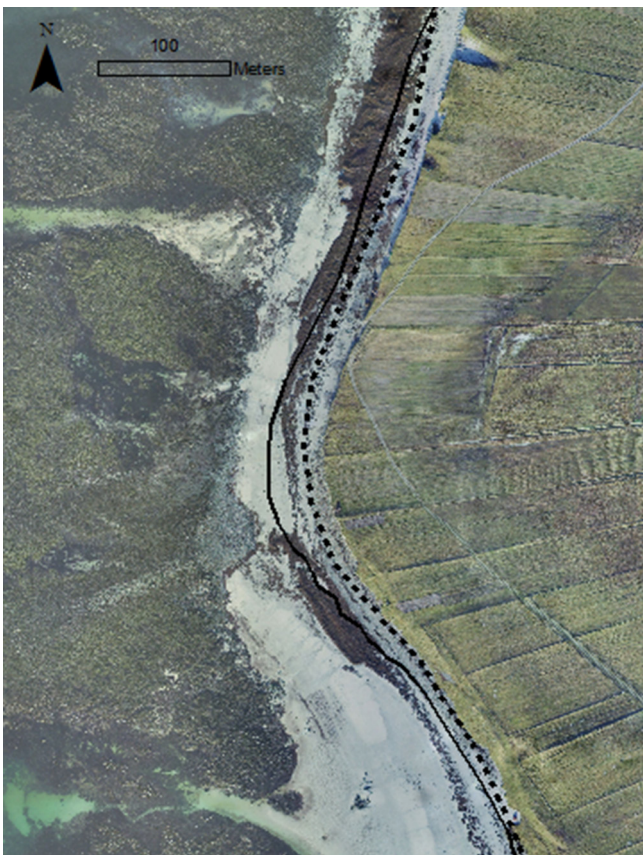
Fig. 3. Positions of mean high water at ordinary spring tide (MHWOST) in 1881 (solid line) and 1972 (dashed line), superimposed on 2005 aerial photography of Kilpheder. Aerial imagery ©SNH on behalf of Western Isles Data Partnership.

Change in the position of the mean high-water mark of ordinary spring tides (MHWOST) between maps from the 1880s and 1970s suggests that there has been an ongoing landwards movement of the machair front at this site, with greater retreat at the centre of the headland (~ 30 m, ≤ 0.3 m/yr), and lesser retreat to the north and south (Fig. 3). Historical maps are notoriously inaccurate; the difficulty of accurately identifying MHWOST in the field, distortions on paper and during scanning, and the width of the line used to plot a feature all contribute to an error that is often significant, and commonly as high as ~ 15 m (Hooke and Kain, 1982; Baily, 2009). It is therefore necessary to interpret data with caution. However, consistency in the direction of change along the coast and local knowledge support the historical evidence for ongoing headland retreat in this area.

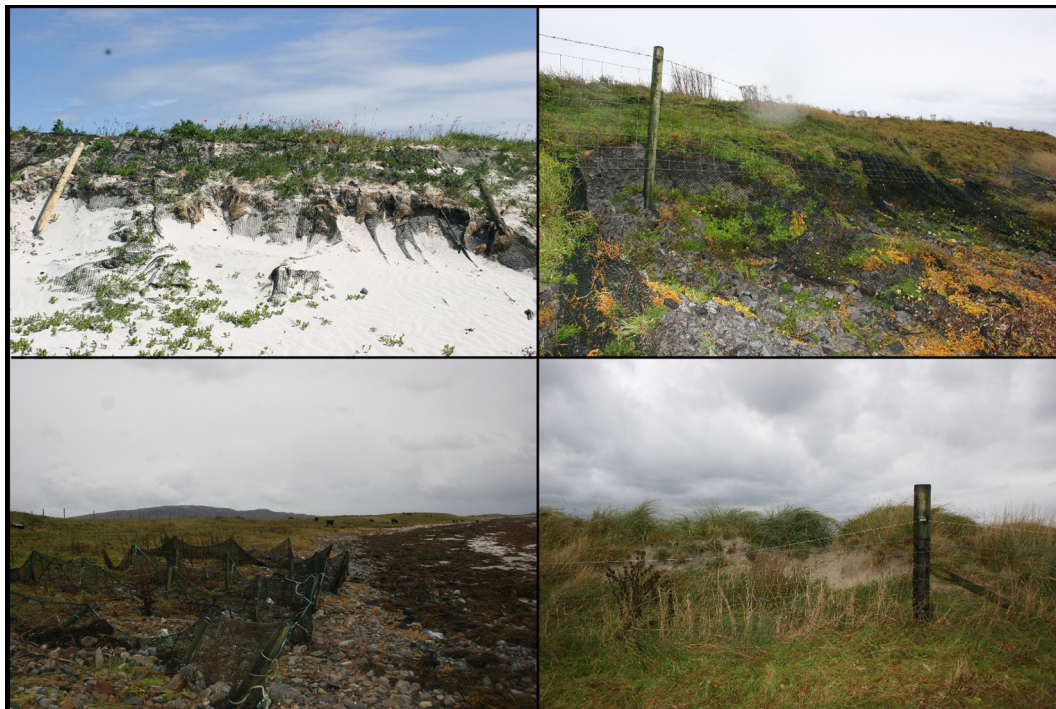
Fig. 6. Photos of the ridge at Kilpheder showing clockwise from top right: eroded scarps on the sea-ward side of bund (March, 2012); the top of the ridge, partly re-vegetated following over-topping during winter 2012–2013 (March, 2013); damaged sand traps made from fishing nets, located to the south of the ridge (March, 2012); sand accumulation in the eroded scarps at the base of the seaward side of the bund (June, 2012).

Visual inspections of the ridge between May 2011 and November 2013 indicate that maintenance is now required on several aspects of the defence (Fig. 6). The fencing designed to exclude livestock from the bund was knocked down on the seaward side of the defence in winter 2011–2012, and has not been repaired since. On several site visits cattle were seen to be grazing on the bund. While there is some evidence for sand accumulation at the base of the ridge during the summer months, over the course of winter 2011–2012 and 2012–2013 deep cusped scarp were

eroded on the seaward face of the bund (Fig. 6). This has exposed the buried crushed rock and shingle, which is now being transported away from the site by longshore drift. Fishing nets displaced during storms have not been repaired, and the sand trap fencing to the north and south of the ridge appears to be largely ineffective. Furthermore, the ridge was over-topped during winter 2012–2013, which caused erosion of the artificial sand dune above the ridge. Eroded areas had partially re-vegetated prior to the beginning of the winter 2013–2014 storm season.
