Wise practices for coping with  
**BEACH EROSION**

# Anguilla

Department of Fisheries and Marine Resources, Anguilla  
Department of Physical Planning, Anguilla  
University of Puerto Rico, Sea Grant College Program  
Caribbean Development Bank

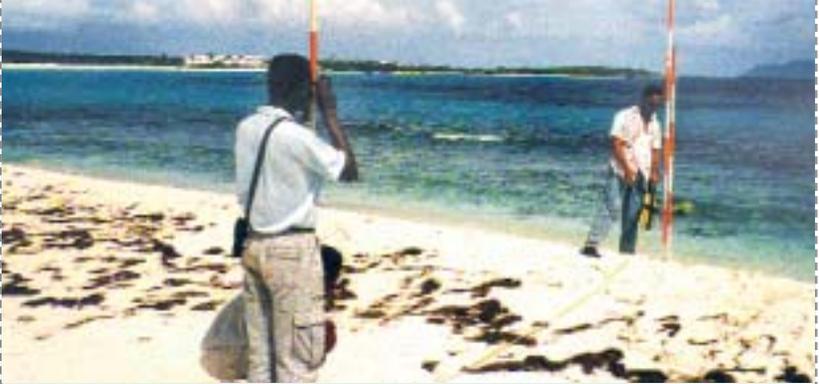
Beach monitoring  
in progress at  
Shoal Bay West,  
1992

In order to manage these changes, Anguilla's beaches have been monitored since 1992 by the Department of Fisheries and Marine Resources, who measure the beach slope and width every 3 months at numerous sites around the island, as well as at the offshore cays.

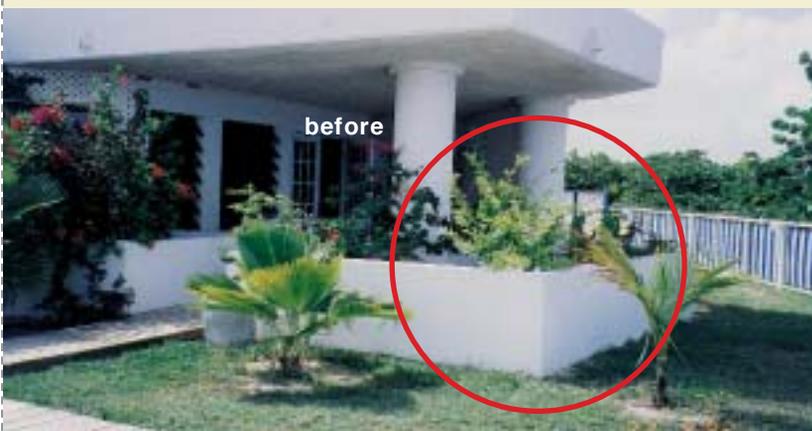
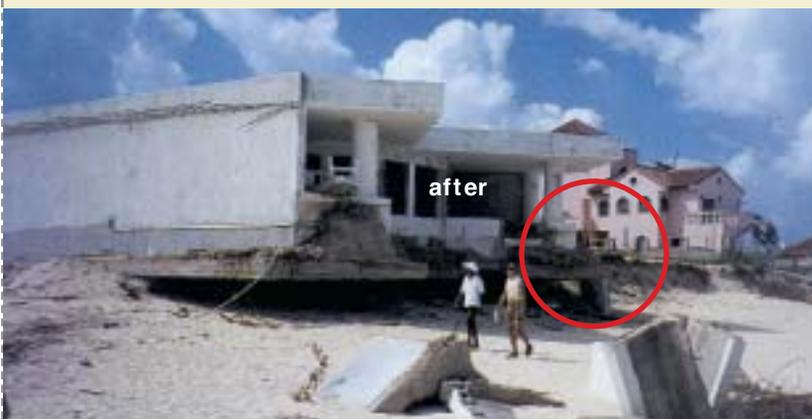
Beachfront properties were transformed overnight after Hurricane Luis struck in 1995. Mead's Bay Central: reference point before and after Hurricane Luis

before

after

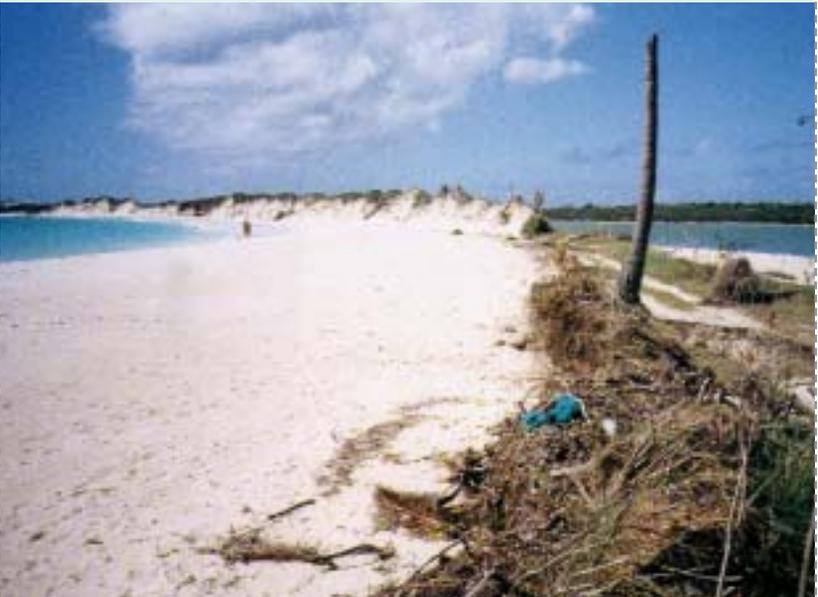
*Cove Bay, 2 months after Hurricane Lenny struck (Nov. 1999). There used to be a wide belt of sand dunes separating the salt pond (right side of photo) from the sea. Now only eroded remnants exist*

At Cove Bay there used to be an extensive line of sand dunes separating the salt pond from the sea and measuring more than 3 metres high. In 1995 Hurricane Luis eroded the seaward face of these dunes and in 1999 the waves generated by Hurricane Lenny broke through the dunes in places, joining the salt pond to the sea.

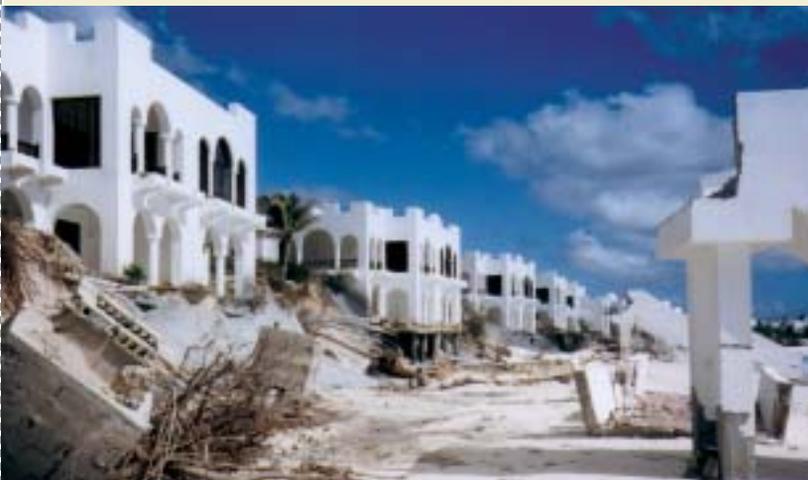
(left) Maunday's Bay after Hurricane Lenny in 1999. Hotel villas were undermined and stairways leading over the once extensive dunes were left as isolated monuments

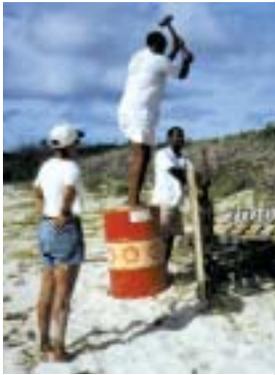
Building sand fences at Savannah Bay, 1997

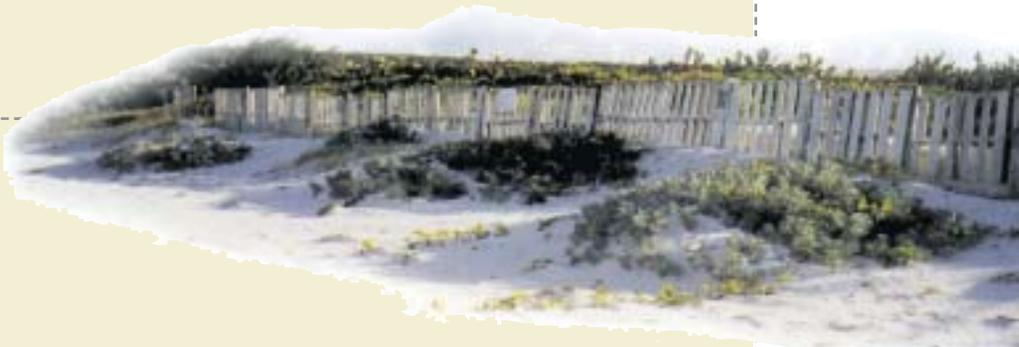
*Sand fences  
and sea lavender,  
Shoal Bay, 1998*

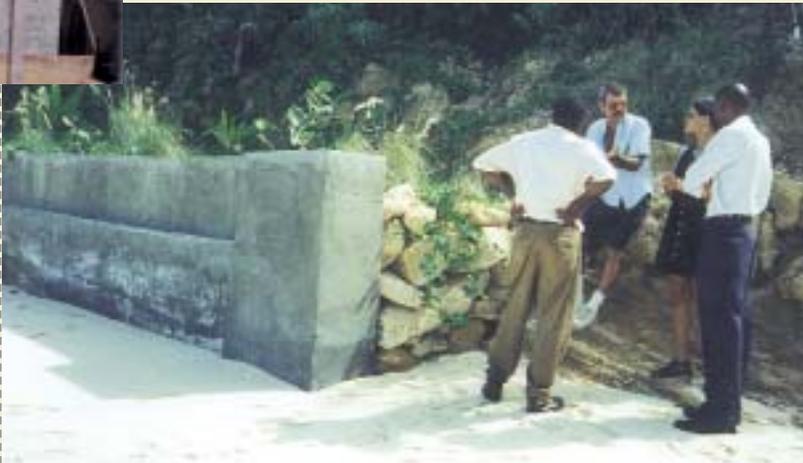
*A retaining wall under  
construction at Mead's Bay  
after Hurricane Luis, 1995*

- Resorting to 'hard' engineering structures such as seawalls, revetments and bulkheads, only when there is a need to protect beachfront property from wave action. Such structures, even with careful design, result in the loss or narrowing of the beach over time.
- Considering all other beach enhancement measures such as offshore breakwaters, groynes and beach nourishment (placing sand from the offshore zone or from an inland source on the beach) at a particular site. All such measures require careful design and environmental impact assessments, so always first consult the Department of Physical Planning.
