**Assessment of Hybrid Type  
Shore Erosion Control Projects  
in Maryland's Chesapeake Bay  
Phases I & II**

**David G. Burke**  
Burke Environmental Associates  
Annapolis, Maryland

**Final Report Submitted To:**

**March, 2005**

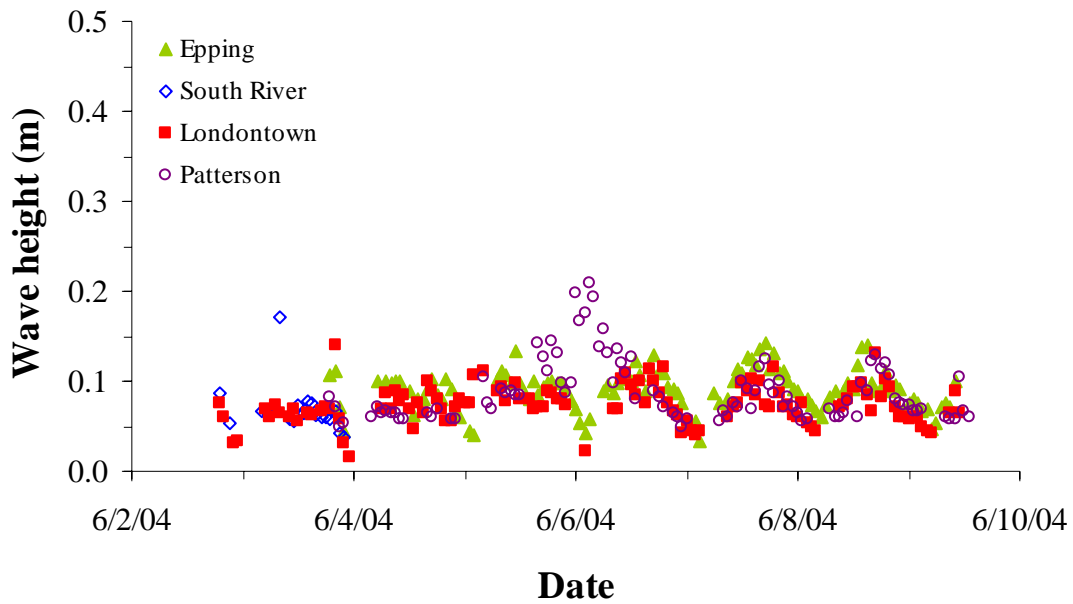
**Figure 1B. Significant Wave Height at the CBT Study Sites.** The oscillations in wave height observed between 6/5 and 6/10 are a result of tidal fluctuations (more vertical wave attenuation during high tide than at low tide).

were comparable to those at Elliott Robertson. These were relatively small ( $< 0.1$  m) perhaps due to the gentle offshore slope at the site or the relatively calm winds during the 7 day period over which the waves were recorded. CBT sites had slightly higher significant wave heights than DNR sites and the highest waves were observed at JPPM which also had a relatively high fetch. The highest waves for all sites (up to 0.5 m) were observed at Wye NRMA. While sampling, we observed boat-generated waves. One boat generated 37 waves which locally increased water turbidity. Therefore, the significantly higher waves at Wye NRMA could have been a result of boating activity. Extensive boat traffic in the London Town area also has the potential to affect the wave climate. Therefore, boat traffic should be considered when evaluating possible Living Shorelines and other coastal structures.

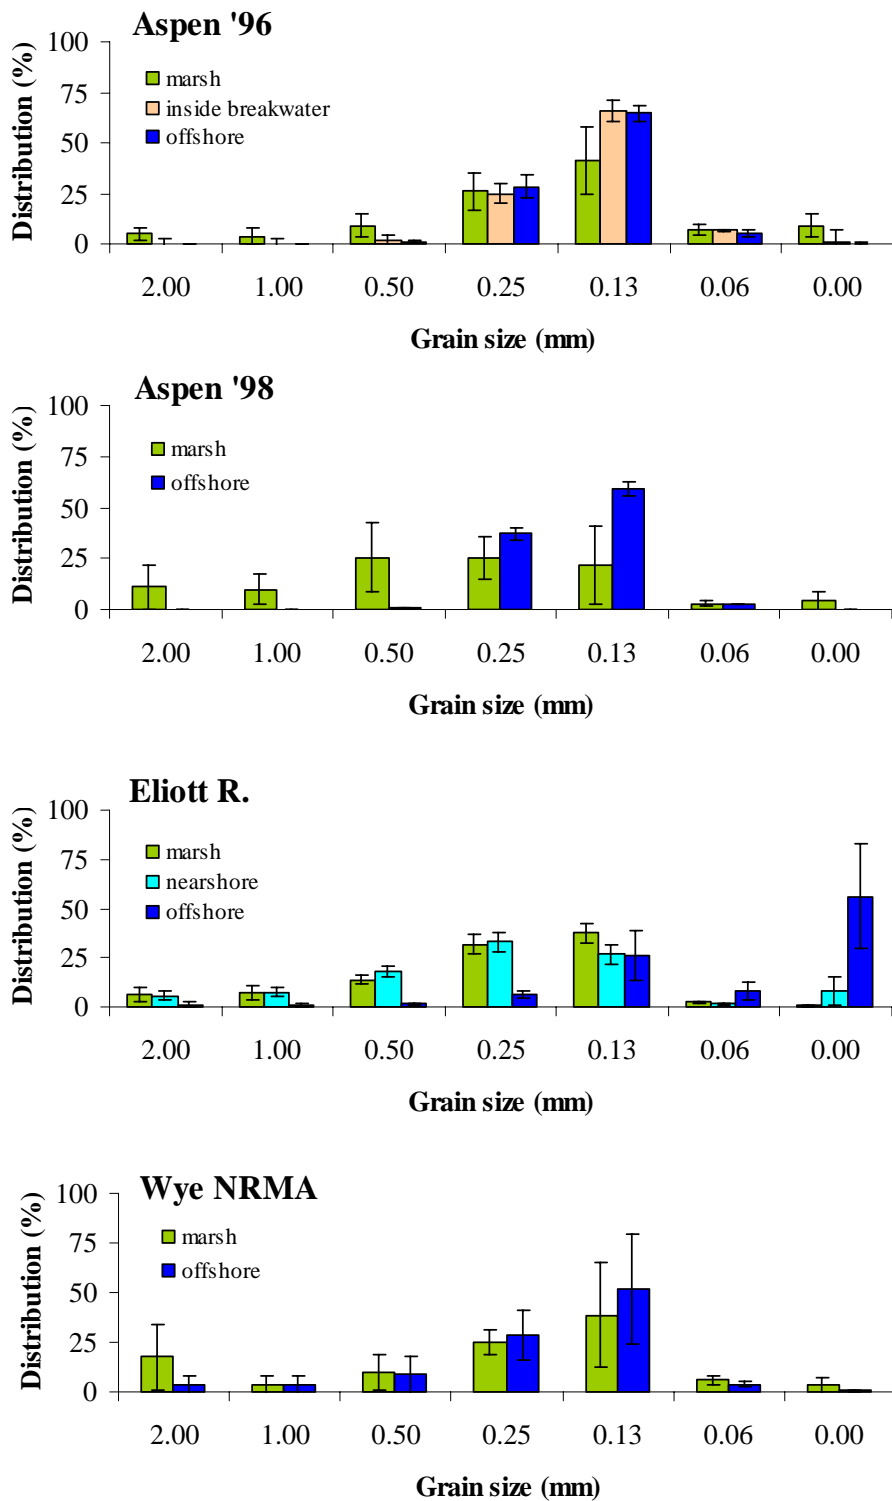
**Figure 2A. Sediment Grain Size Distribution for DNR sites.** Offshore samples were collected at a depth of approximately 0.7 m. Grain size classes are as follows: gravel (2.00 mm), very coarse sand (1.00 mm), coarse sand (0.5 mm), medium sand (0.25 mm), fine sand (0.13 mm), very fine sand (0.063 mm) and silt + clay (0.00 mm).

Sediment characteristics can be a better indicator of wave exposure than wave heights as waves tend to be measured over a relatively short period of time (days) while sediments represent a long-term (weeks to years) equilibrium with local hydrodynamic conditions. For example, sub-tidal sediments at Elliott Robertson were quite fine (mainly silt + clay, Figure 2a), an indication of quiescent conditions and a small fetch. All other sub-tidal (i.e. offshore) sites were dominated by fine sand (Figure 2), a sediment type indicative of stronger hydrodynamic conditions than in areas where silt and clay are deposited. Although guidance governing the construction of coastal structures call for fill material to be medium to coarse sand with a median grain size of 0.6 mm, the marsh area of the studied sites was dominated by finer fractions (fine sand) except for Aspen 1998, London Town and JPPM where medium sand dominated (Figures 2A & B). Fine sand may be adequate for low wave energy sites but will not offer a stable substrate on high energy shorelines or during storm events. The offshore areas tended to reflect the general sediment composition of the marsh area but often had a higher fraction of fine particles than the marshes. This difference is likely due to the sediment deposited in the intertidal area for shoreline stabilization.

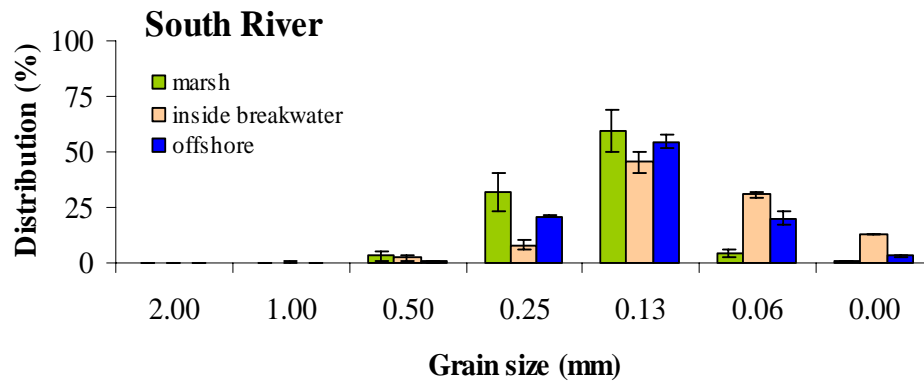
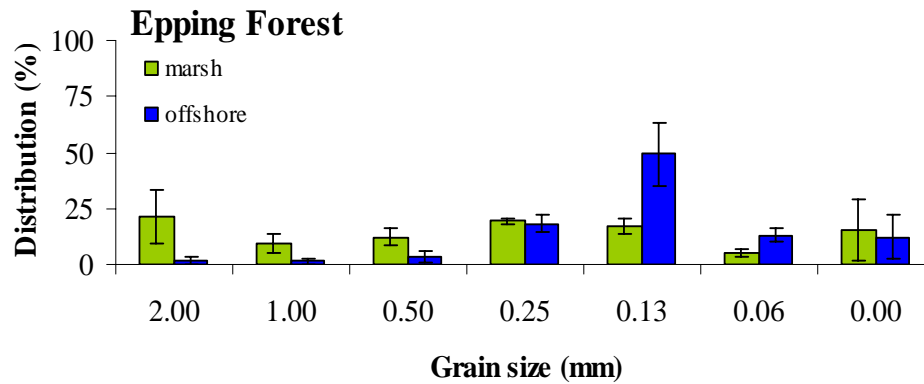
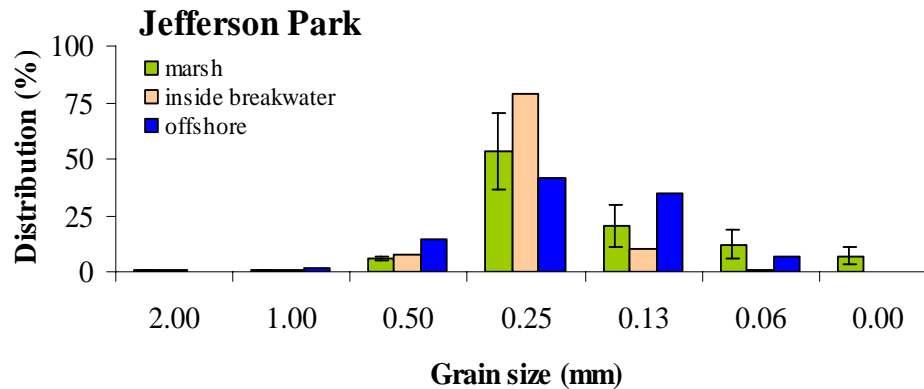
**Figure 2B. Sediment Grain Size Distribution for CBT sites.** Offshore samples were collected at a depth of approximately 0.7 m. Grain size classes are as follows: gravel (2.00 mm), very coarse sand (1.00 mm), coarse sand (0.5 mm), medium sand (0.25 mm), fine sand (0.13 mm), very fine sand (0.063 mm) and silt + clay (0.00 mm).

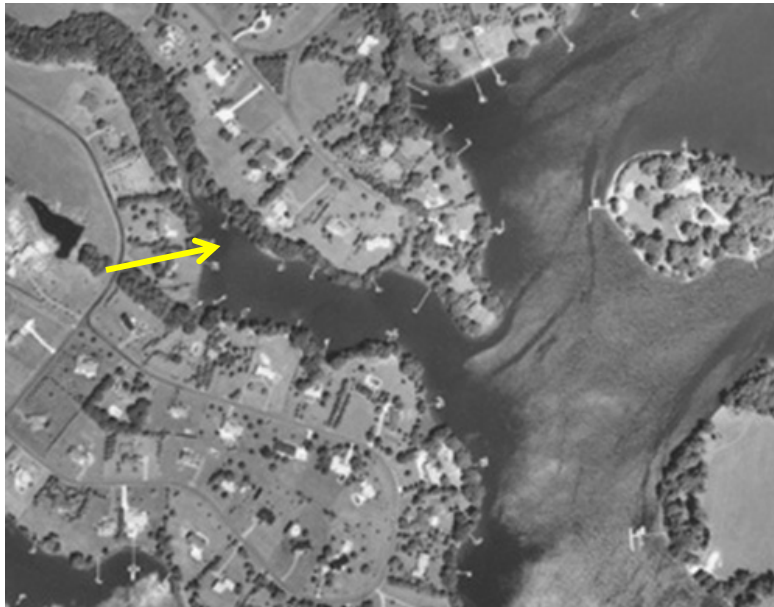
**Figure 3. Aerial view of Elliott R. Site.** The groins at Elliott R.'s were located in a relatively quiescent creek with very soft sediments. Long shore transport appears to be minimal leading to no or little trapping of sediment by the structures. Instead, the sand deposited in the marsh zone may be lost once resuspended (see text).

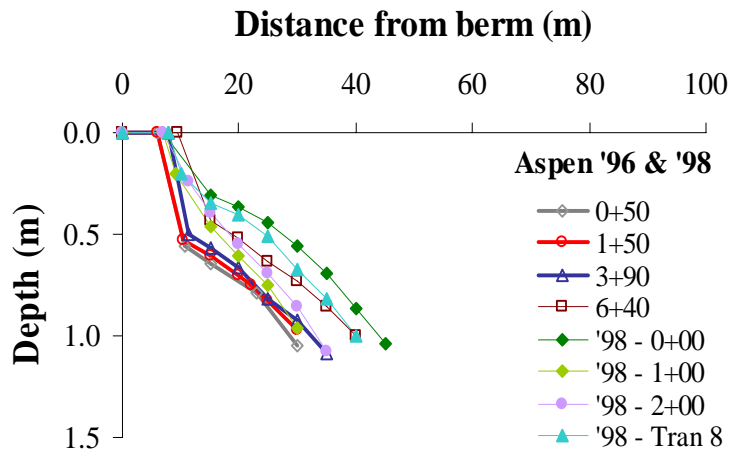
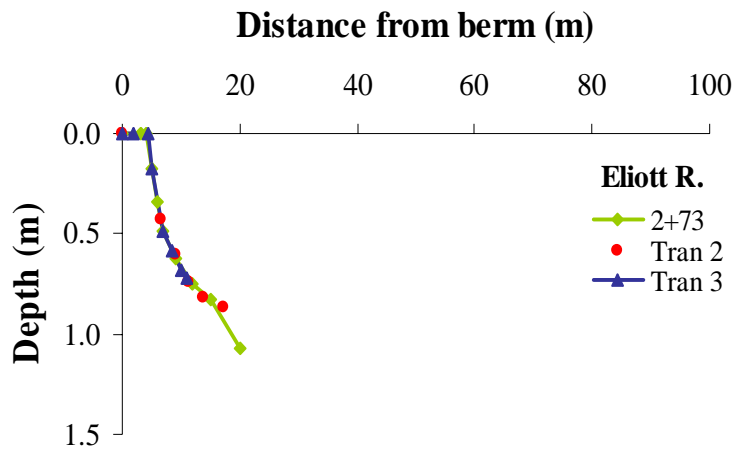
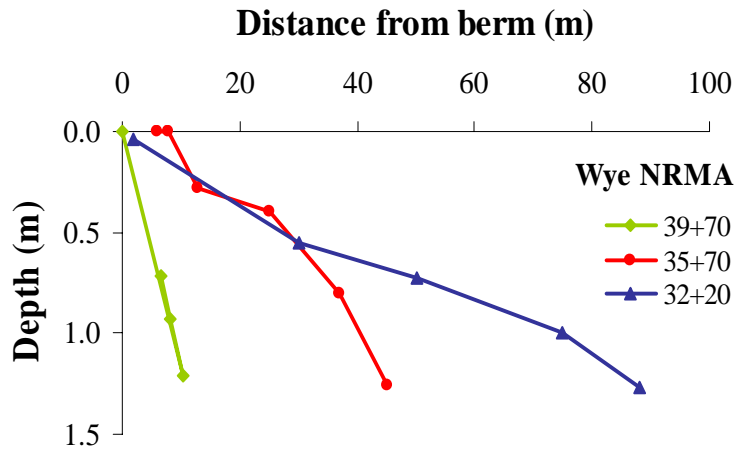
**Figure 4. Present shore profiles at DNR sites.** Measurements of water depth at each transect within each site. Each line represents a transect perpendicular to shore.

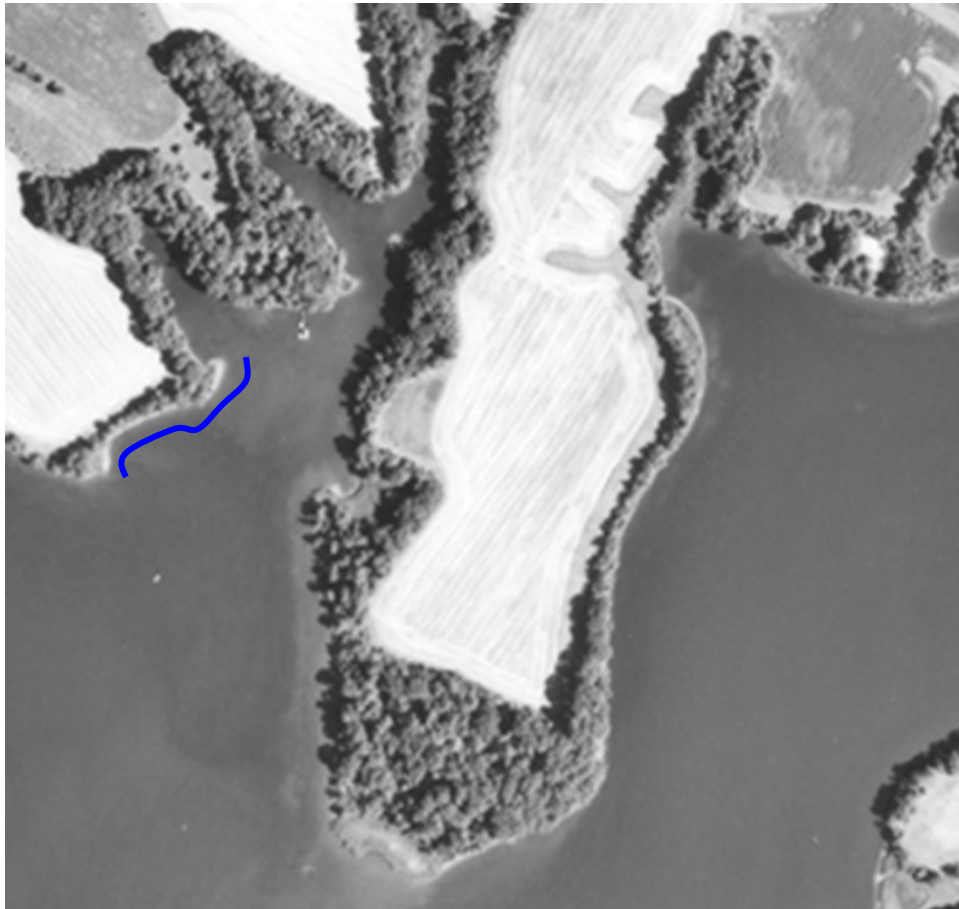
**Figure 5. Aerial View of Wye NRMA site.** The groins at Wye NRMA do not seem to extend far enough into the water to trap the sediment being transported by longshore currents. As a result, a sand spit is forming at the eastern end of the project (arrow). Perhaps only fetch and wave climate were considered when designing this structure but boat-generated waves appear to also be quite significant at this site.

In contrast, at Wye NRMA, sand seems to be transported by storm events or during high tides forming a sand spit at the northern end of the study site (Figure 5). This sand spit has been deposited in relatively deep waters forming a very steep shoreline (Figure 4 Wye NRMA 39+70). It appears that if the groins had extended farther offshore they

could have trapped more of these sediments minimizing the formation of this sand spit. Other areas adjacent to the study site are less steep and extensive shallows can extend quite far offshore (Figure 4 Wye NRMA 32+20). Such shallows attenuate waves as they propagate onshore thereby protecting the shoreline even in the absence of breakwaters or groins.

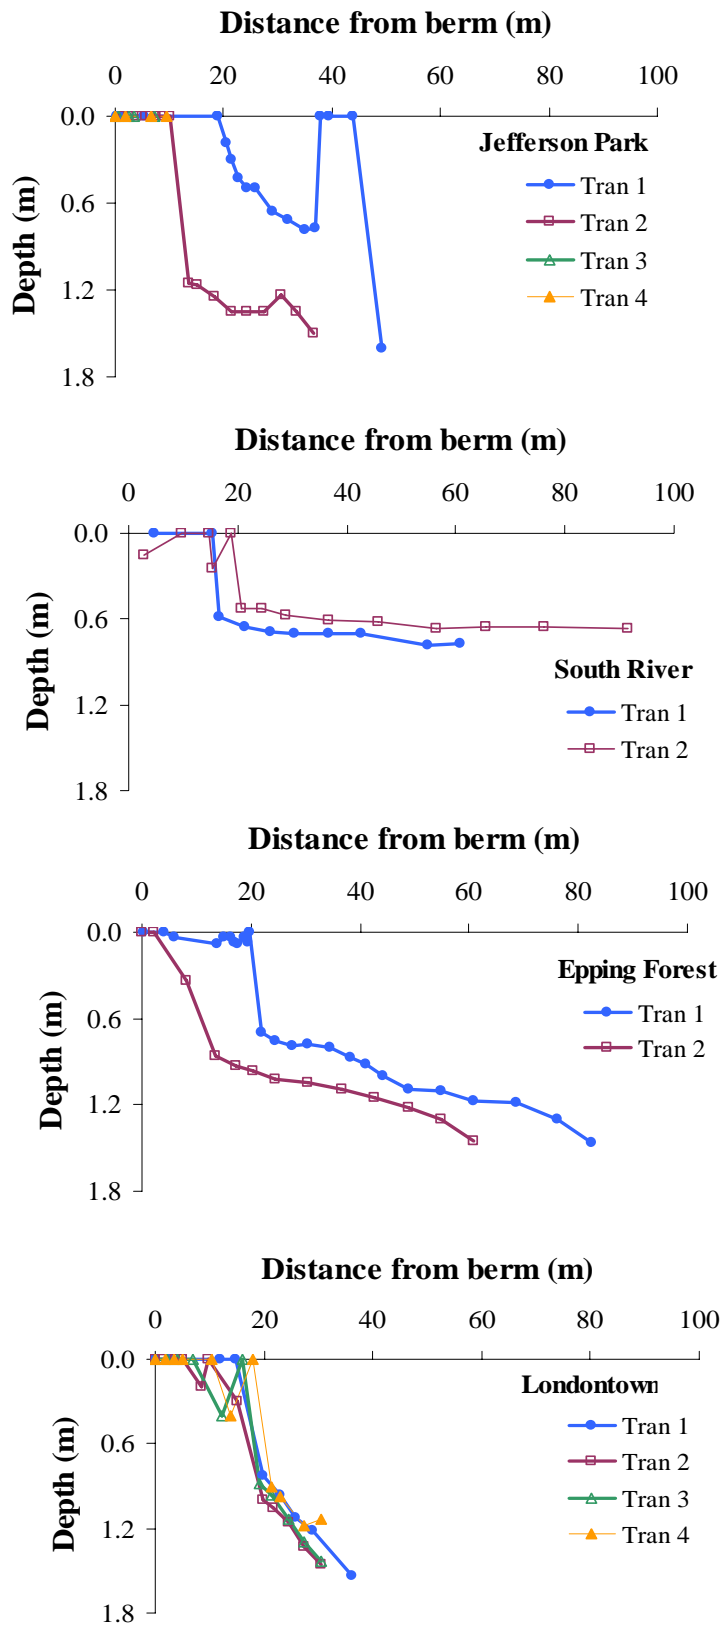
**Figure 7. Present shore profiles at CBT sites.** Measurements of water depth at each transect within each site. Each line represents a transect perpendicular to shore.

The area adjacent to the South River Farm Park site is characterized by a broad sand shoal (Figure 11) with a gentle slope (Figure 7) which is colonized by *Ruppia maritima*. This SAV bed, although sparse, was quite extensive and flowering at the time of sampling. The source of sediment that formed this shoal may be the eroding bank at the study site and/or the beaches south and northwest of there. Independent of the source, sediment dynamics in this area is extensive as can be seen by the patterns in Figure 7.

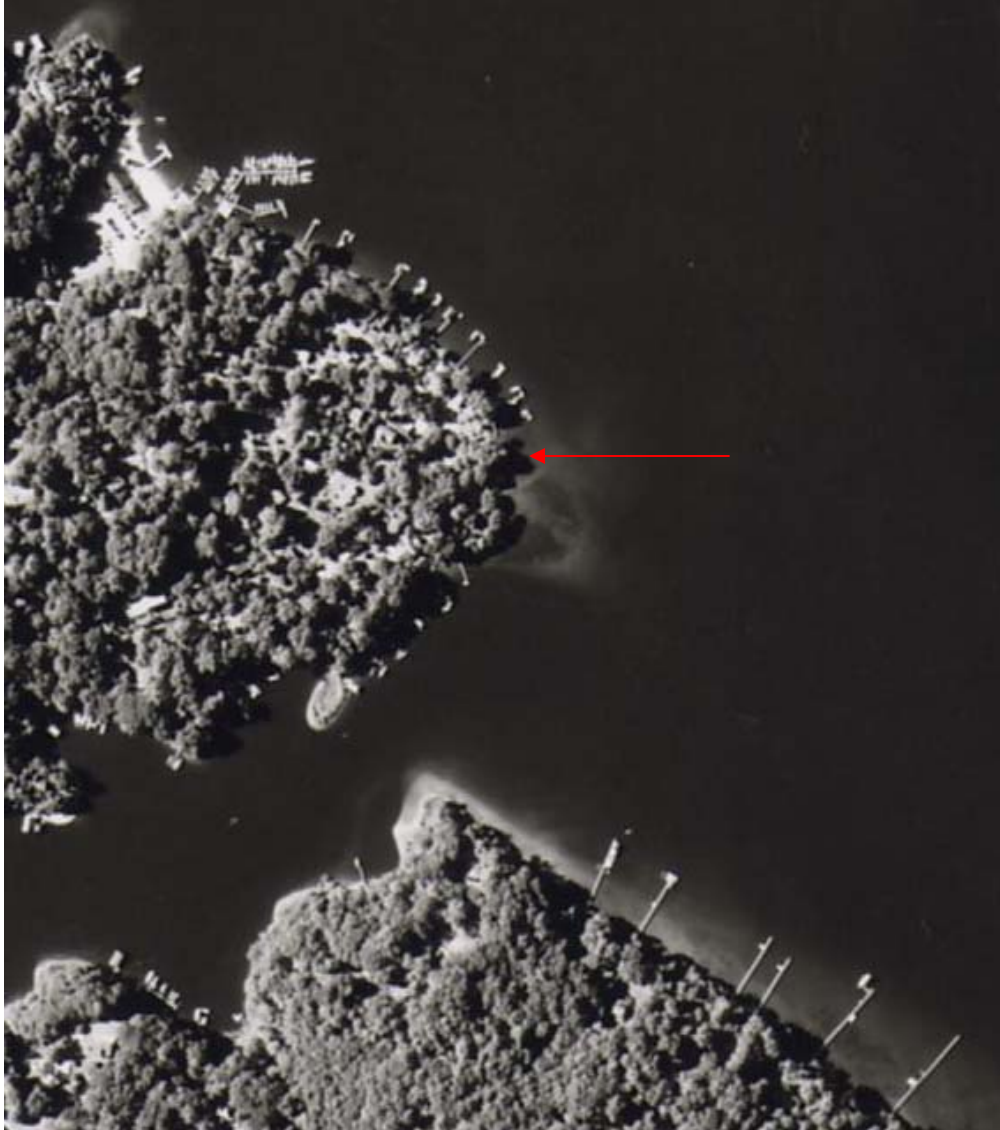
**Figure 8. Aerial view of the Epping Forest Site.** Note the sediment fan just south of the vegetated breakwater (red arrow).

The vegetated sill at Epping Forest is located adjacent to the mouth of a creek that deposits sediments in the form of a fan in the offshore area (Figure 8). As a result, the slope of the shoreline is gentle (Figure 7) and supports some submersed aquatic vegetation (SAV); *Ruppia maritima* and *Potamogeton perfoliatus*. The source of the sediment is not only the creek but also adjacent embankments that are/were eroding. The adjacent areas appear quite sediment-starved (lack of sedimentary features).

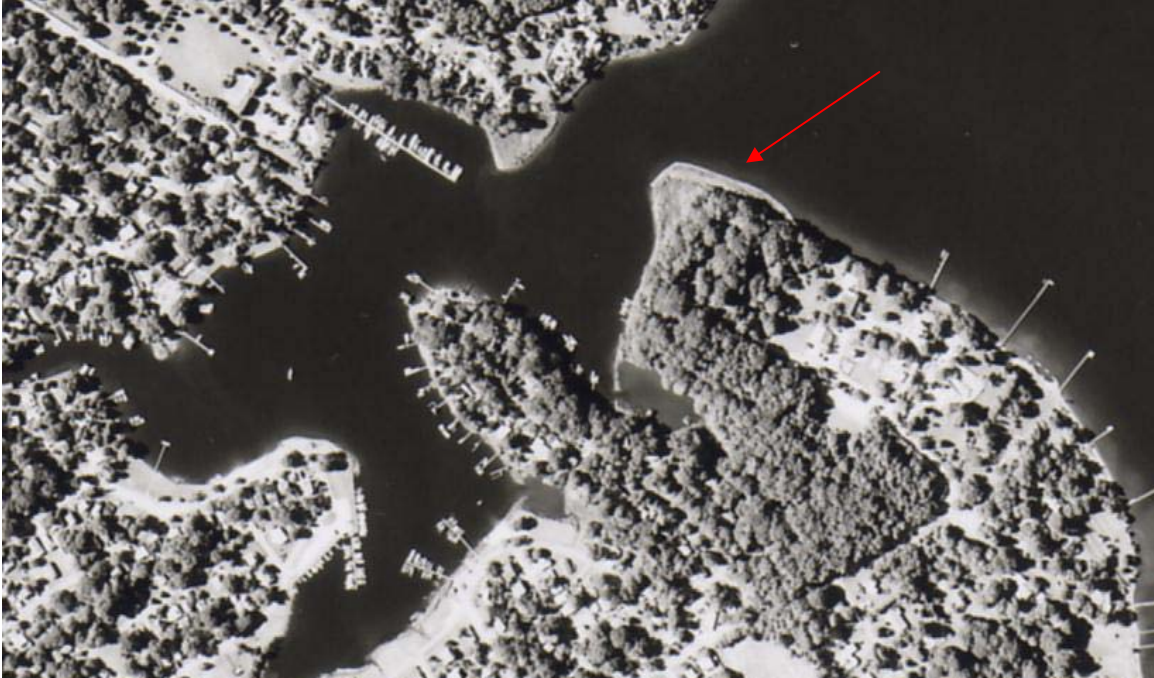
**Figure 10. Aerial view of the London Town Site.** Note the lack of sediment patterns adjacent to the structure but their presence SE of the breakwater.

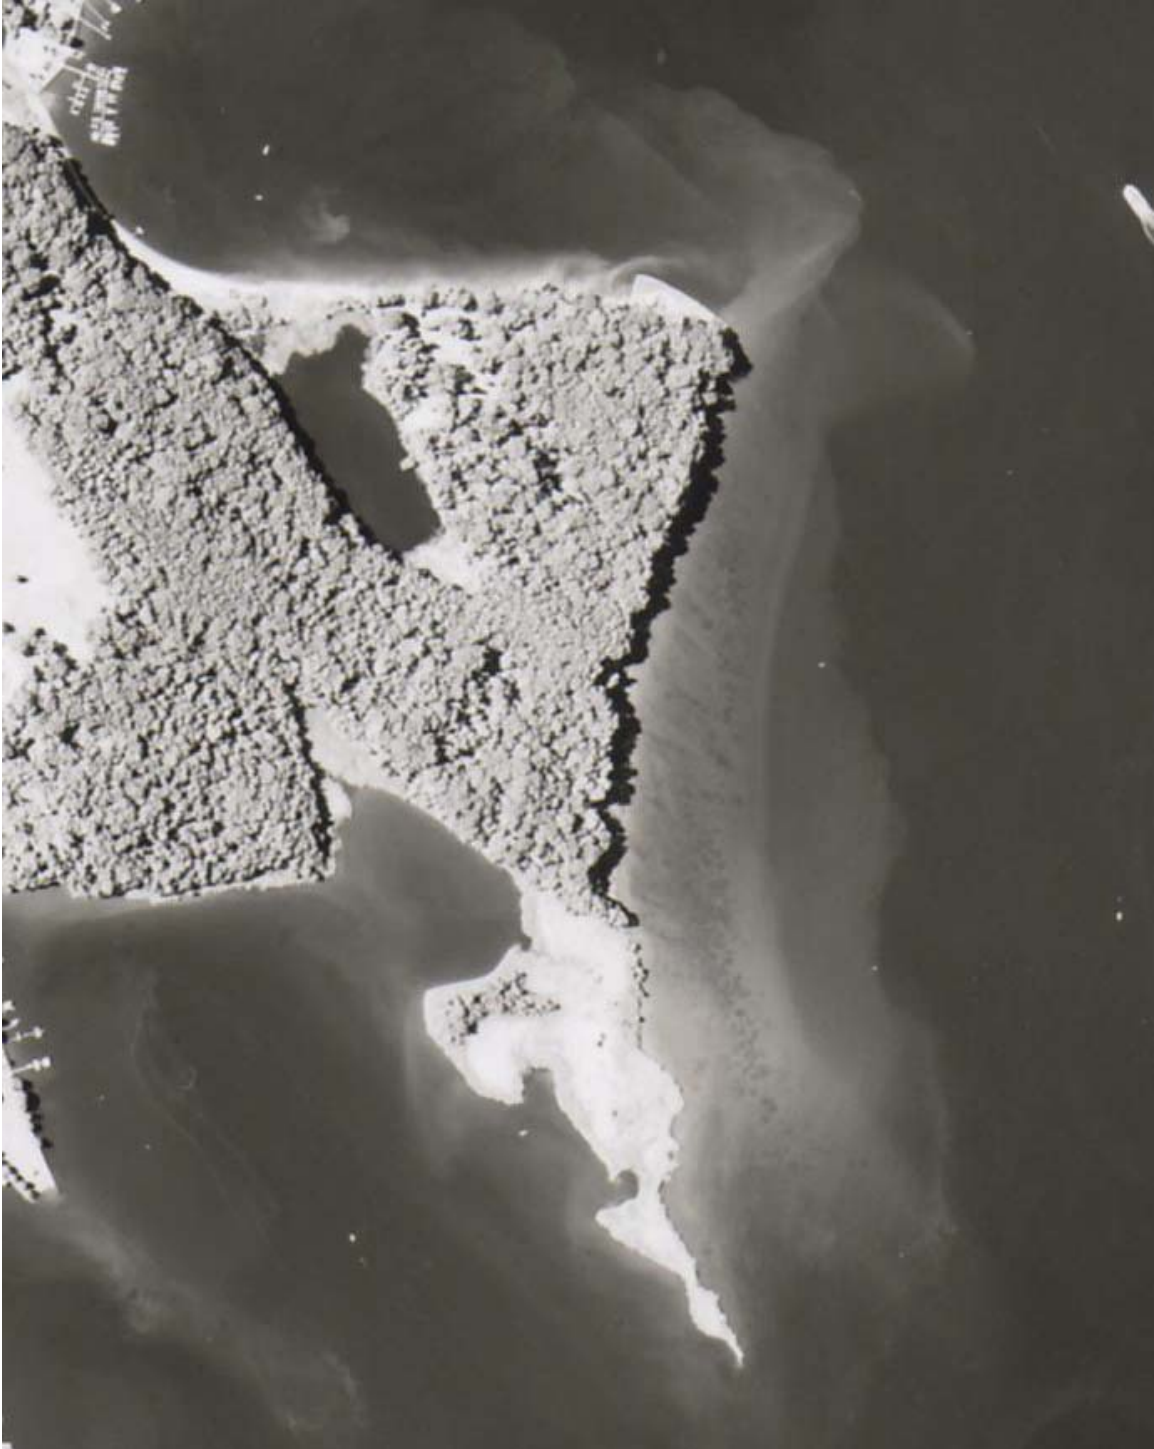
**Figure 11. Aerial view of the South River Farm Park Site.** The structure at this site is obscured by the shadow of the trees. Note the broad shoal adjacent to the shore and the patches of submersed aquatic vegetation.

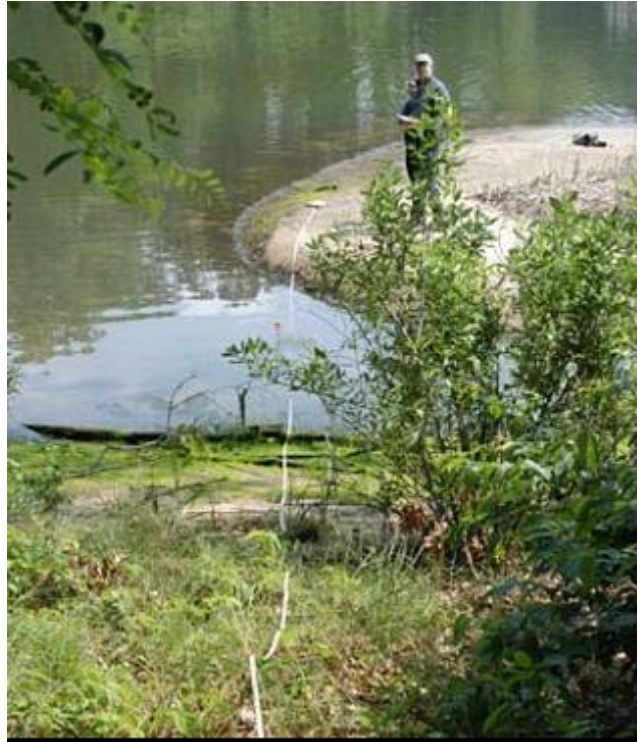
**Figure 12. Accreting sand spit at Wye at Transect #1 (42+70)**

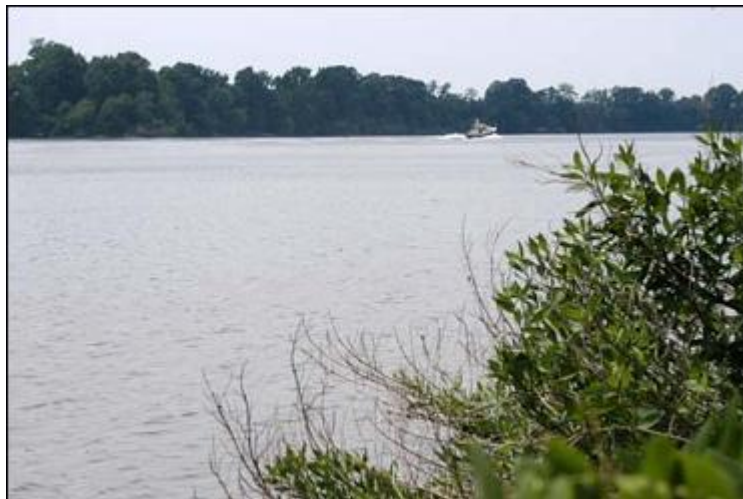
**Figure 13. Boat navigating the Wye River near the shoreline project**

There was one clump of marsh plants which was eroded into the sub-tidal area. A sill might be a better option at this location to help protect the marsh from wave action which appeared to be exacerbated by boat traffic in traveling in the channel of the Wye River (Figure 13).

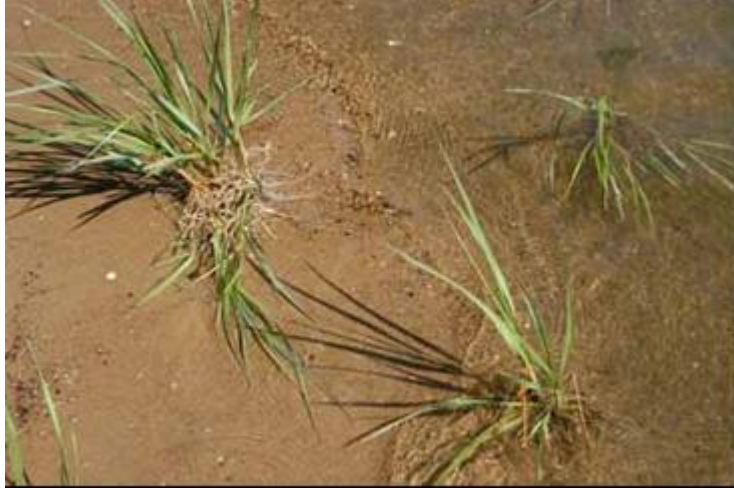
**Figure 18. Eroded substrate of *Spartina* at Epping Forest.**

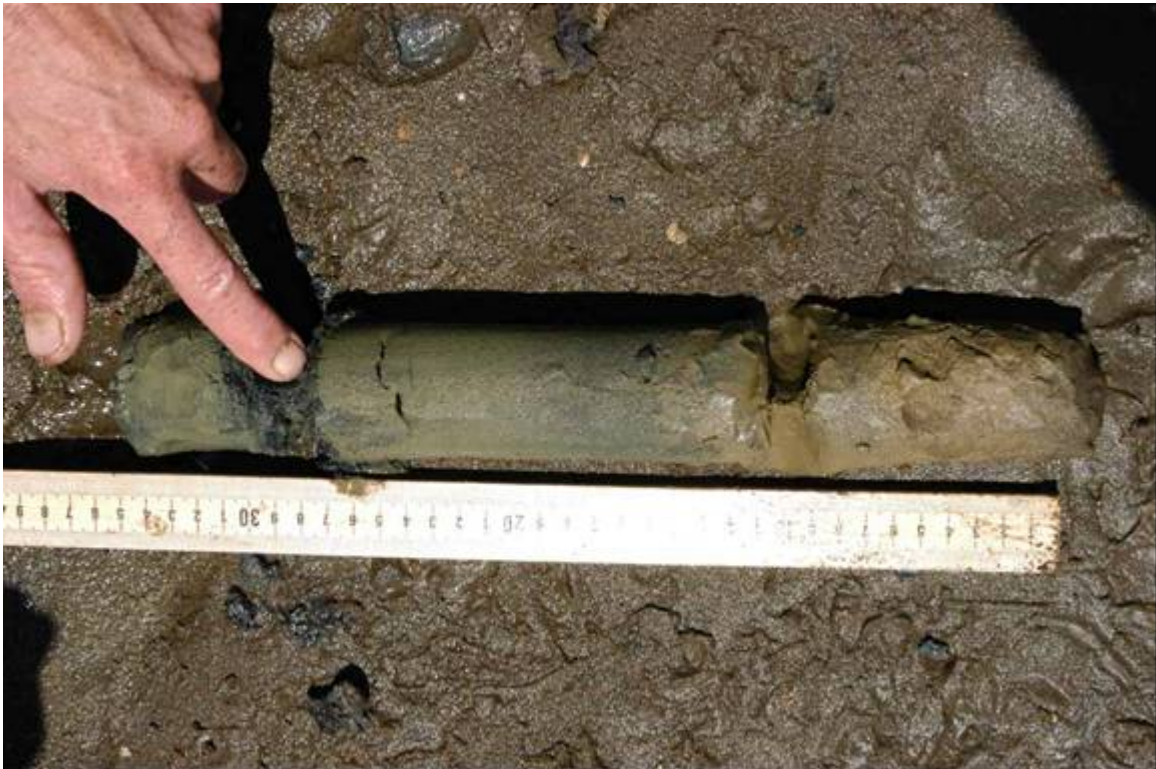
**Figure20. Sediment core at South R. Farm Park, June 2004 showing 5-6 cm over the old black organic marsh layer.**

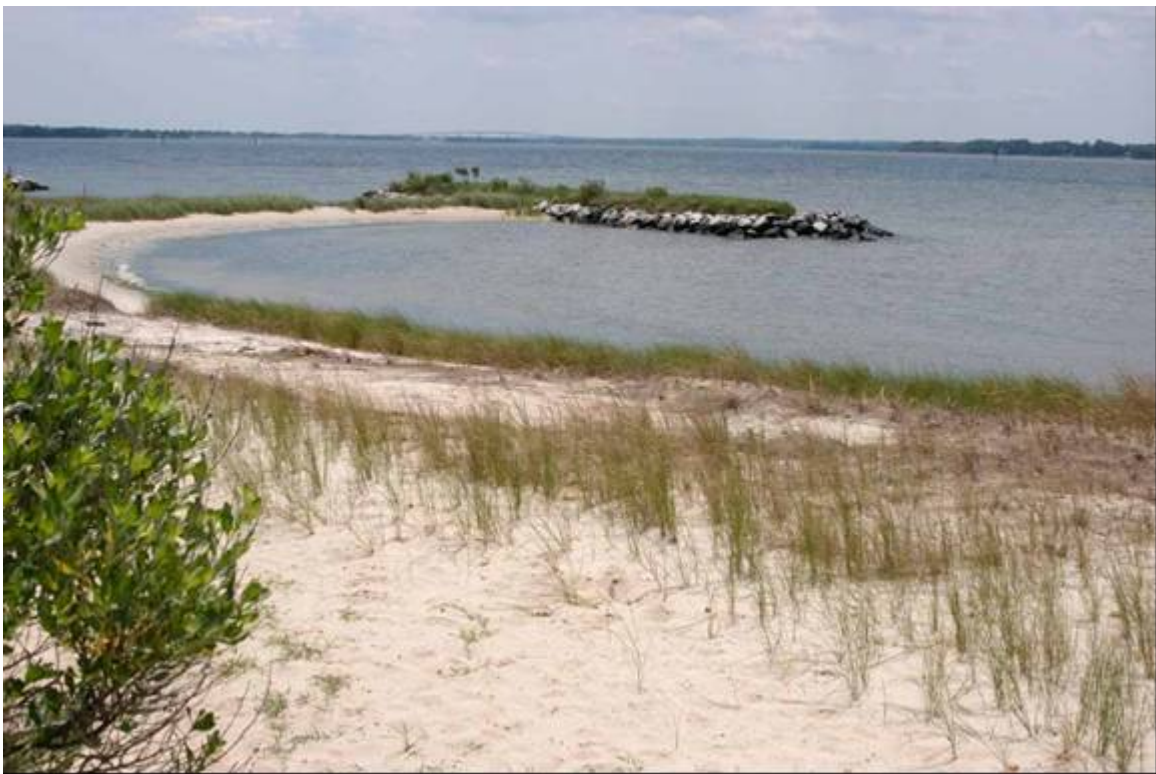
**Figure 24. Marsh and dune vegetation on tombolo at Peterson Point on Patuxent River.**

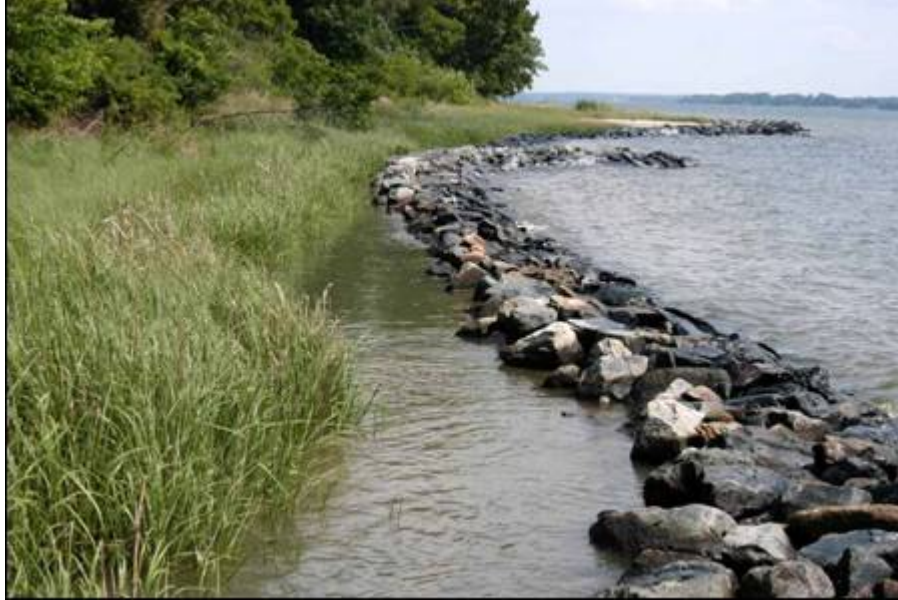
**Figure 25. Breakwaters, northern end of the Jefferson Patterson Park & Museum site.**

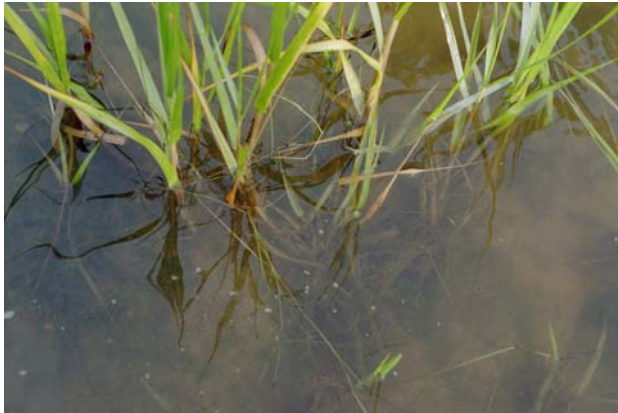
Figure . Epping Forest, Section 1, left roots recover
