Summer Research 2014 - Final Report

Radiation Shielding - HEP Lab A - Florida Institute of Technology

Abstract

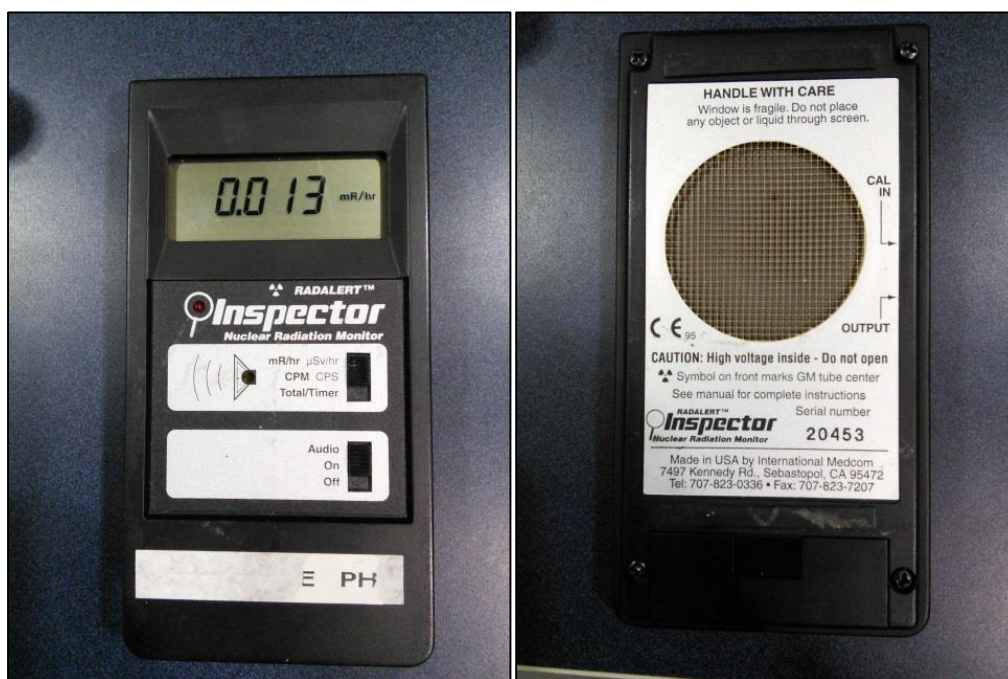
Figure 1: Radalert Inspector Nuclear Radiation Monitor. (Left) The measurement/settings readout side. The Audio/On/Off switch was set to 'Audio' for all safety checks and regular testing. (Right) The detector-side.

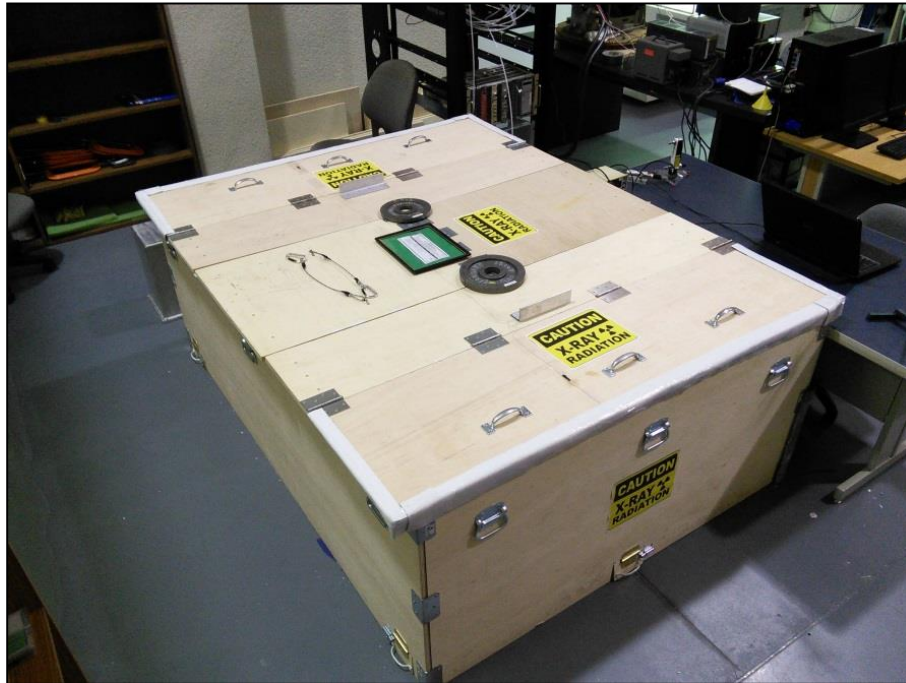
Figure 4: The LLB fully closed and ready for operation.

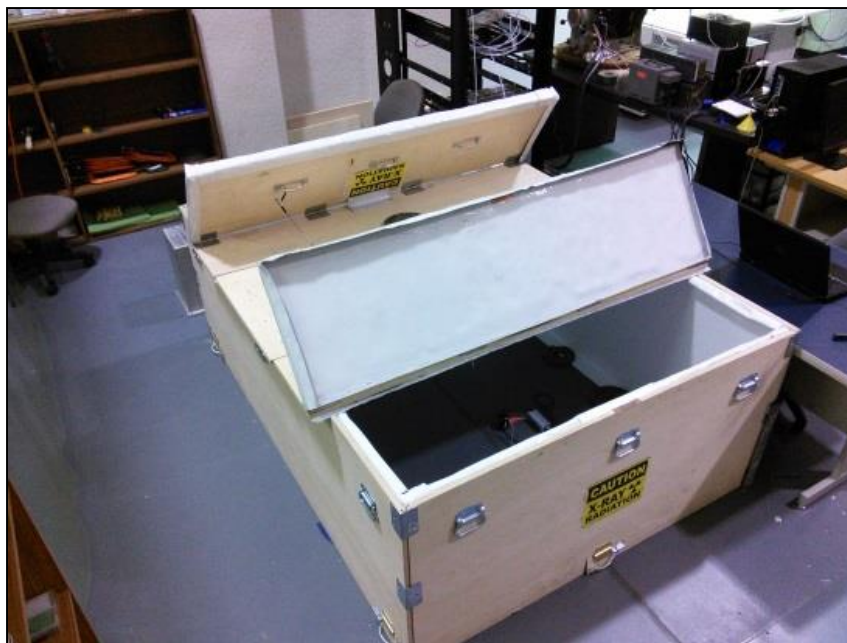
Figure 5: The LLB with both lid doors open. Each lid weighs around 50 lbs. and has a metal kickstand to hold it open and safety cables to prevent it from slamming shut.

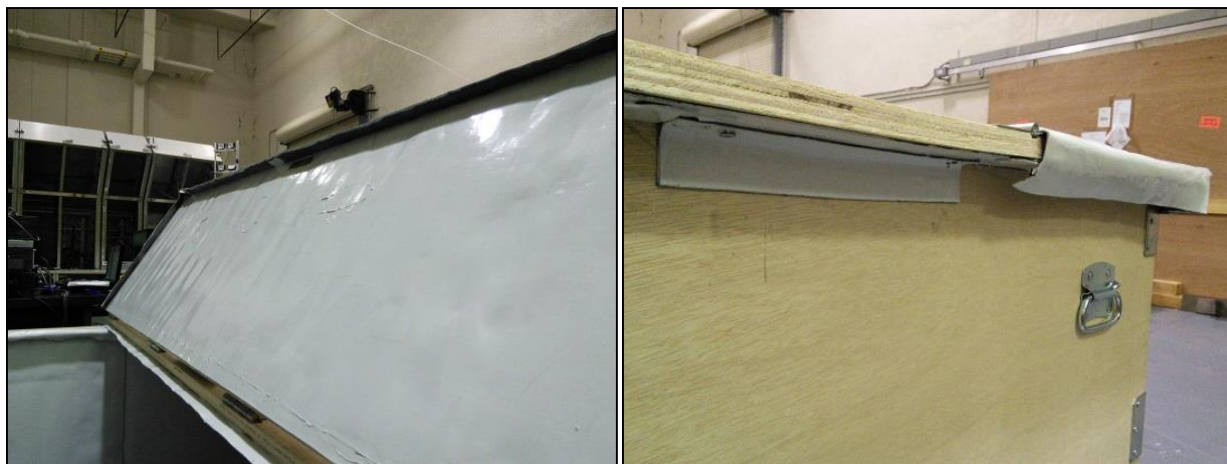
Figure 7: Close-ups of exterior top-edge seals on and round the lid doors. These seals were added as response to radiation leaking from separation between the lid and tops of the sides of the LLB.

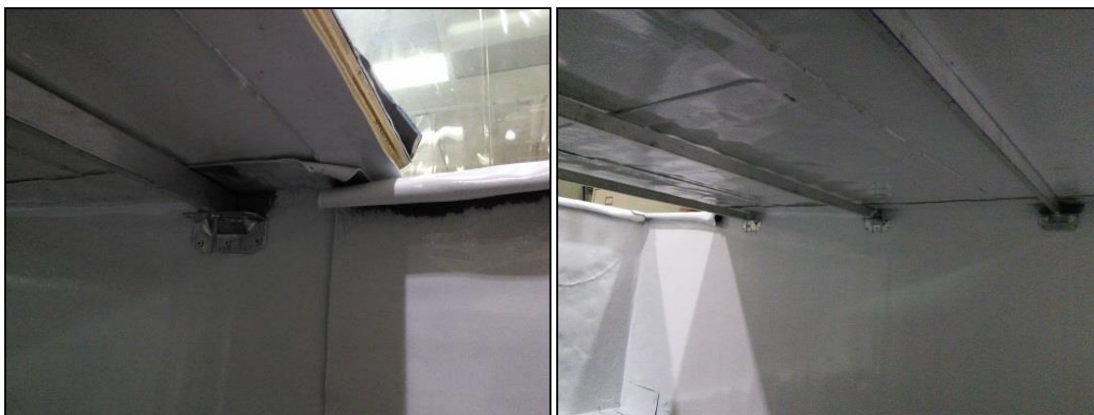
Figure 9: (Left) Overlapping seam-sealers on the inside of the LLB. (Right) The 3 aluminum support bars that keep the lid from bowing under its own weight. The 3 pieces of the lid weigh a total of ~200 lbs.

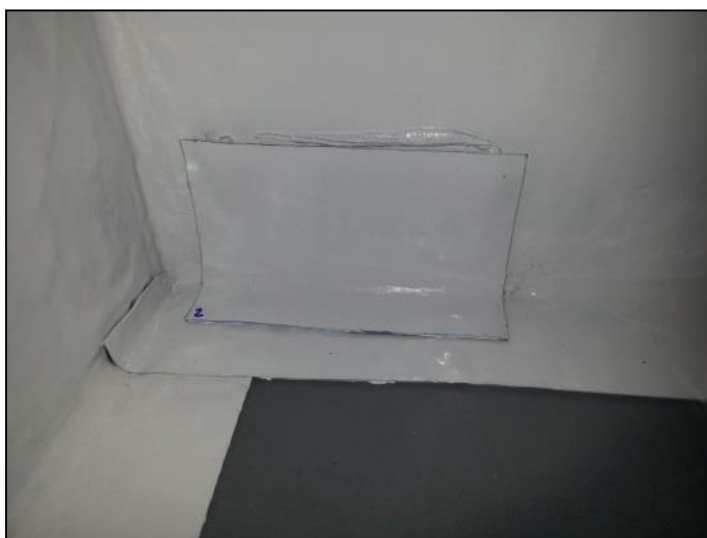
Figure 10: Velcro-attached inside seal of a closed access port. Underneath the solid Velcro-attached seal, but not visible here, is a square 'picture frame' seam-sealer that is permanently glued around the cut in the large side panel's lead.

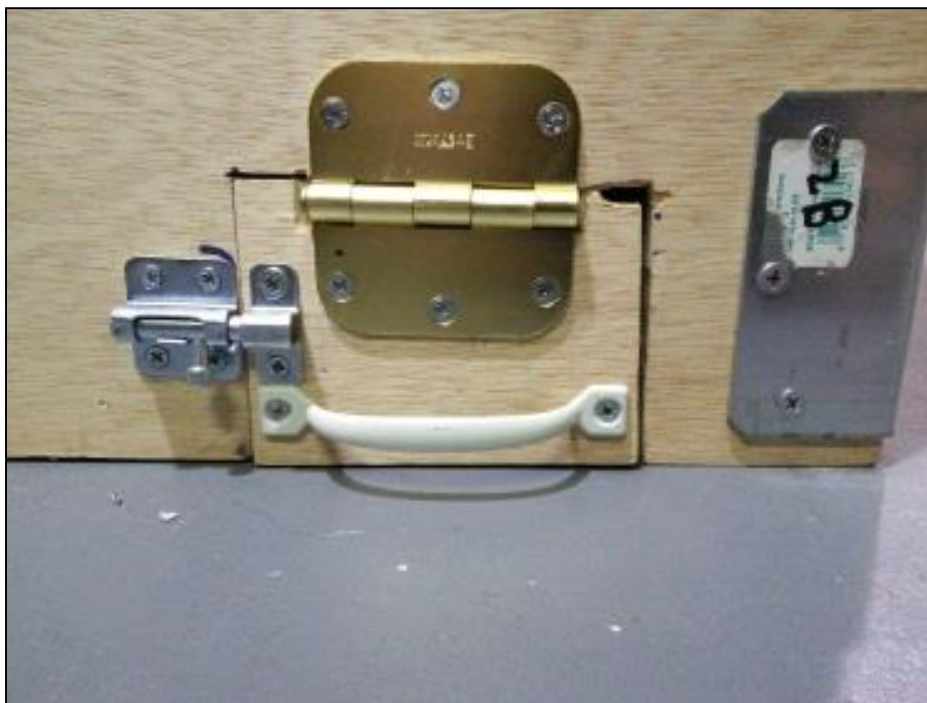
Figure 11: Outside view of access port #2 in its closed position.

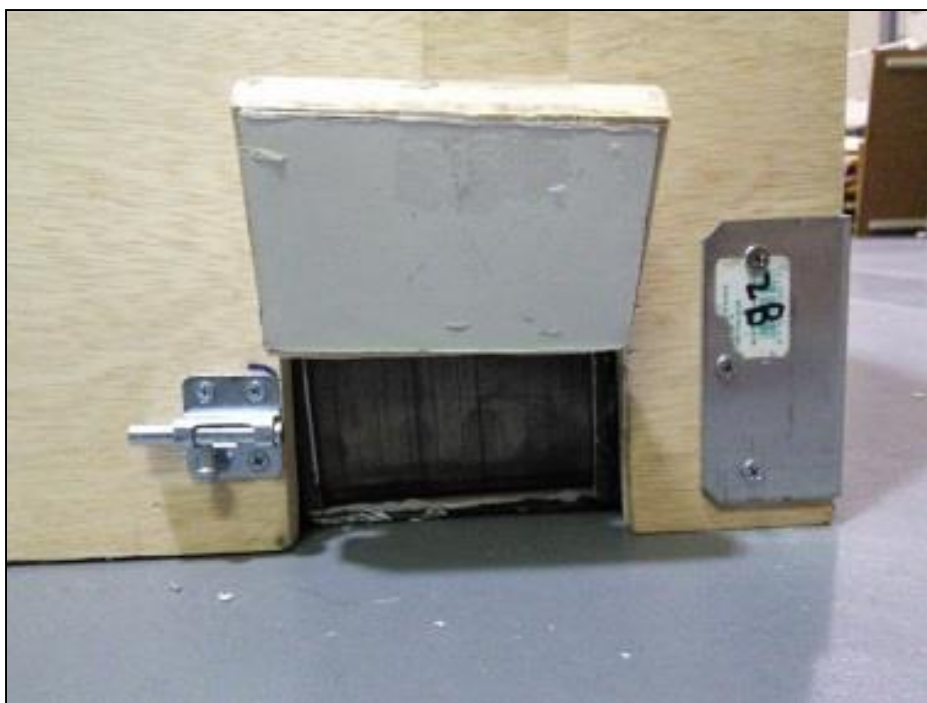
Figure 12: Outside view of access port #2 in its open position. The back of the Velcro-attached solid seal from Fig. 10, as well as the inside lips of the 'picture frame' seam-sealer, are shown too. Notice the inside of the hinged wood piece is also covered in its own lead paneling.

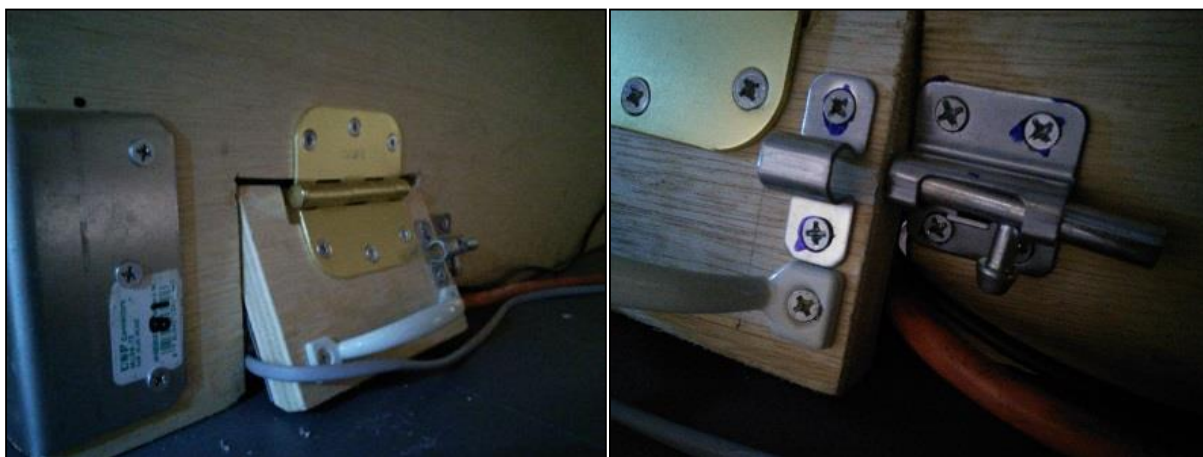
Figure 13: Two views of how port #8 was partially open while being used for radiation testing.

Leaving the port like Fig. 13 with no additional shielding led to large radiation leaks during safety check testing and so had to be improved before actual 5 min testing runs took place. Since port #8 was the only port not completely sealed for this testing, the 17 in. x 17 in. x 0.25 in. thick sheet of lead shown in Figure 14 was used as necessary external shielding.

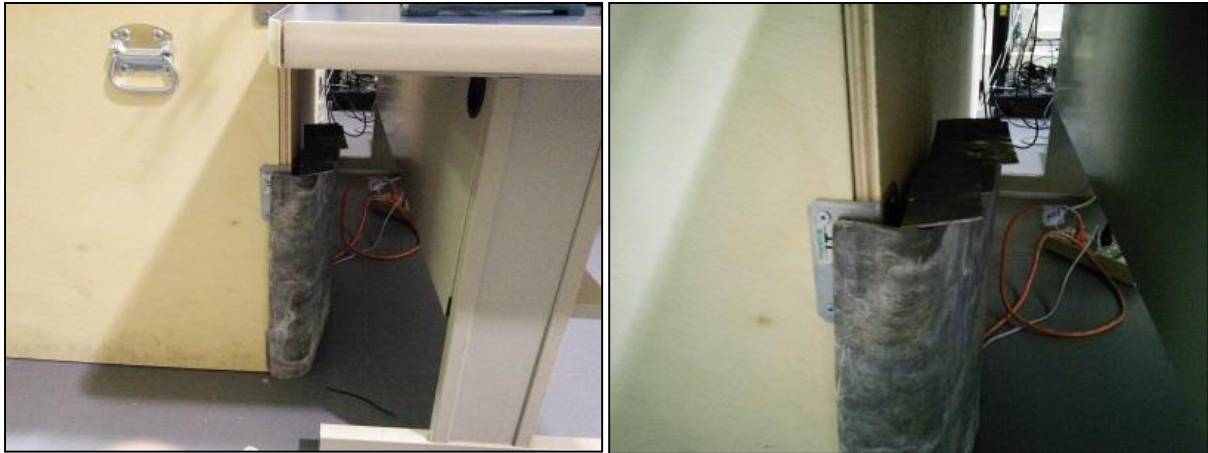
The 0.25 in. thick external sheet was also bent around the corner of the LLB and had its top gap covered by other pieces of regular 1/16 in. thick lead sheet for complete protection.

Figure 15: Different views of the external shielding including the 3 pieces of 1/16 in. thick lead sheet placed on top of the 0.25 in. thick sheet.

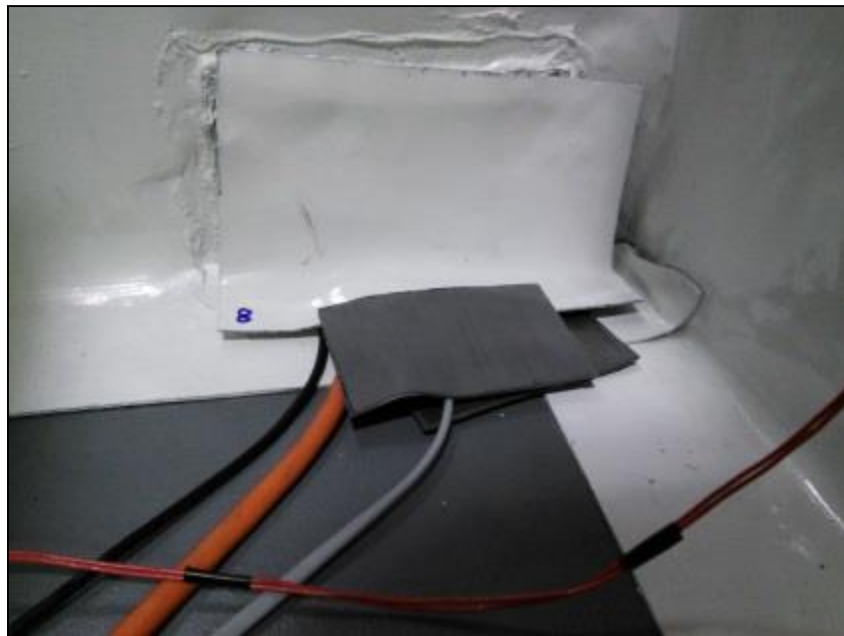
On the inside of port #8 the Velcro-attached inside seal was placed over the cables as best as possible and was complimented by a final piece of additional 1/16 in. thick lead shielding as shown in Figure 16.

Figure 16: Interior shielding of the partially open access port #8.

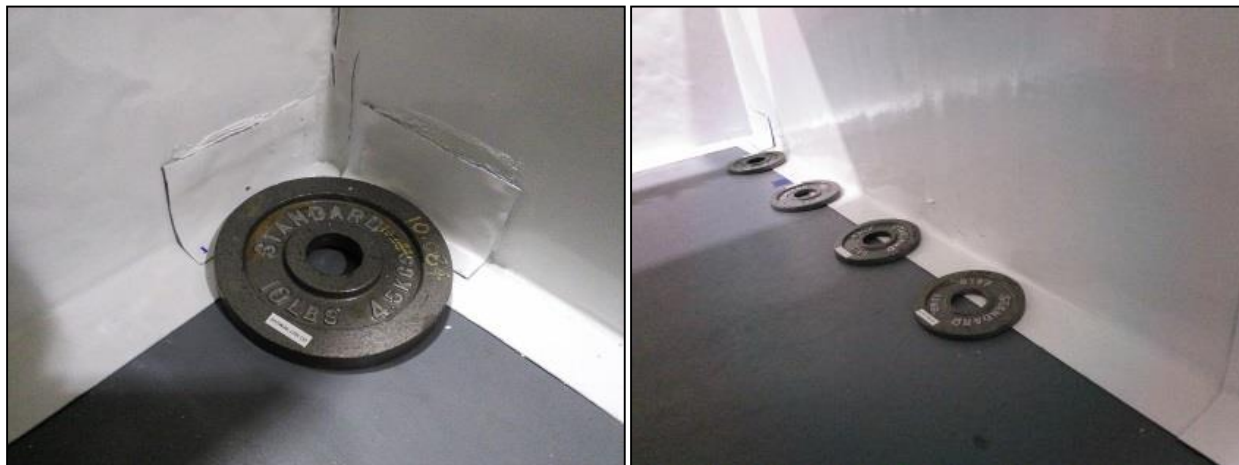
Finally, the last adjustable shielding features of the LLB are weights as shown in Figures 17 & 18. These weights were put in place to bring down radiation levels that were $> 15\%$ over background for 5 min trials. The extra weight reduced separation between the lead and the ground or lead and other lead to reduce leaks. All weights were labeled as "DO NOT REMOVE."

Figure 17: Various 5 lb. and 10 lb. weights used to reduce leaks on the inside of the box.

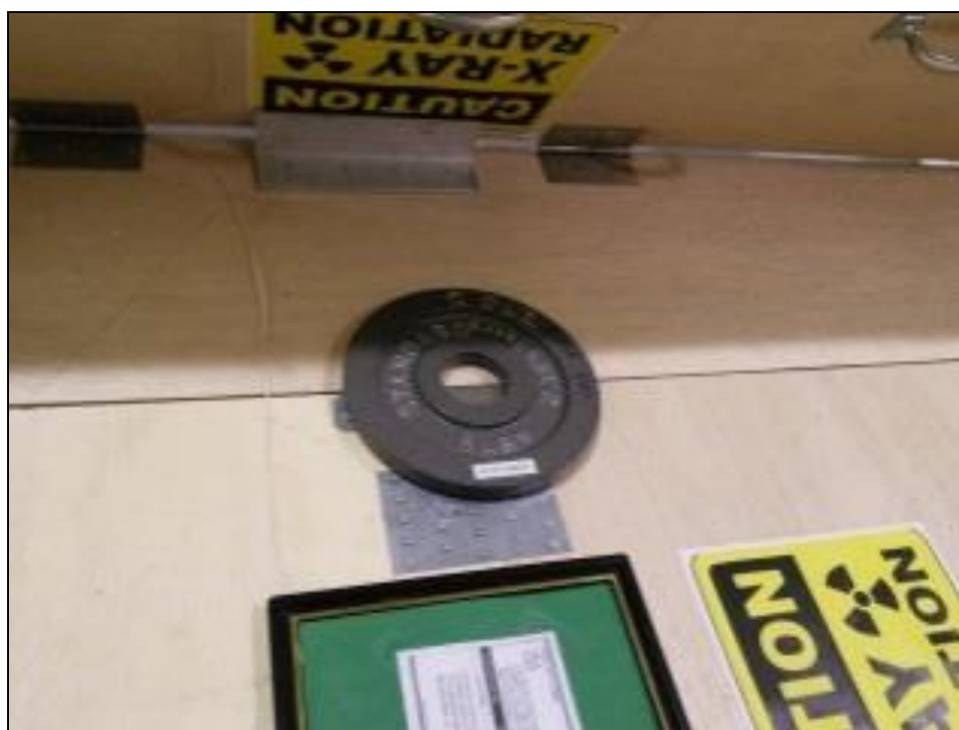
Figure 18: Additional weight (1 of 2) on the lid of the box to reduce separation between pressed lead sheets and thus stop radiation leaks.

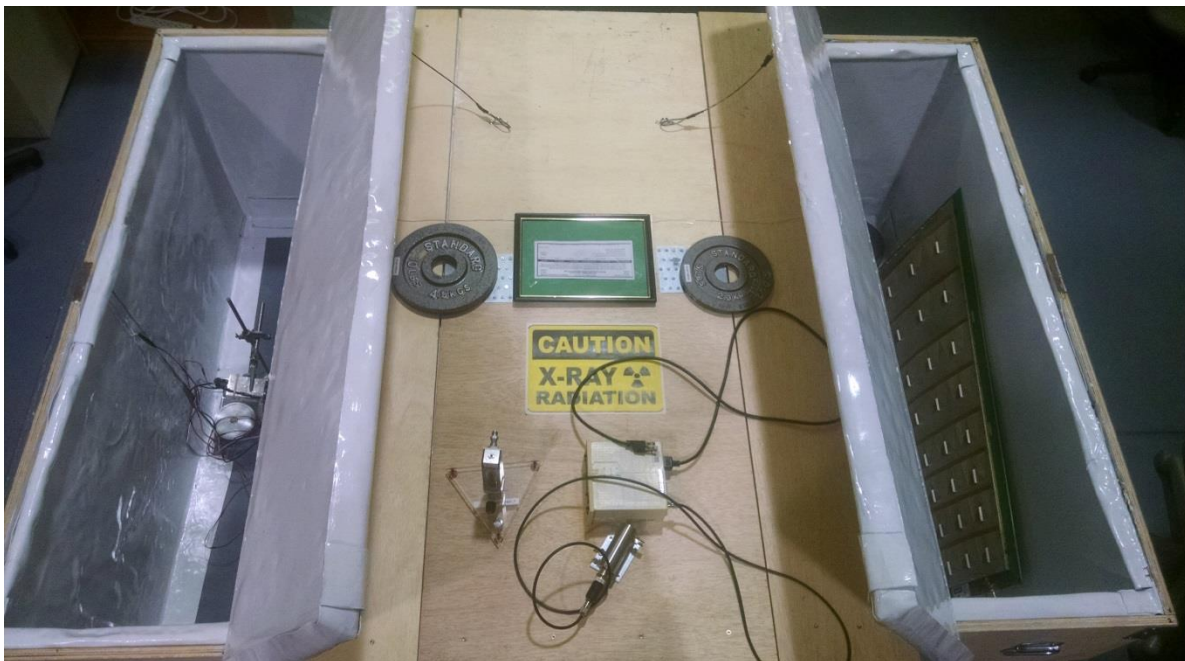
Figure 21: A final overview of the box with x-ray source and detector in respective testing locations.

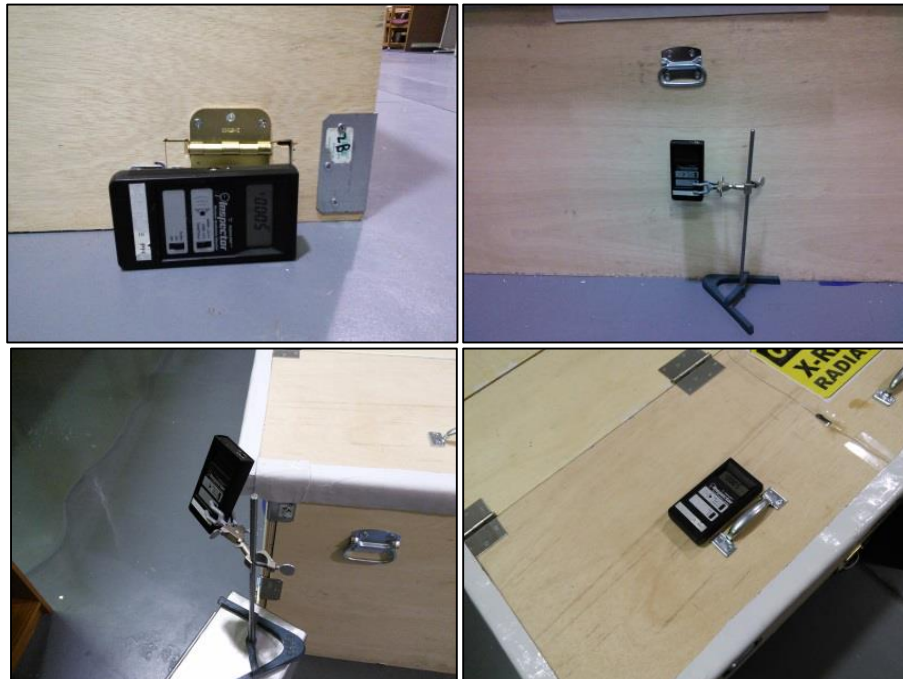
Figure 28: Examples of the Geiger counter in some actual testing positions. (Top Left) Access Port #2; position number 2. (Top Right) Side Panel Clean Mid; position number 24. (Bottom Left) Corner Clean-Parking Top; position number 17. (Bottom Right) Lid Panel Parking; position number 31.

1. When testing at an access port, a flat-top or flat-side face position, and edges at bottom, middle, or top position, the Geiger counter's detector-face was always parallel to the plane of the wood of the face being tested. This is shown in Figure 28.
2. When testing at top corners, the Geiger counter was oriented to have its detector-face normal to the apex of the corner. This is also shown in Figure 28.
3. When testing at bottom corners, the Geiger counter was oriented like bottom edges described above.
4. Testing one portion of a larger feature that is uniform throughout, such as the middle of a 7 ft. side panel or a long lid seam-sealer, was used as data for the entire feature.

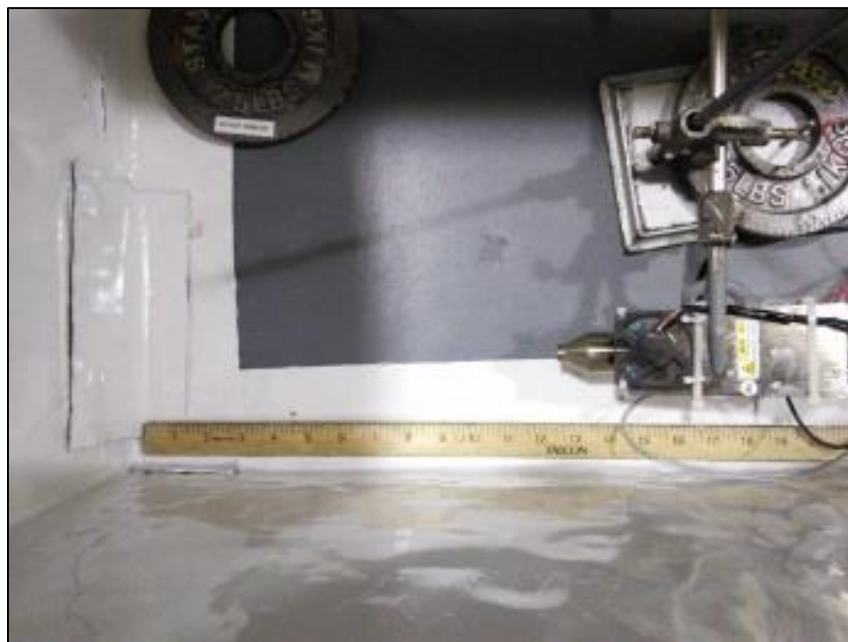
Figure 32: The Mini-X in its point blank testing position for Access Port #2.

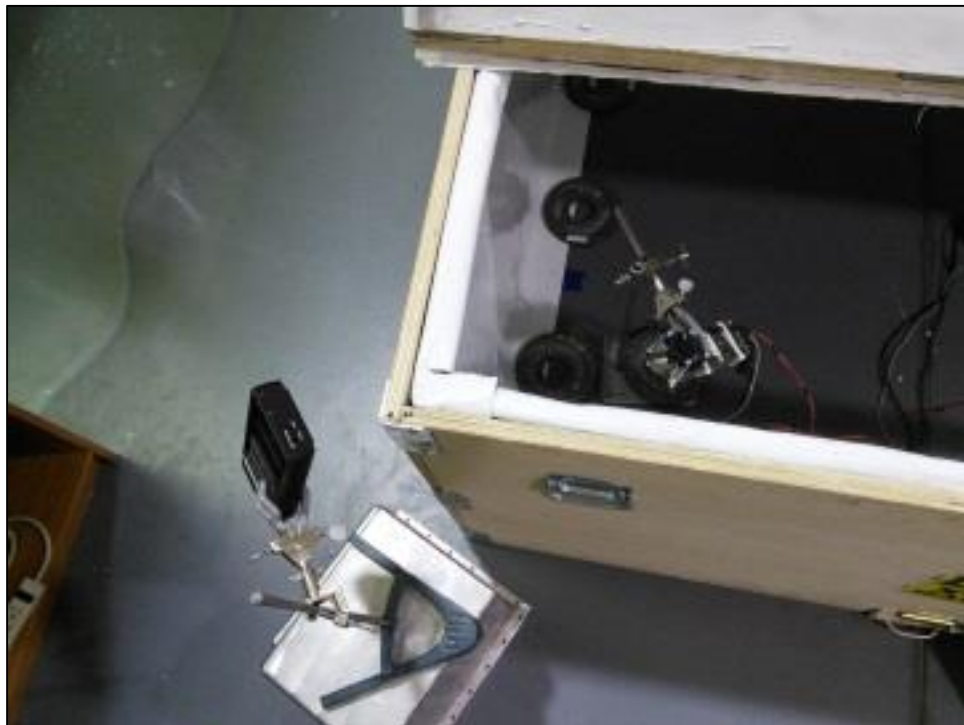
Figure 34: A view of both the Geiger counter and the Mini-X positioned to point-blank-test a top corner.

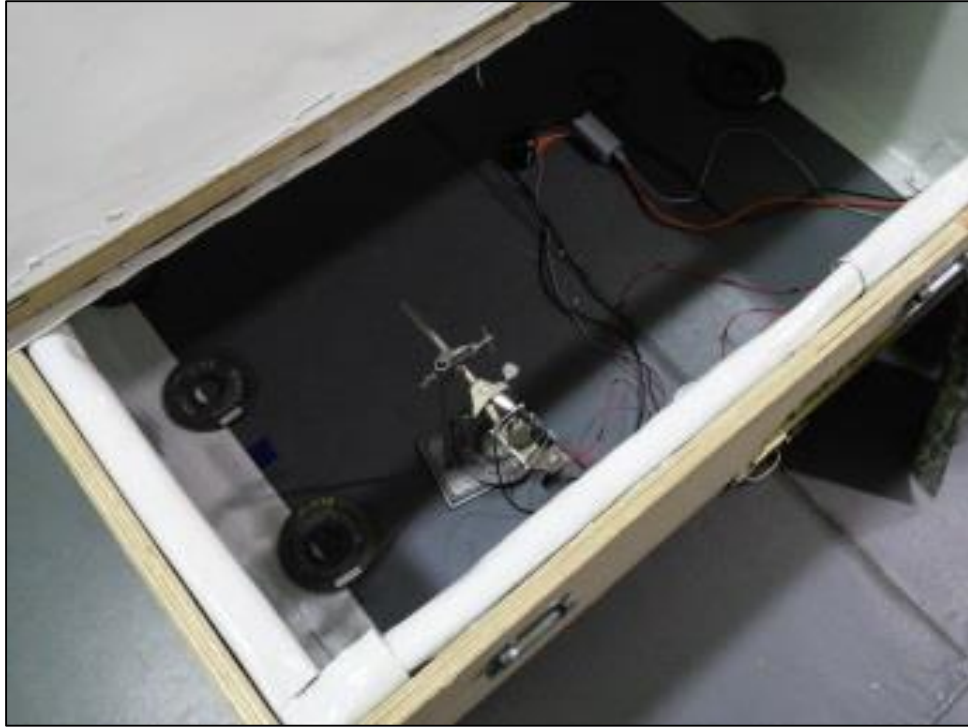
Figure 35: The Mini-X positioned to fire straight up at the lid for a point blank test.

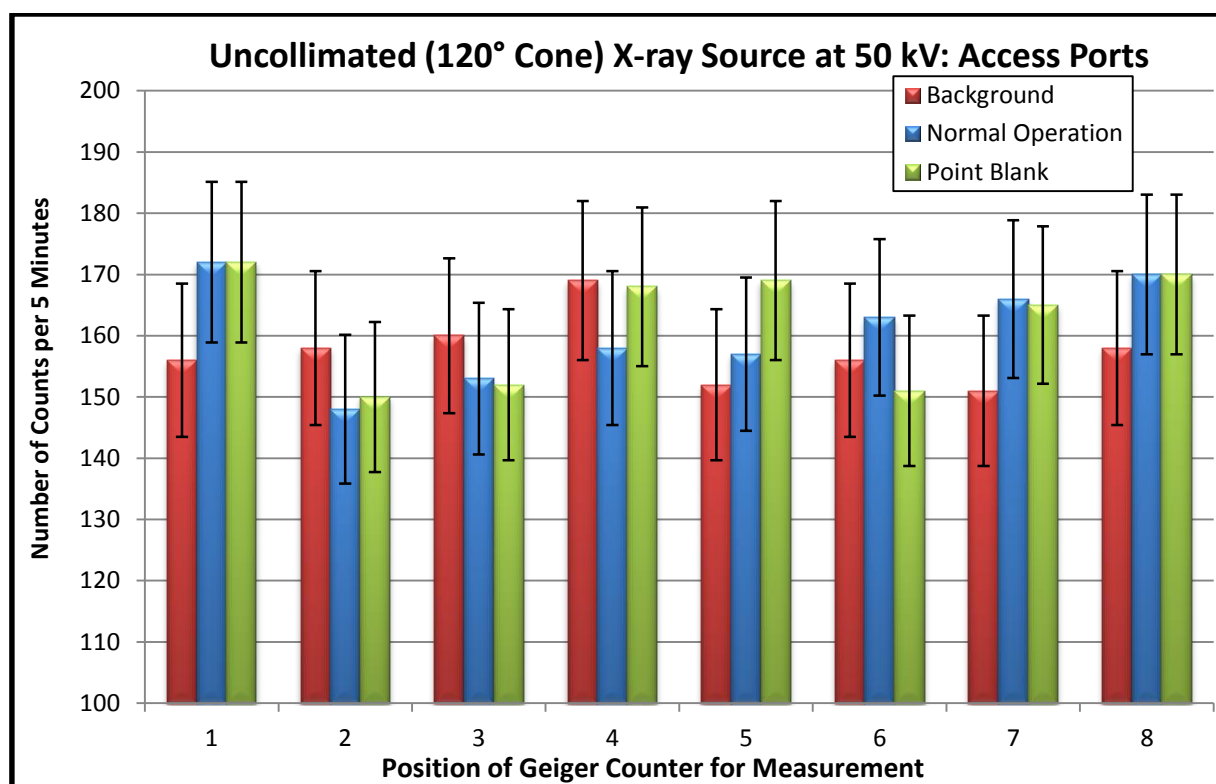
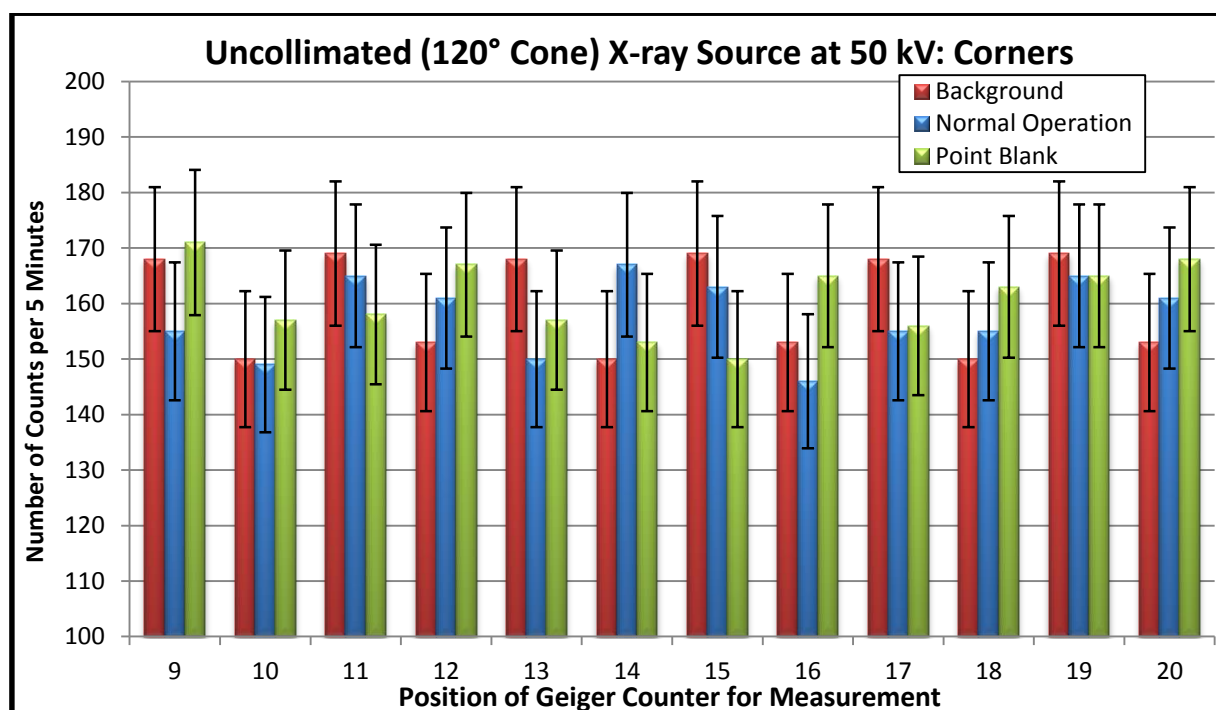
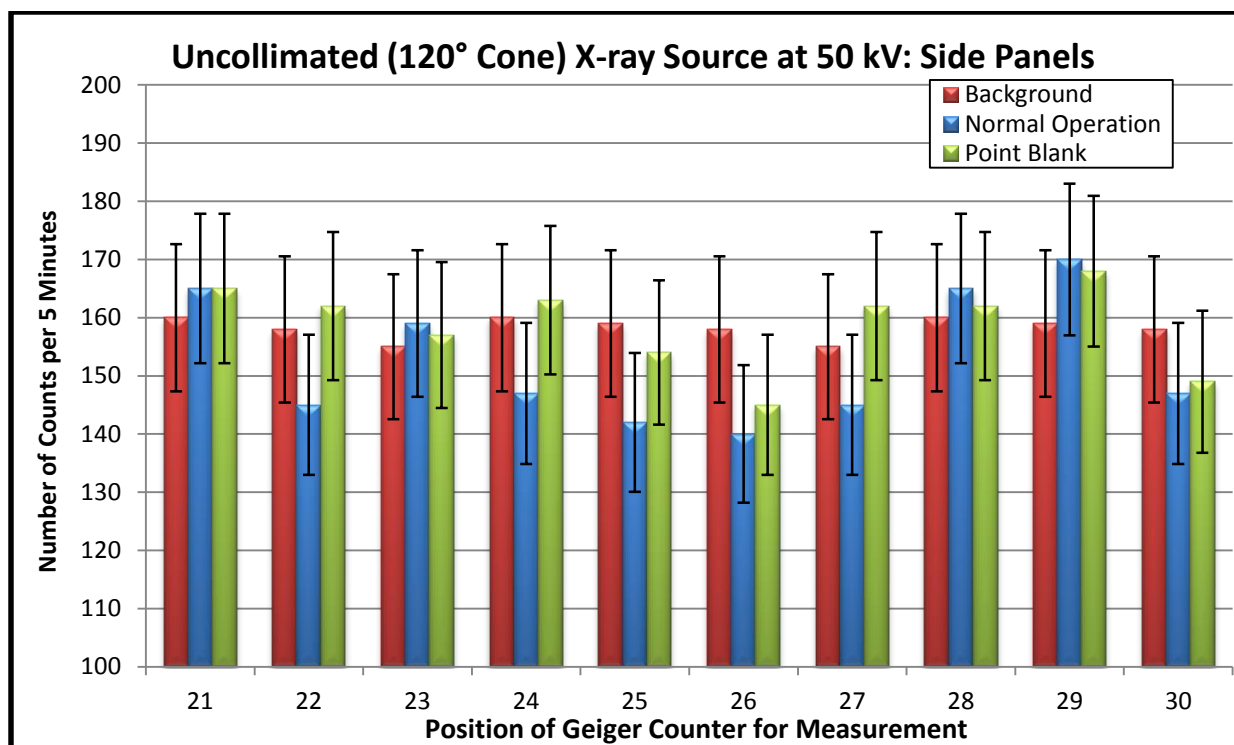
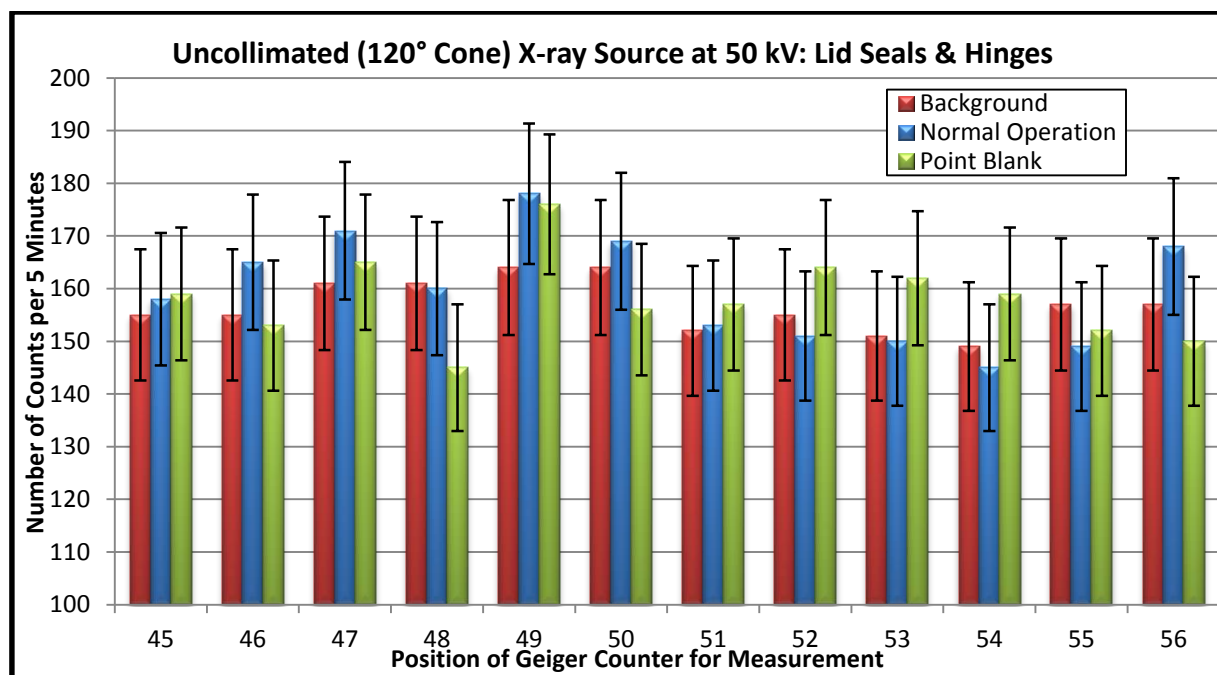
Figure 36: All raw data for Geiger counter positions 1-8 (access ports).

Figure 37: All raw data for Geiger counter positions 9-20 (corners).

Figure 38: All raw data for Geiger counter positions 21-30 (side panels).

Figure 39: All raw data for Geiger counter positions 31-44 (lid edges & panels).

Figure 40: All raw data for Geiger counter positions 45-56 (lid seals & hinges).

As Figures 36-40 show, all total number of counts collected for all NOP and point blank positions were within their and their background's absolute error; therefore, no statistically significant amounts of radiation was found to be leaking from the LLB.

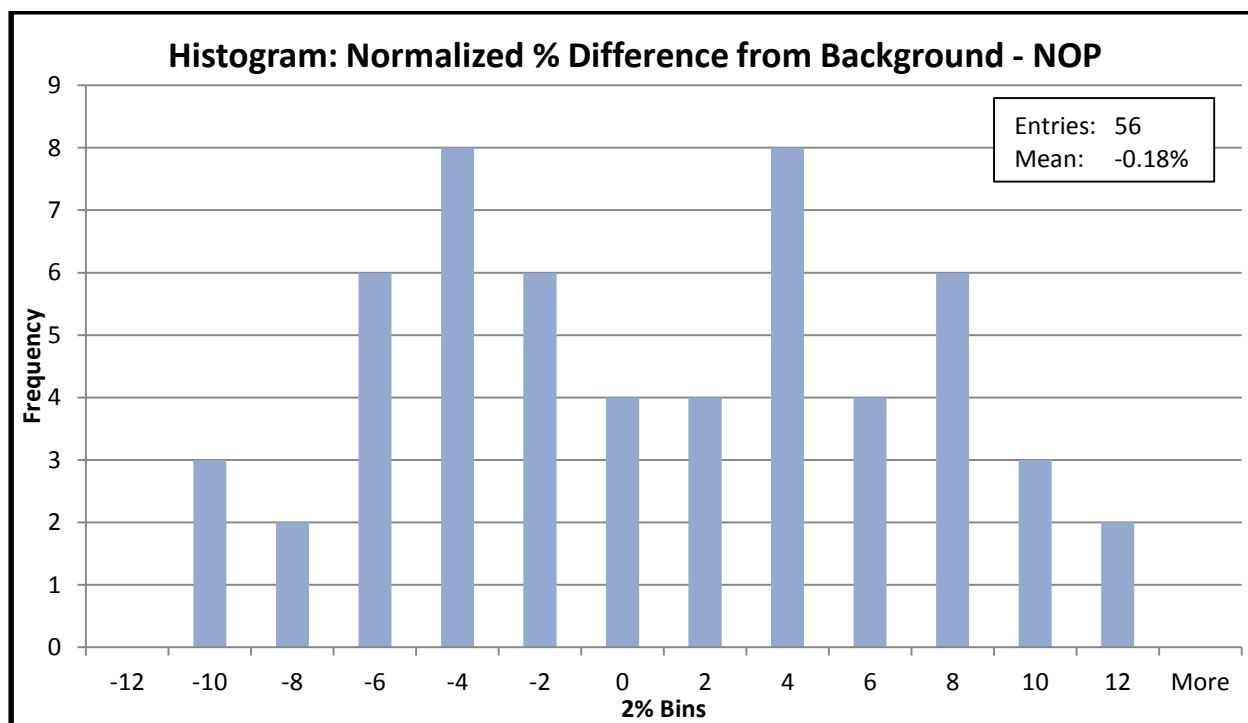
Figure 42: Distribution of NOP test positions' normalized percent differences from background.

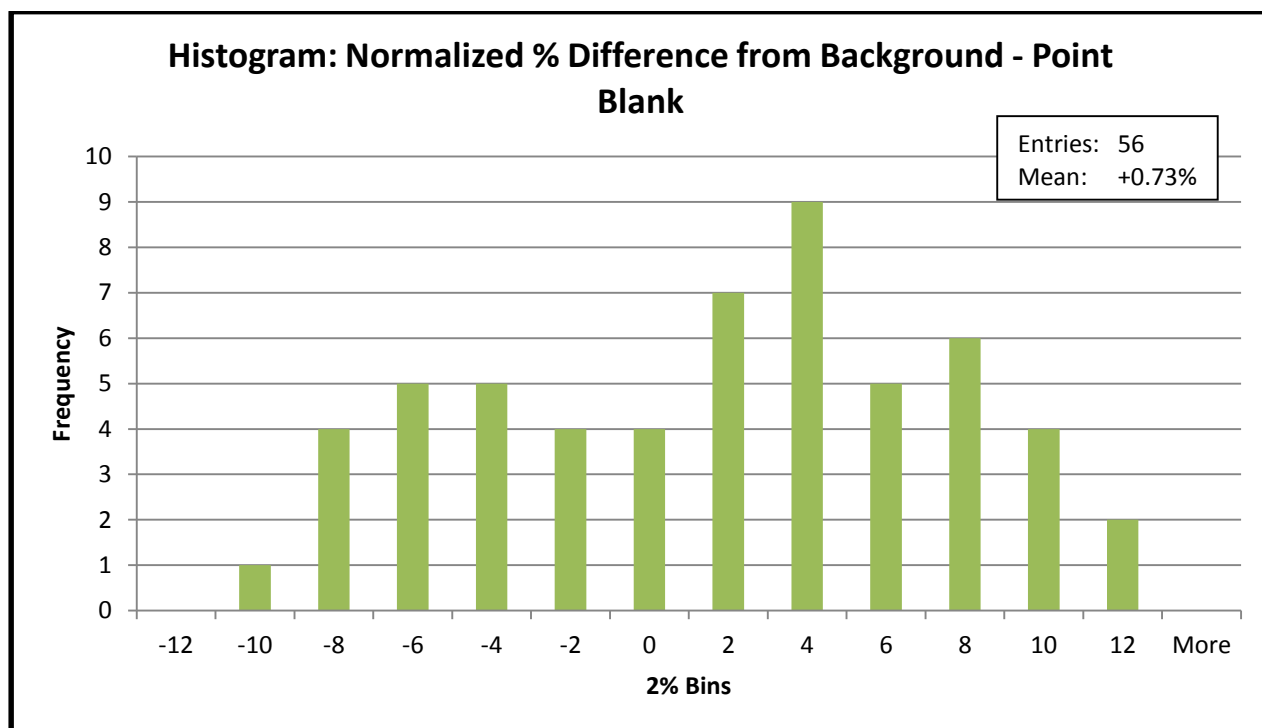
Figure 44: Distribution of point blank test positions' normalized percent differences from background.
