# Hurricane Ike

Nature's Force vs. Structural Strength

**Institute for  
Business &  
Home Safety®**

September 2009

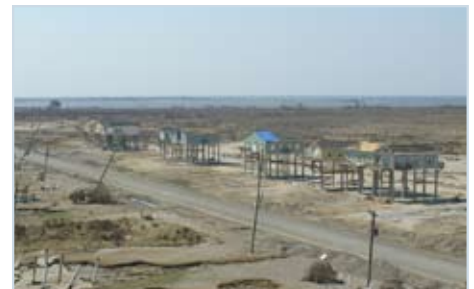
While **Fortified** homes performed exceedingly well compared to the more than 270 other surrounding homes on Bolivar Peninsula that were completely destroyed by Ike (Figure 3), they did sustain some damage. The key findings and recommendations contained here were formulated after IBHS compared and contrasted the performance of the **Fortified** homes with the conventional construction surrounding them, as well as examined relevant building code and other construction-related performance requirements. These research results can significantly improve the performance of both existing and new structures in hurricane-exposed areas.

**Figure 3** An aerial view of nine of the 10 **Fortified** homes still standing following Hurricane Ike amid the rubble of other traditionally built houses that did not survive.

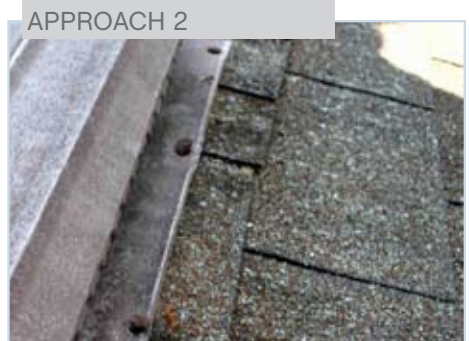
Poorly attached ridge vent covers can easily be replaced or the anchorage can be strengthened, since these are the last items to be installed on a shingle roof.
