EIC Prototype GEM rebuild

Jared Hadley
December 11, 2020
PHY 4902

A Chronological Record of the Disassembly and subsequent rebuild of the EIC GEM prototype

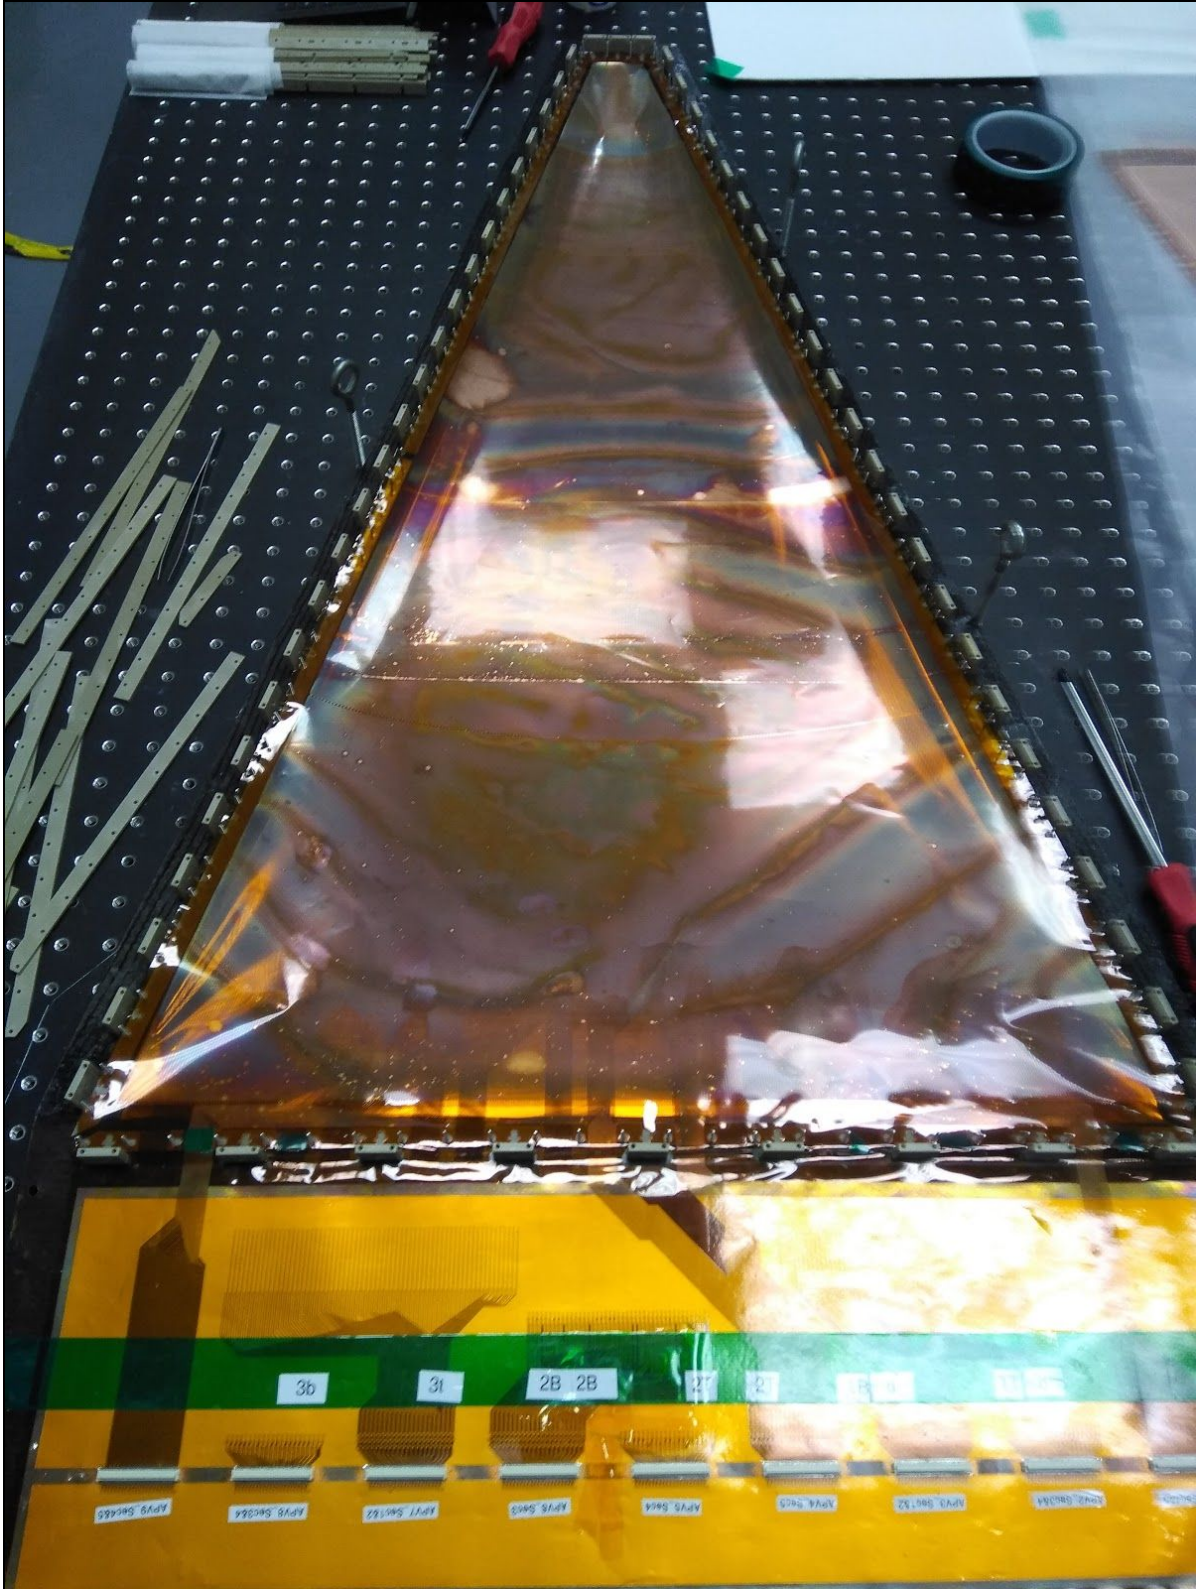
Figure 2: With all GEM foils removed, The readout board can be seen. (second rebuild)

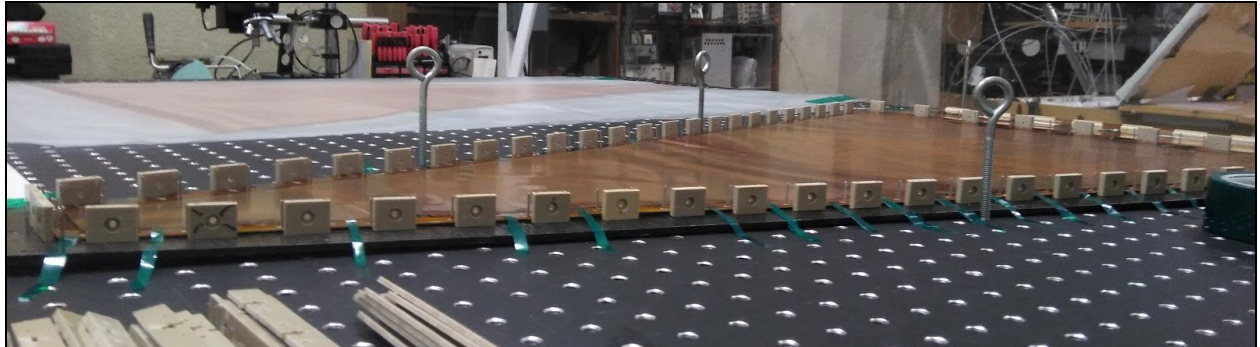
Figure 3: Tape keeping tension on the ROB (second rebuild)

Once GEM2 and GEM3 were removed, we spent several hours carefully removing pieces of tape from the foils that had been used for pretentioning during its last rebuild. Then we were able to start the rebuilding process. By carefully applying small pieces of tape, we were able to pre-tension the readout board, as pictured below.

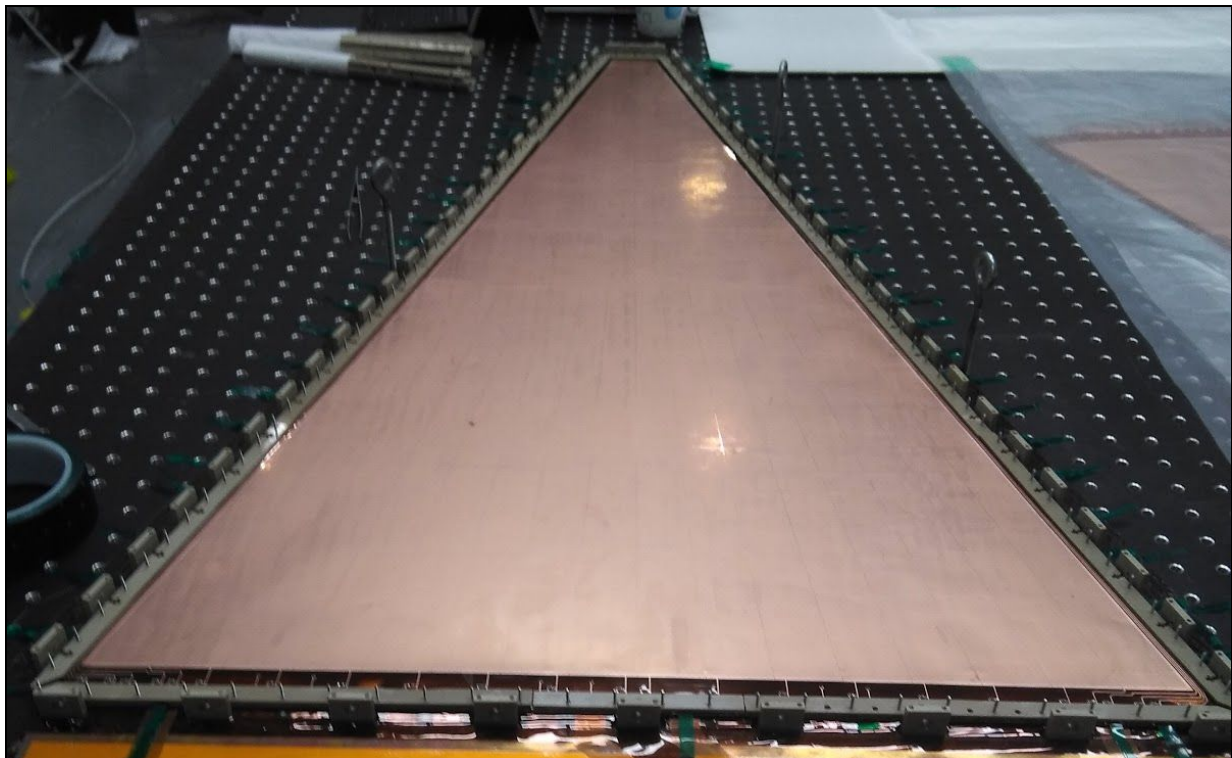
Figure 4: Here we see GEM3, which has been placed onto the stack. Note its lustrous copper shine, It is almost completely unblemished by the hands of undergraduates.

Following naturally, the first of the new PEEK frames were added and GEM3 was carefully placed over them. It was pretensioned with the same technique used on the ROB.

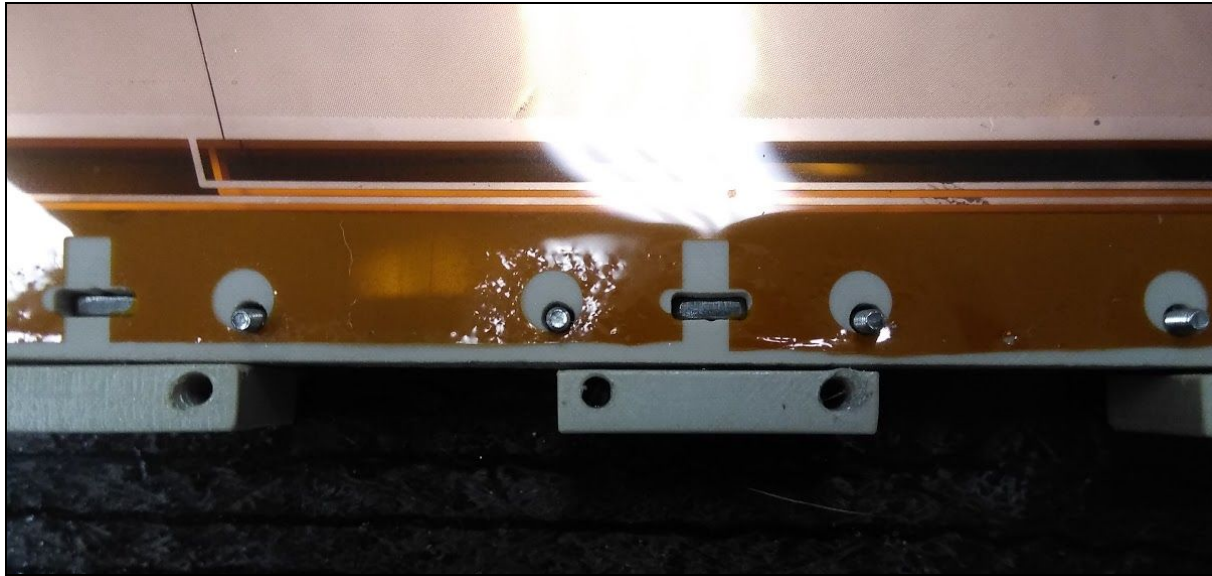
Figure 5: The snug fit of the new square nuts into the PEEK frame.

Quickly after this, GEM2 was added, and with it the new square nuts, which slotted into the PEEK frames beautifully.

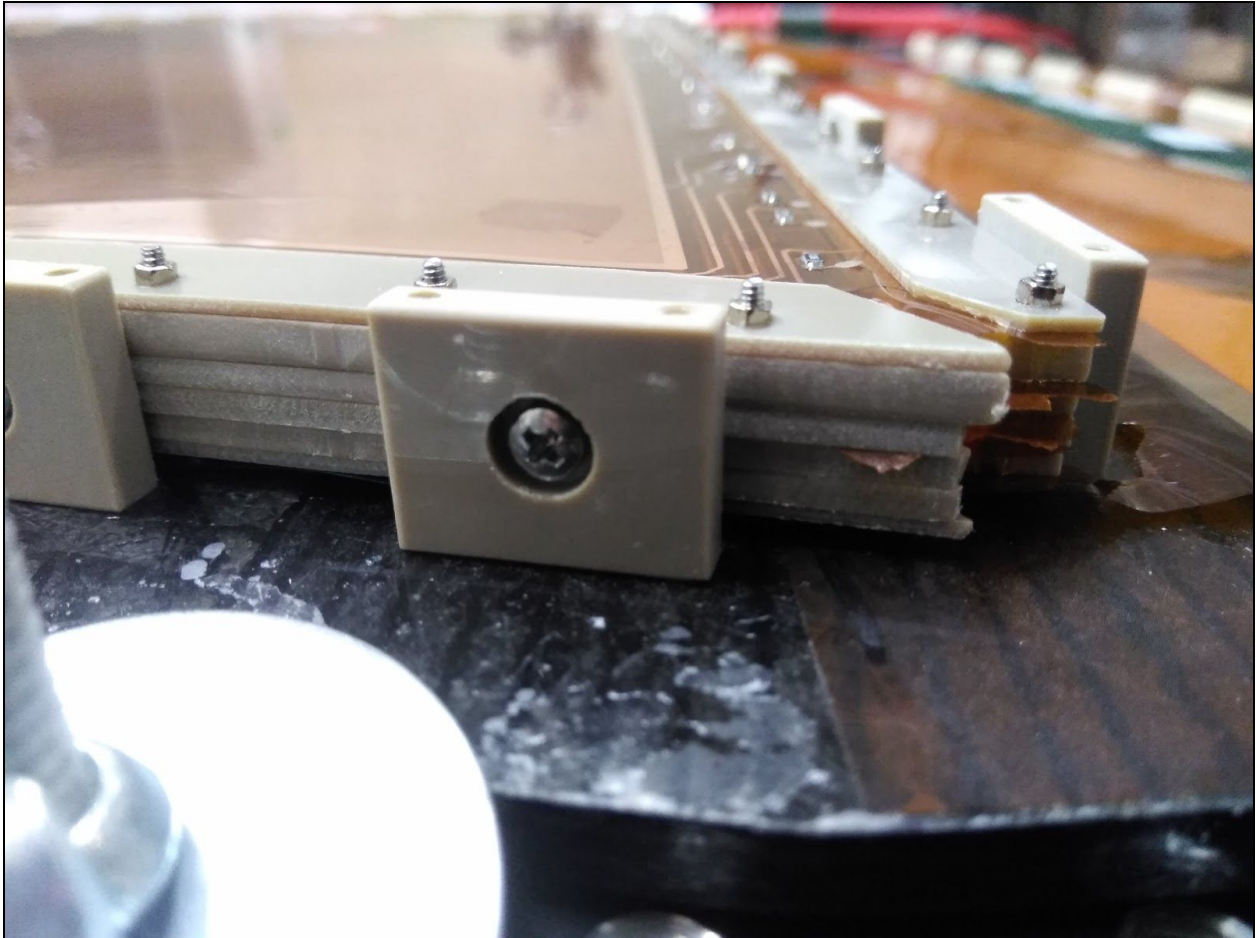
Figure 7: A close view of the hex nuts used to secure the stack, and the phillips head pullout bolts

Once GEM1 and the drift foil were placed on, we used hex nuts to secure the stack and prevent the foils from independently losing tension (this can be done most easily by using the famous “precision nut driver”). Then we carefully tried to remove the remaining slack by tightening the pullout bolts.

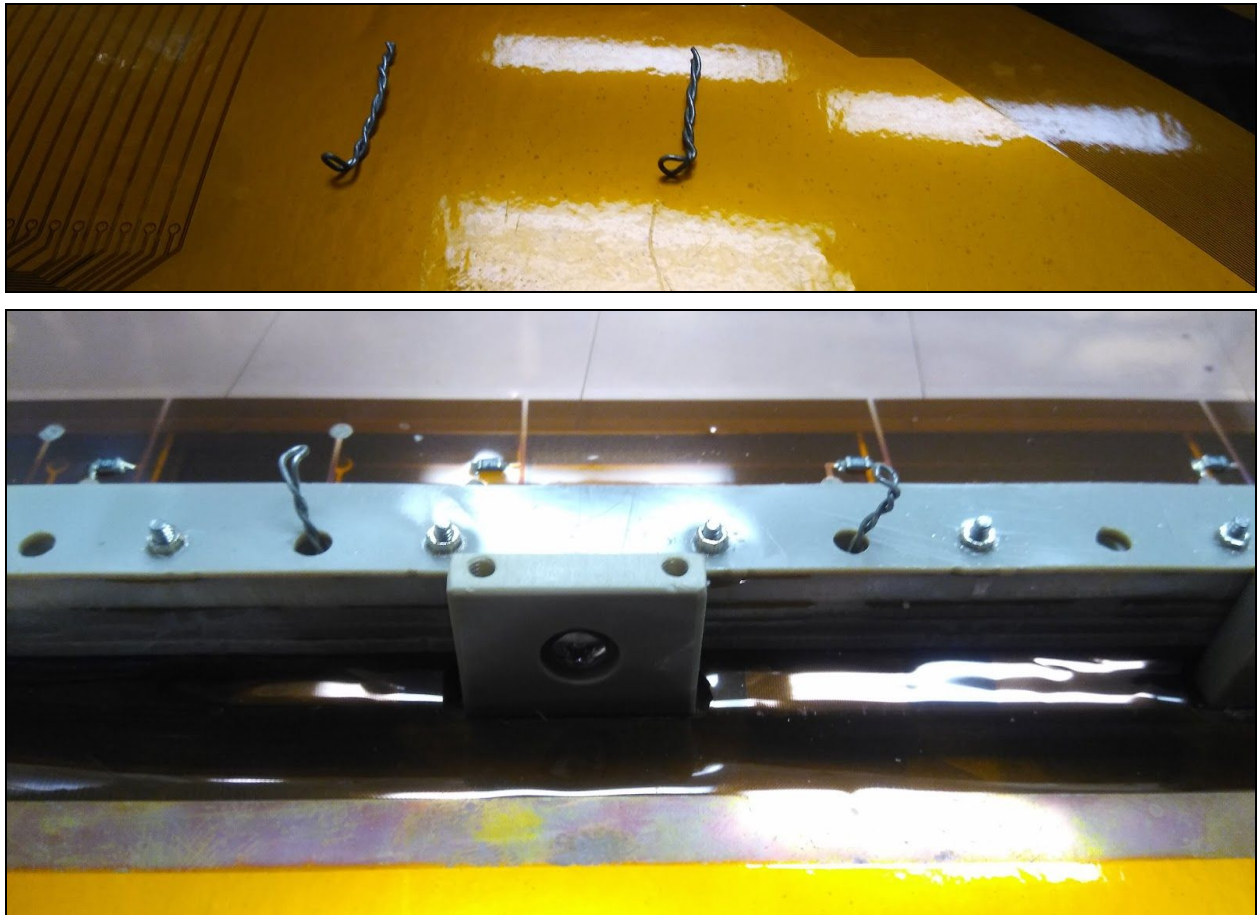
Once the stack was secured, we tested the resistances of the GEM foils and transfer gaps with the megger. The probes on the megger couldn't reach the pads through the small holes in the PEEK frames, so a pair of crude leads were fashioned to aid in the testing. The Initial results from these tests were promising, suggesting that no major shorts were present in or between the foils. (See the data in Table 1 taken on 9/21/2020.)

Figure 8: Crude leads and their application.

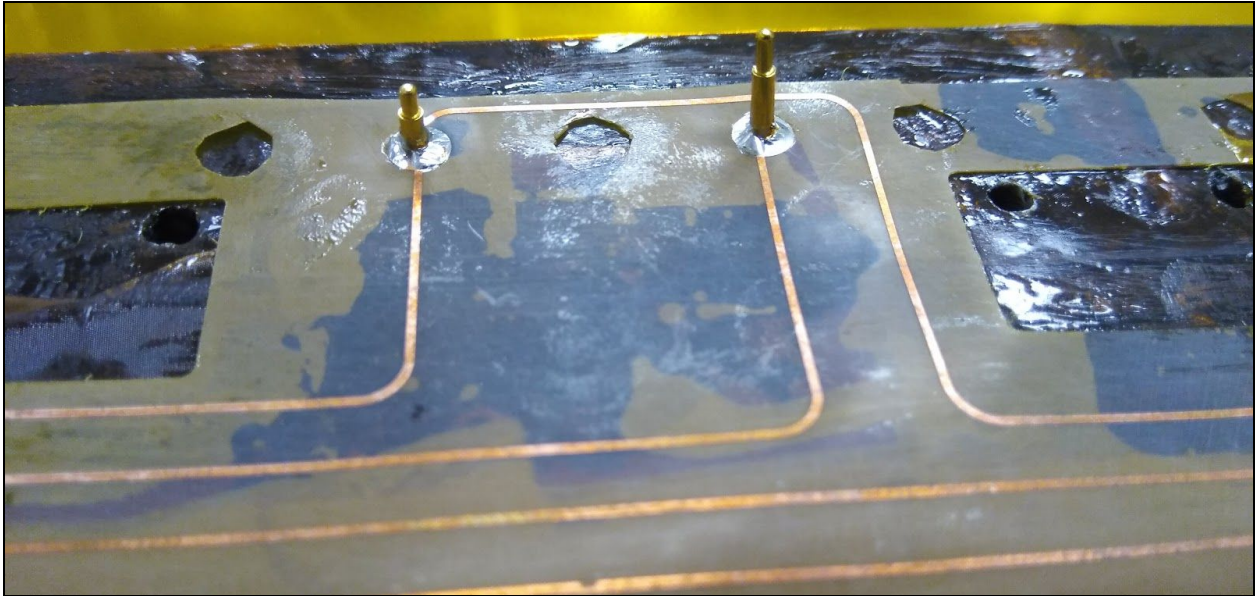
Figure 9: Pins and copper traces on the inside of the window.

Meggering on the external traces again gave promising results, showing no major shorts (See the 9/28/2020 data in Table 1).

Following from this, The window was placed over the detector. Pins on the inside of the window fit neatly into the previously mentioned holes in the PEEK frame, and allow it to be connected to an HV divider. The traces to the pins can also provide convenient leads for troubleshooting the detector while it is sealed.
