# EIC GEM Detector Prototype - Spring 2020 Progress Report

Brendan Steffens

April 2020

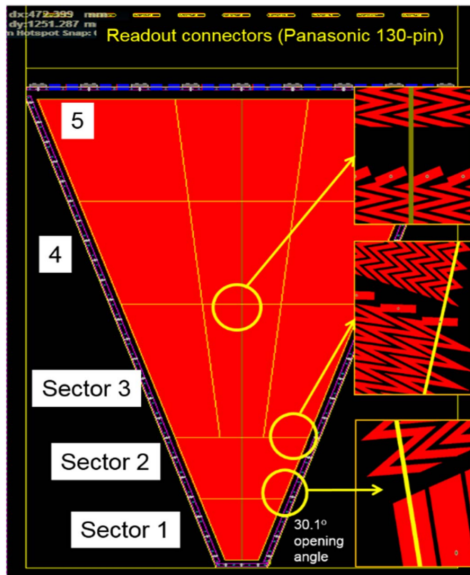
Figure 10: The layout of the EIC GEM prototype. Figure adapted from Hohlmann et. al: "A Low-mass GEM Detector with Radial Zigzag Readout Strips for Forward Tracking at the EIC".

Another immediate problem that should be addressed moving forward is the damage to the HV traces on the readout, mentioned previously, and shown in Figure 7. Presently, it is unknown what effect, if any, this damage will have on detector performance in the future. This should be investigated by the next HEP member working on the EIC prototype. The short exists with respect to Sectors 4 and 5. The significance of these labels can be seen in the schematic provided in Figure 10.

- Develop 3D-printed or machined adapter which allows the torque screw-drivers to be used with the metric tensioning screws for the prototype.
- Investigate the damage caused to the HV traces on the readout.
- Develop plan for increasing the gas tightness of the prototype.
