# **Experimental Hardware Development and Testing**

Eric Hansen Senior Undergraduate Research Report Summer 2013 Faculty Advisor Dr. Marcus Hohlmann High Energy Physics Lab A Department of Physics and Space Sciences Florida Institute of Technology

# **1m Acrylic Box Commissioning**

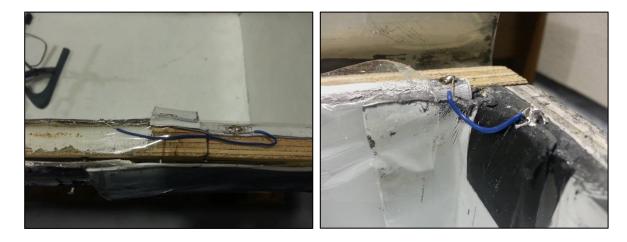
Figure 18: Completed expanded box with Interlock wires now installed (left=on, right=off)

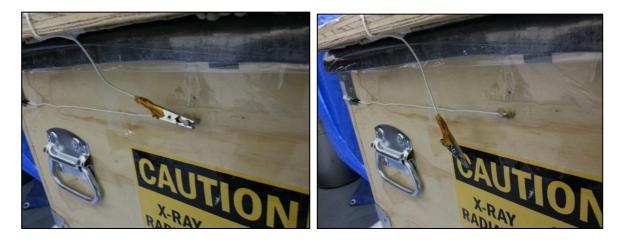
The interlock was installed so that there is a clip on each end of the box that must make contact with a nail for the interlock circuit to be complete. The hinged door must be closed for it to work.

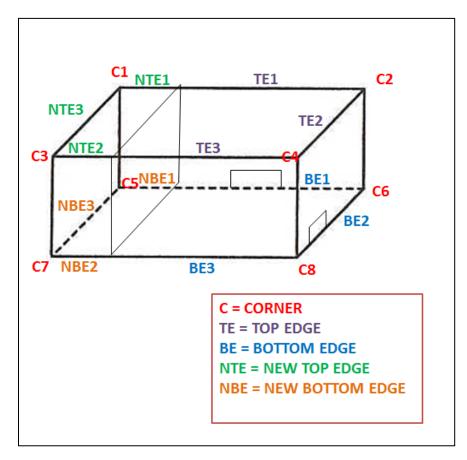
Figure 19: First part of the testing location key

As the data show, the corners leaked small amounts of radiation above the measured background levels, but no levels went over or even near 0.12 mR/hr (dangerous levels) for the tested locations. Not shown in Table 1, but diagramed in Figures 19 and 20 are the two rectangular holes that were used as cable feedthroughs. The only measurement taken for these holes was taken at a distance during which the Geiger counter beeped furiously and was observed to read 25+mR/hr. As soon as this measurement was observed (at an angle out of the source's cone of radiation), the Mini-X was shut off. Further testing was not safe. This one measurement was taken with the source pointed down at the
