Wise practices for coping with

BEACH EROSION

Montserrat

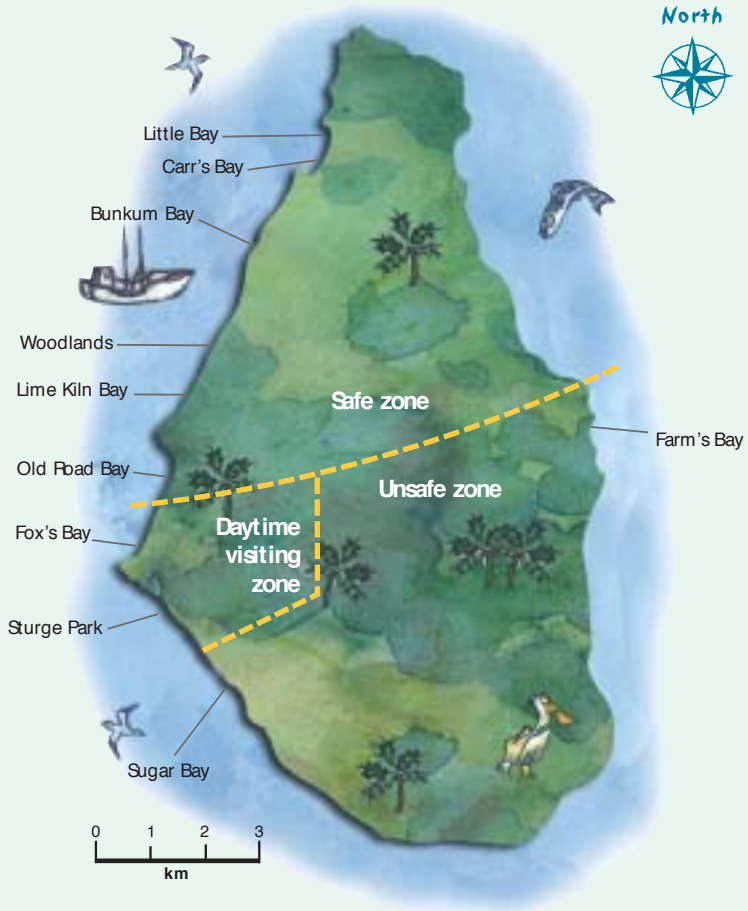
**Location of
monitored
beaches
in Montserrat**

In order to manage these changes, Montserrat's beaches have been monitored since 1990 by the Ministry of Agriculture, Land, Housing and the Environment, and more recently by the Fisheries Division. They measure the beach slope and width every three months at several sites around the islands. During the volcanic emergency, 1995-1998, monitoring was interrupted, but recommenced in 1999.

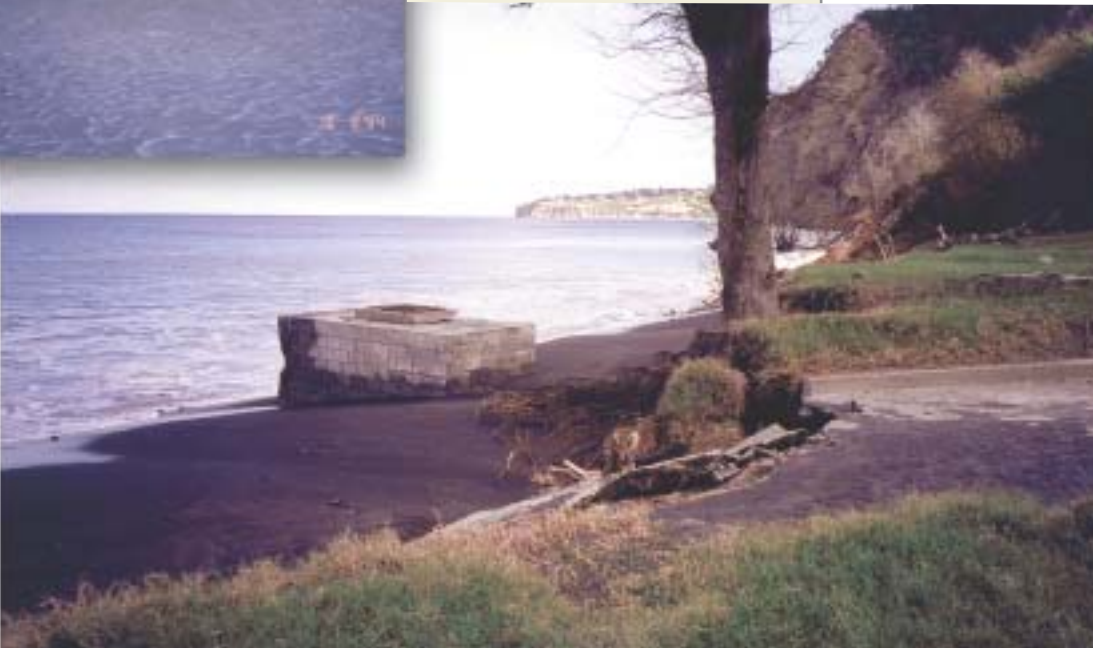
Fox's Bay, 1999,
after the impact of
Hurricanes Luis, 1995,
Georges, 1998,
and Lenny, 1999

When Hurricane Luis struck in 1995, much of the beach was lost at Fox's Bay on the west coast and at other beaches. In the months and years after the hurricane, the beaches recovered to some extent, but were further impacted by Hurricane Georges in 1998, and Hurricane Lenny in 1999.

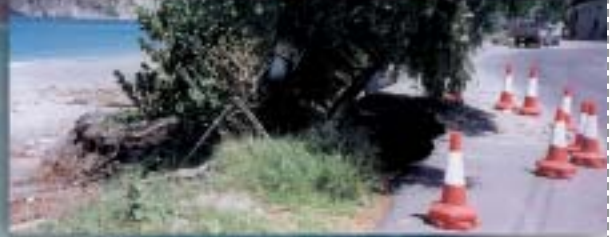
Road damage at Carr's Bay after Hurricane Georges, 1998

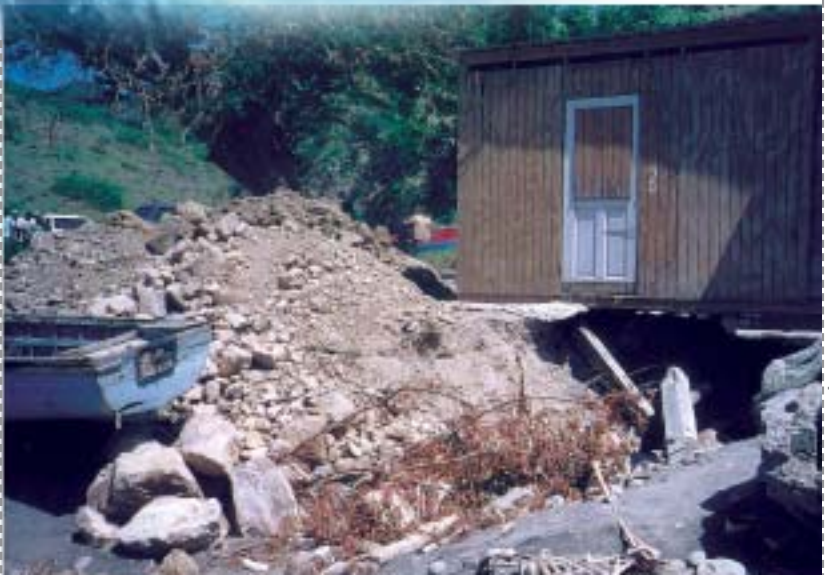
The foundations of this house at Carr's Bay were washed out during Hurricane Georges, 1998

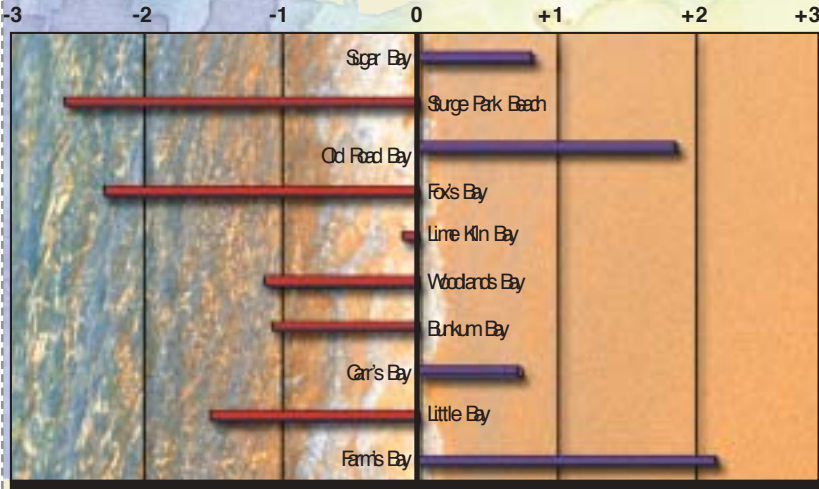
Beach change rates in Montserrat (metres per year)

A negative rate of change (—) indicates erosion and retreat of the shoreline, a positive rate of change (—) indicates accretion or advancement of the shoreline towards the sea.

The table shows generalized rates of change at the measured beaches in Montserrat between 1990 and 1996. During this period most of the beaches showed erosion, a result, at least in part, of the impact of several severe hurricanes. However, most beaches in Montserrat show erosion along one part of the beach and accretion (or build-up) at adjacent sections, thus these figures must be treated as average trends.

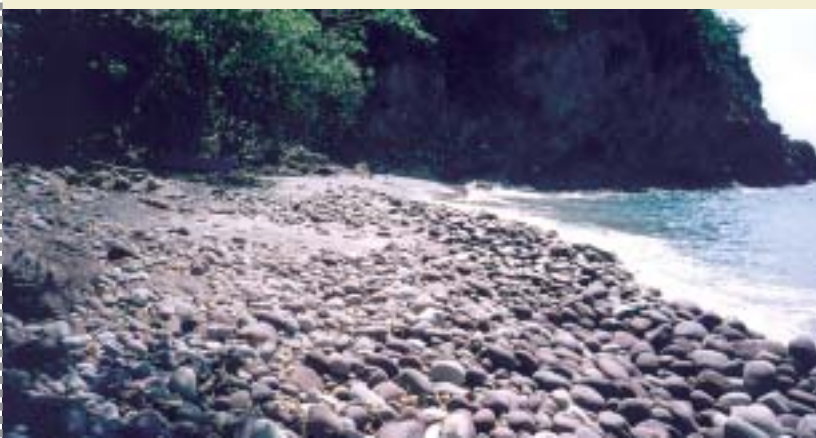
Many of Montserrat's west coast beaches are sandy in the summer months but covered with stones in the winter months, as seen here at Bunkum Bay, 1995

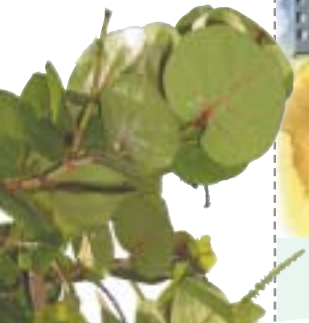
Ensuring new development is a 'safe' distance from the dynamic beach zone, helps conserve the beach and the buildings

- Planning new development so that it is a 'safe' distance behind the beach will reduce the need for expensive sea defence measures in the future.
- Revegetating beach areas beyond the reach of storm waves, and other coastal areas, with native vegetation, e.g. grasses, vines and salt resistant, deep-rooting trees, such as sea-grape.
